**Havarikommisjonen**  
Accident Investigation Board Denmark

**Bulletin 2023-271**

**Accident to D-EIRX (Reims F 172P) on Fur (EKFU) on 24-4-2023.**

**ISSUED AUGUST 2023**

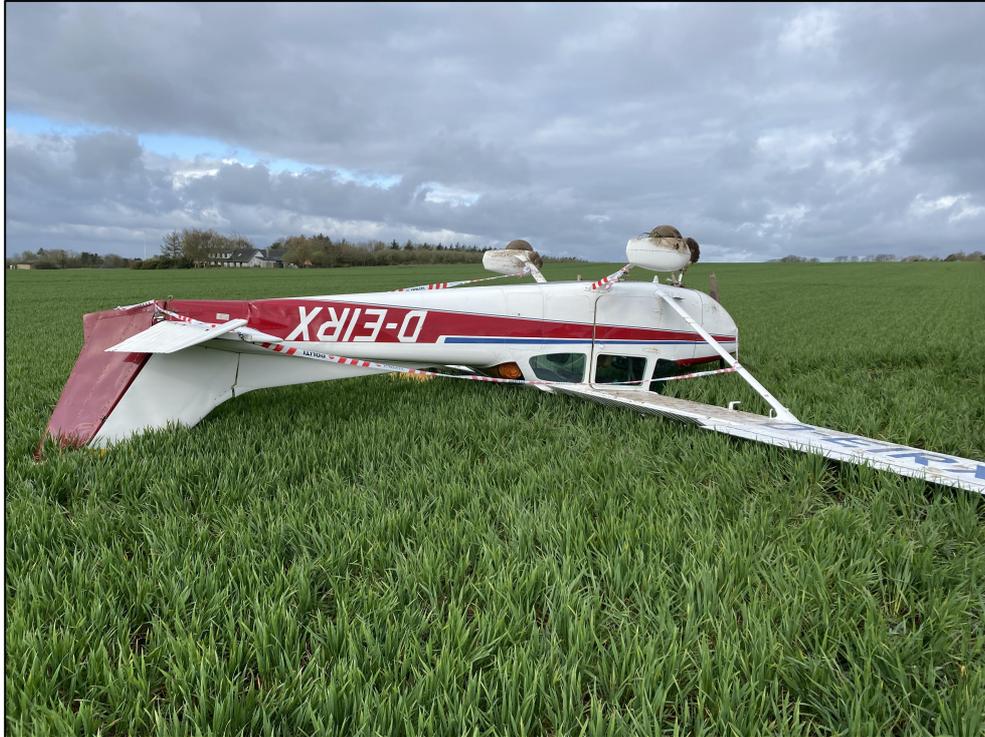
In a sideway skid, the aircraft ran off the side of the runway into a soaked field. The nose wheel sunk into ground, and the aircraft rotated over the propeller and the left hand wingtip and came to rest upside down

The runway excursion into a soaked field with crops consequentially led to a rollover and substantial damages to the aircraft.

Figure 1. The aircraft in an upside down position on the accident site.

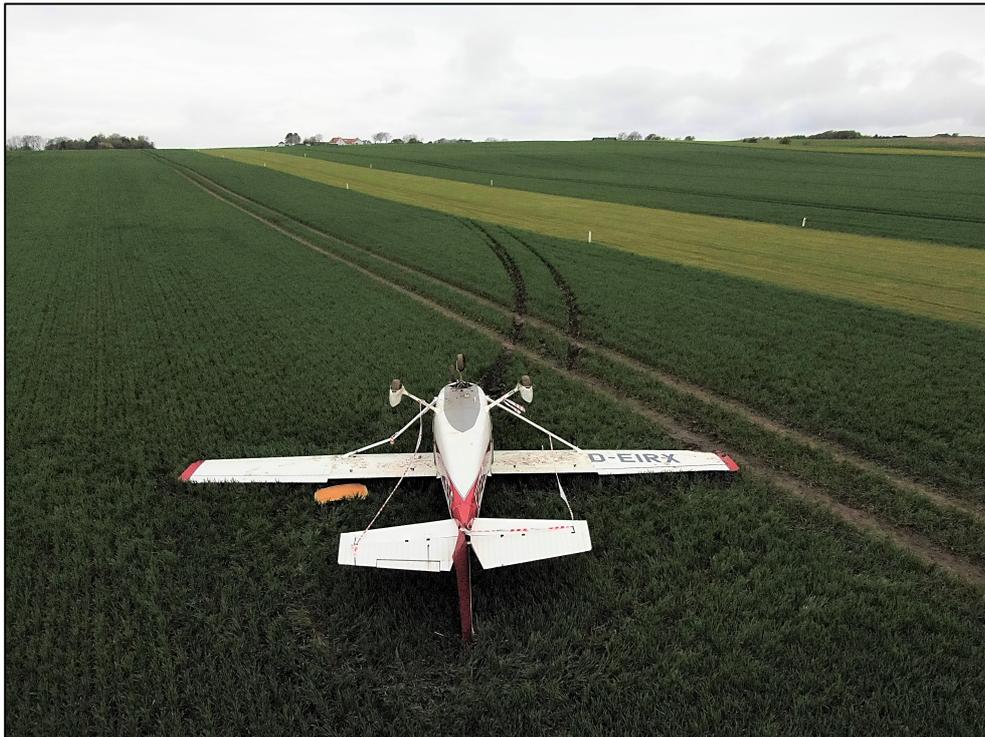
Figure 2. A drone photo of the accident site.

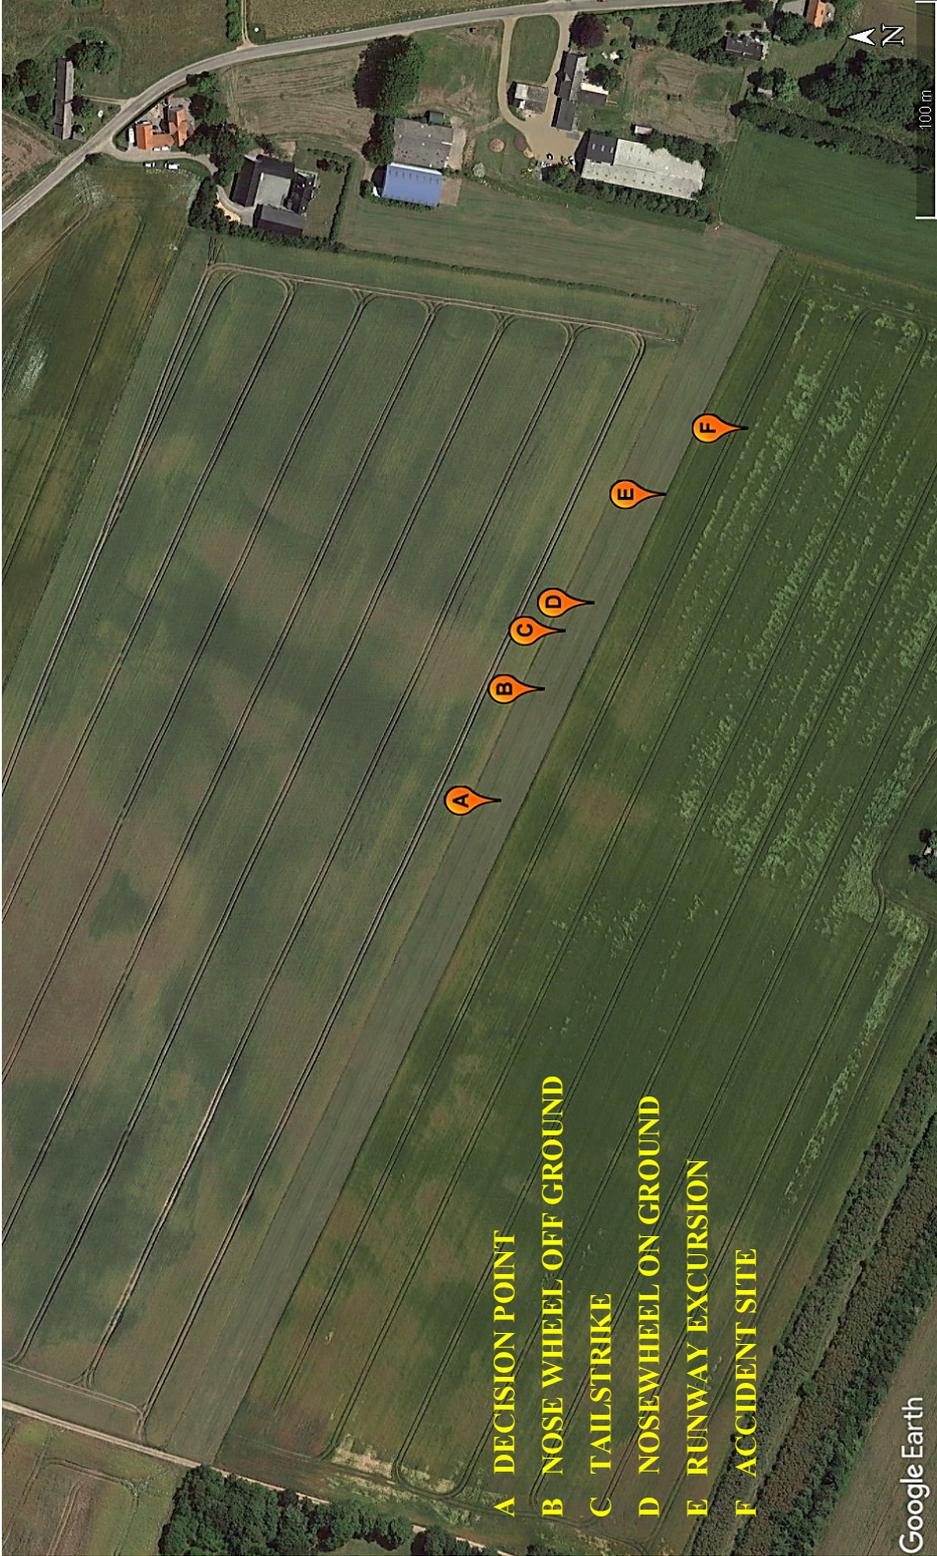
- b. Ground roll and runway excursion.
  - Aircraft tire marks from the beginning of the ground roll until the aircraft came to rest in a field were clearly visible.

- During the initial ground roll, the pilot had directional control along the runway centreline.
  - After the pilot predetermined stop/go decision point (approximately 330-340 m), the aircraft started veering slightly to the left of the runway centreline.

- After a ground roll of approximately 385 m, the nose wheel was off ground, while the main wheels still were on ground.
  - After approximately 414 m, while the nose wheel was off ground and the main wheels still were on ground, the tail section stroke the ground over a distance of 5.7 m. The aircraft was in a significantly veering turn to the right.

- After approximately 430 m, the main wheels and the nose wheel were on ground. The aircraft headed toward the right side of the runway.
  - The aircraft started skidding sideways to the right.

- After approximately 487 m, the aircraft ran off the side of the runway into a field.
  - After an approximately 45 m sideway skid into the field, the nose wheel sunk into ground, and the aircraft rotated over the propeller and the left hand wingtip and came to rest upside down.

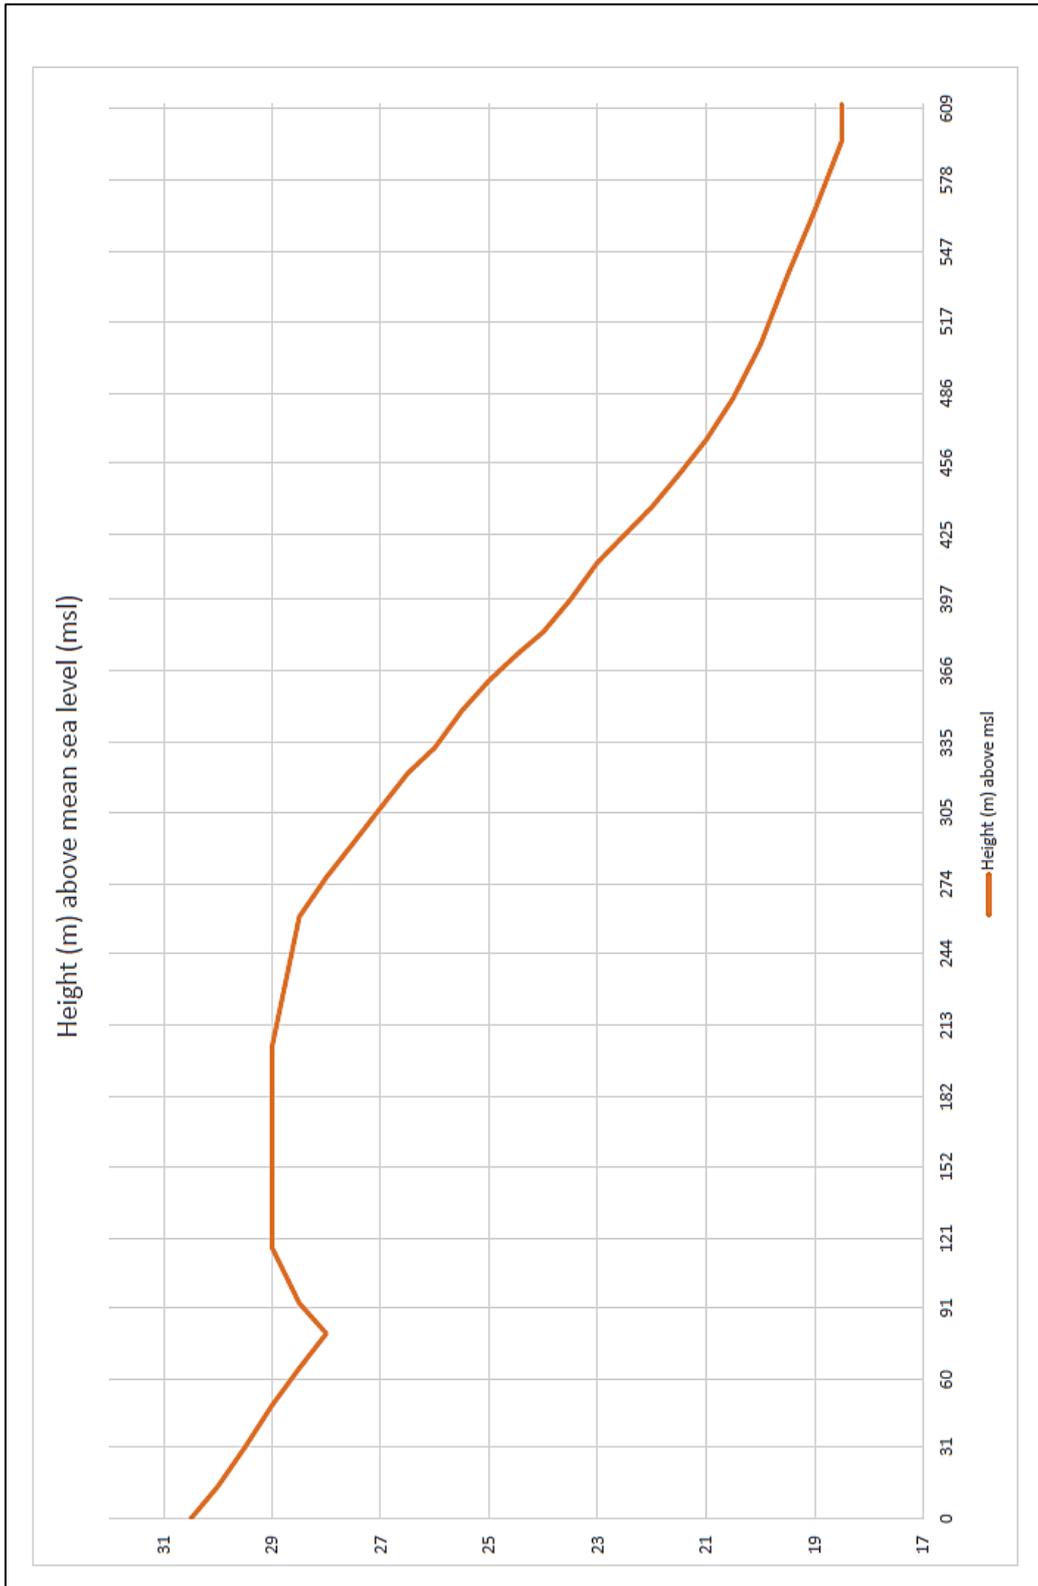
Based on contour lines developed by the Danish Agency for Data Supply and Infrastructure, the AIB calculated the average downslope of runway 12 to be 1.97%

$$\frac{(30.5 \text{ m} - 18.5 \text{ m})}{608 \text{ m}} \times 100 \approx 1.97$$

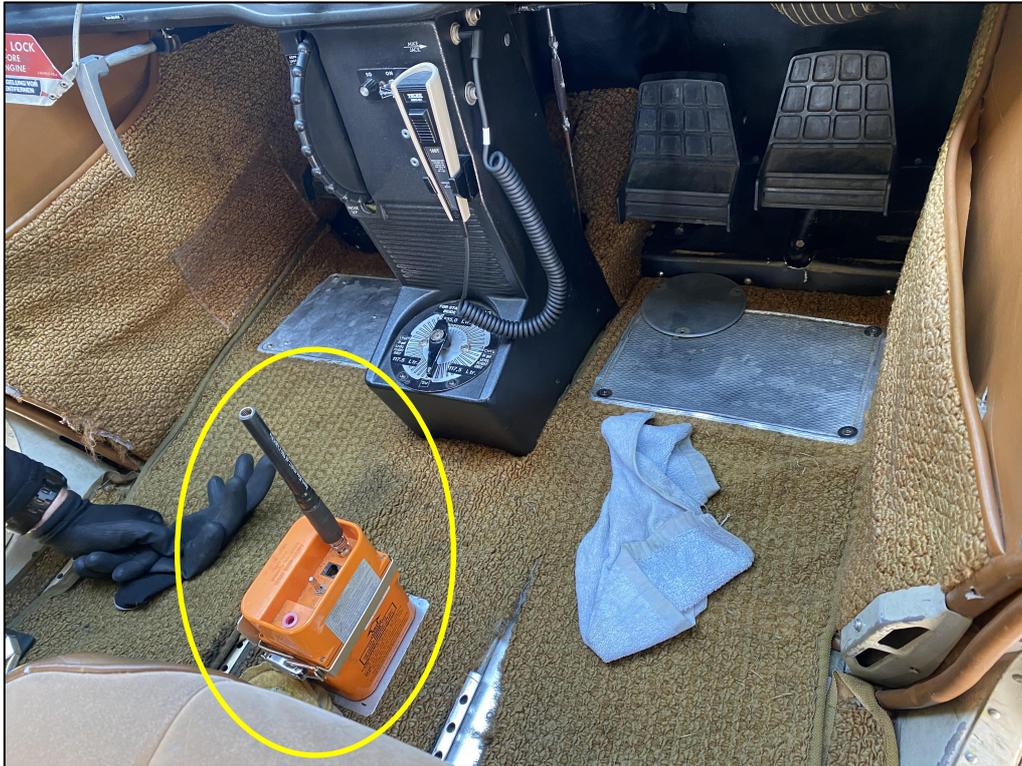
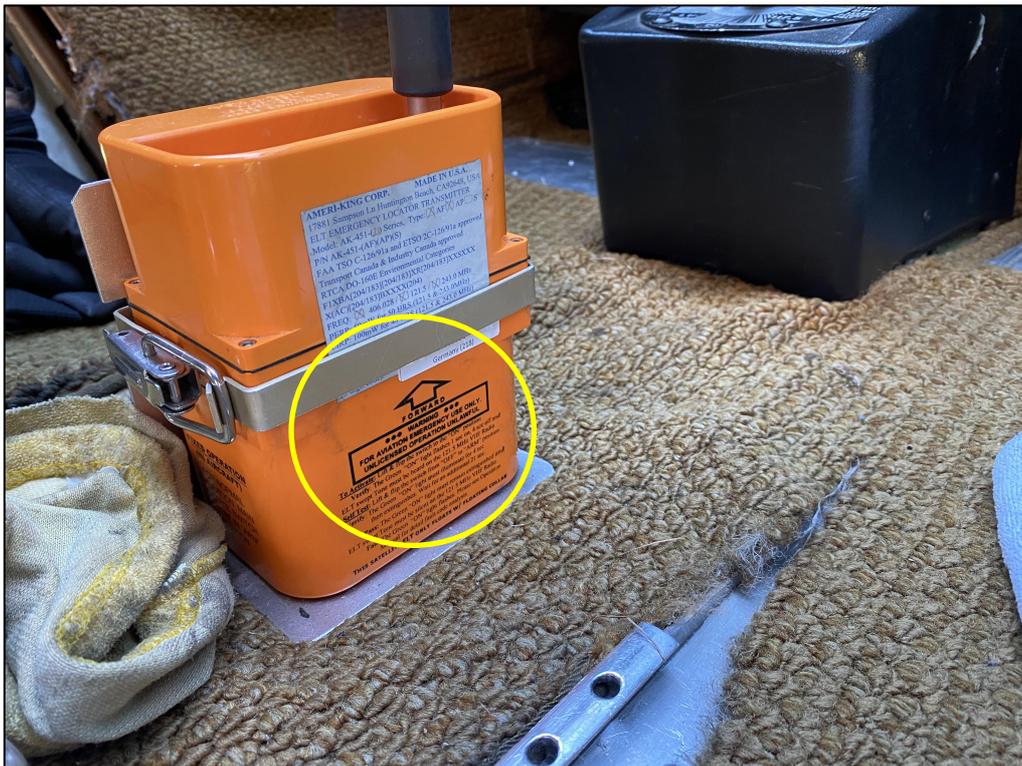
APPENDIX 9

A preliminary and later a thorough onsite inspection of aircraft primary and secondary flight controls gave no rise to remarks.

Damages to the propeller indicated low engine power at propeller ground contact in the field.

- The onboard ELT was in the OFF position.
- The pilot stated not having interfered with the onboard ELT before, during or after the sequence of events.
- The onboard checklist did not stipulate the pilot to arm the ELT before take-off.
- The onboard ELT was mounted between the front seats with the forward arrow, which was printed on the battery case, pointing upwards.
- Half of the ELT antenna was missing.
- [See appendix 9.](#)
- The AIB did an onsite ELT manual activation test without remarks.
- It was not possible for the AIB, neither from the aircraft owner nor the aircraft maintenance organization, to track the documentation on ELT installation and maintenance.
