# **BULLETIN**

**Serious incident**

**14-12-2017**

**PIPER PA46 350P JetProp DLX**

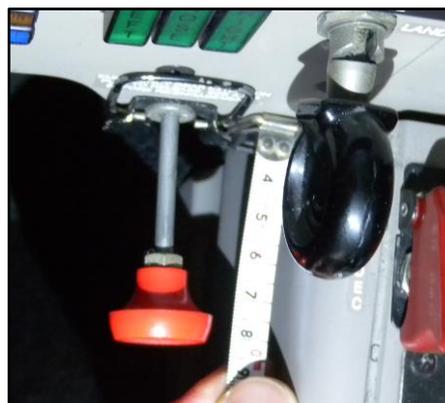
The emergency gear extension control was in a position extending approximately 3 cm from fully in.

See picture to the right (note measurement tape “start” at approximately 3 cm due to bending tip).

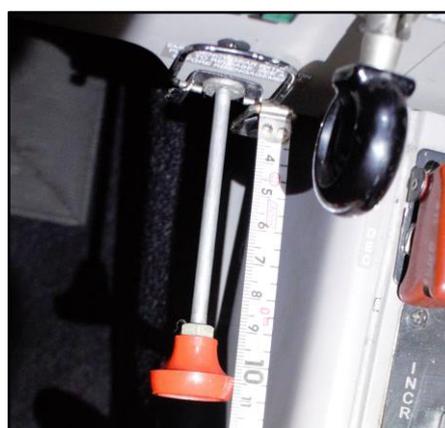
By applying a medium amount of force to the control, the AIB extended the emergency gear extension control another approximately 3 cm.

It was not possible for the AIB to extend the control any further.

Following this, the control was in a position extending approximately 6 cm from fully in.

See picture to the right.

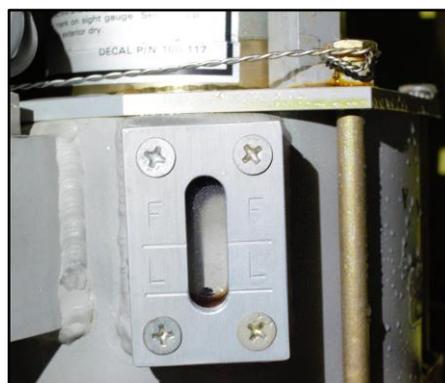
The reservoir sight gage had a small amount of fluid trapped indicating less than “L” (low). The reservoir was empty. See picture to the right.

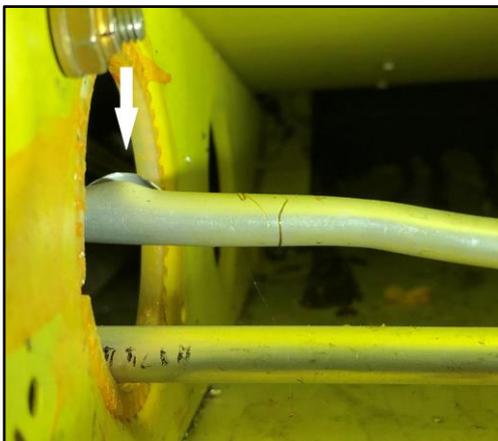
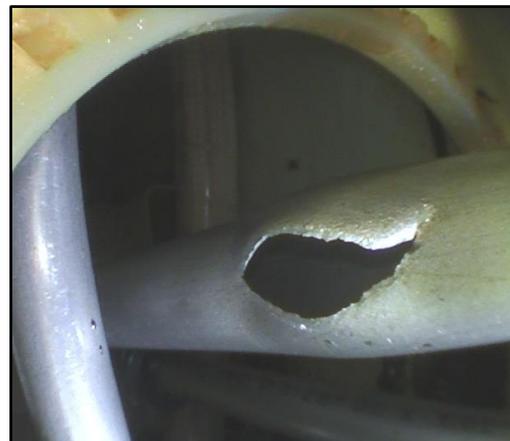
An inspection of the aircraft revealed a pool of hydraulic fluid in the fuselage area below the right pilot seat. A fracture was located on the hydraulic “down” line between the hydraulic pump and the hydraulic manifold. [See appendix 9](#)

See pictures of the failed hydraulic line below.

The AIB technical investigation of the hydraulic system did neither reveal the root cause for the failure (fracture) of the hydraulic down line nor the reason why the “HYD PUMP” c/b tripped during the sequence of events.

The most probable cause of the hydraulic tube fracturing, based on the appearance and location of the fracture, was determined to be a tubing material defect causing a fatigue fracture.

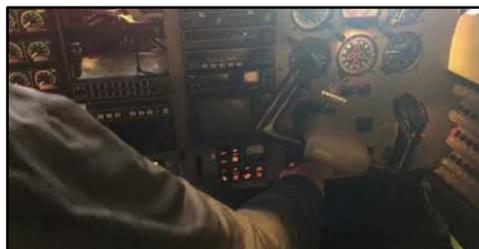
Activating the cabin vent/defog blower produced a distinct rattling noise of loud volume.

Metallic interference (metallic parts scraping against other metallic parts) produced the noise and negatively affected the output of the blower and the airflow across the supplemental heater element.

The noise from the failed blower was similar to what the pilot heard, and the reduced effect of the blower reduced the airflow downstream to the supplemental electric heater.

Without sufficient airflow, the temperature of the supplemental electric heater increased and caused an electrical smell in the cockpit.

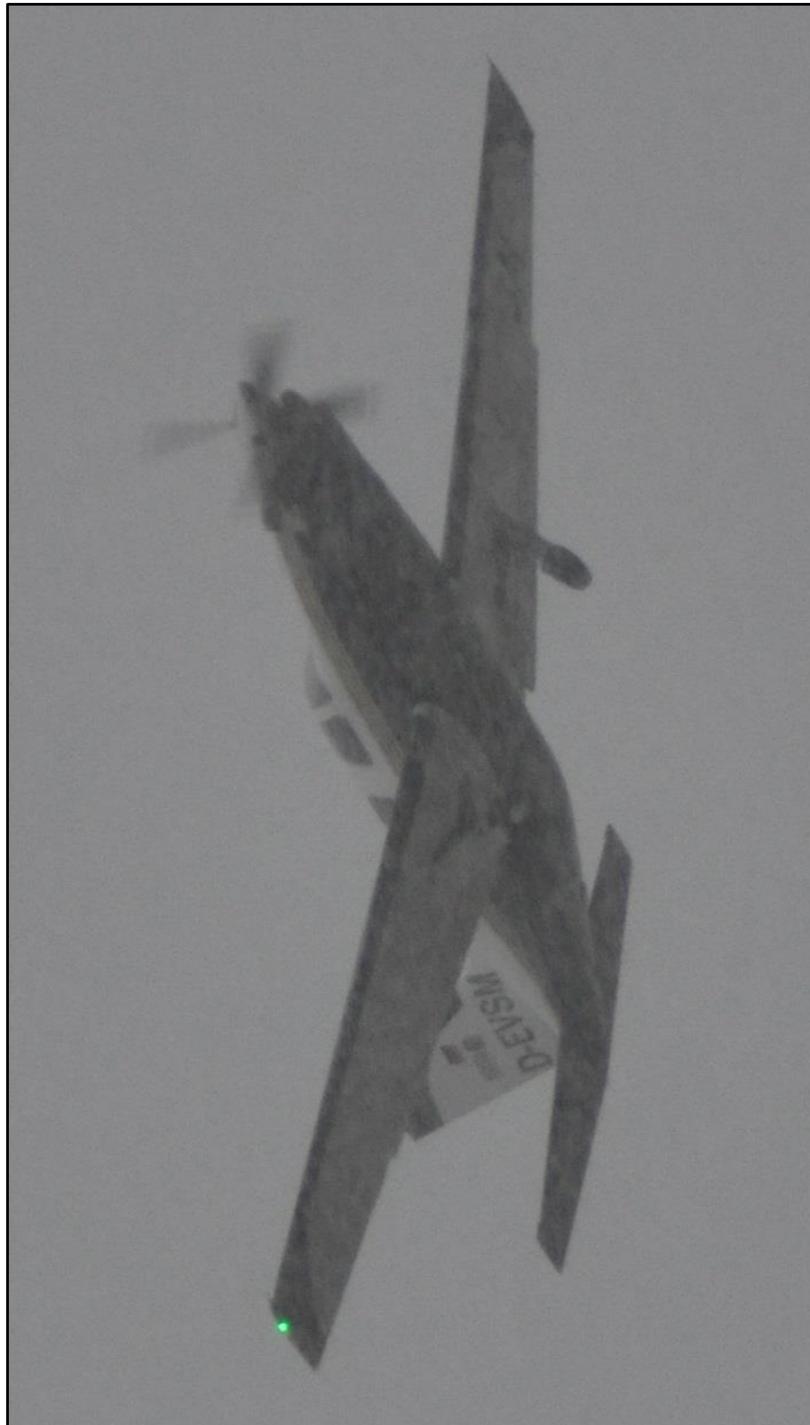
At 10:19:55 hours, the ATCO reported that the main landing gear appeared to be partly down but the nose landing gear was in up position. [See appendix 1.](#)

Picture of aircraft while circling overhead EKYT – landing gear position unchanged until landing
