Havarikommisjonen
Accident Investigation Board Denmark

Bulletin 2023-364

Serious incident to LN-TEP (Cessna U206G) near the city of Helsingør on 4-7-2023

ISSUED MAY 2024

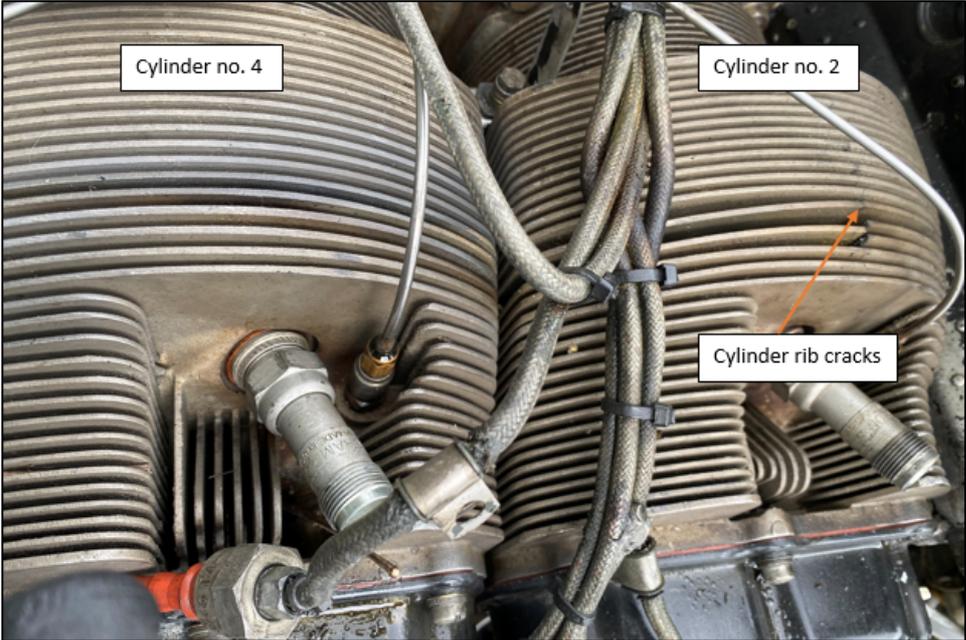
Cylinder no. 2 (left hand inner) cylinder head had several cooling ribs with cracks, and exhaust gas deposits were visible on the adjacent cylinder no. 4 cooling ribs.

Figure 1. Cylinder no. 2 cooling rib cracks. Dark exhaust deposits on cylinder no. 4 cooling ribs.

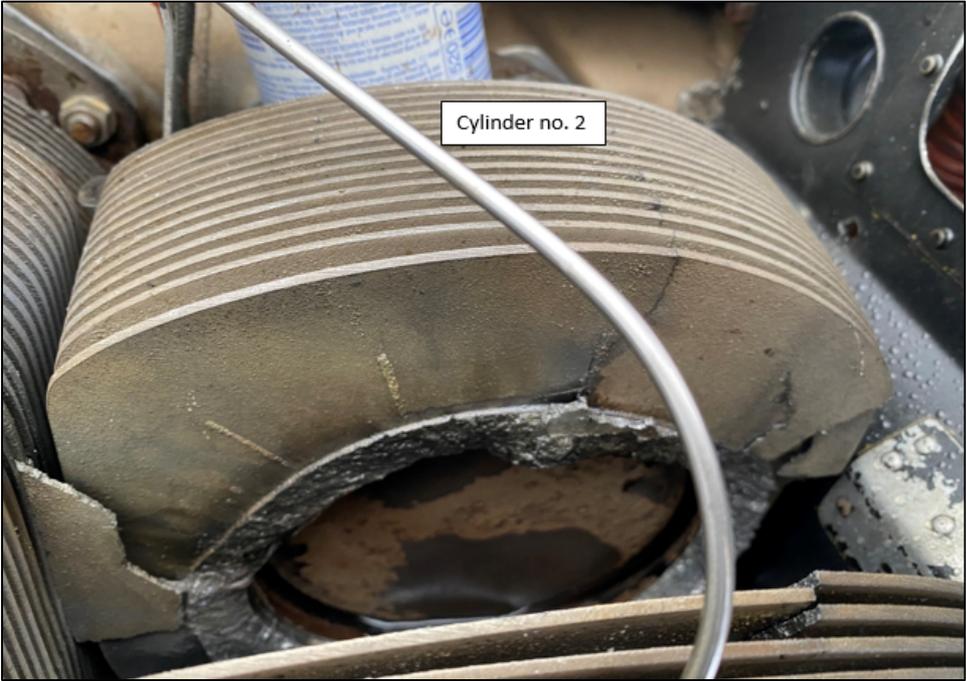
After removal of the air induction pipe and the exhaust pipe from cylinder no. 2, the fractured cylinder head dropped down.

Figure 2. Fractured cylinder head of cylinder no. 2.

Visual and metallographic examinations revealed that the aluminium alloy cylinder head fractured due to intercrystalline corrosion.

The intercrystalline corrosion initiated small geometrical notches reducing the fatigue and static strength of the cylinder head that ultimately resulted in a cylinder head fracture.

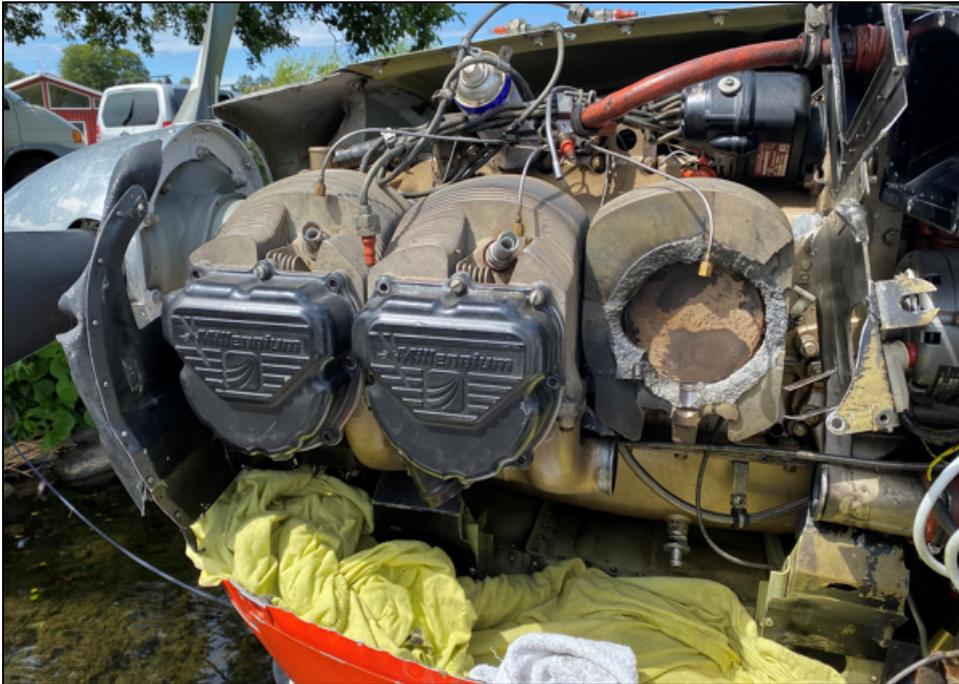
Figure 3. Side view of the engine with the fractured cylinder head of cylinder no. 2.

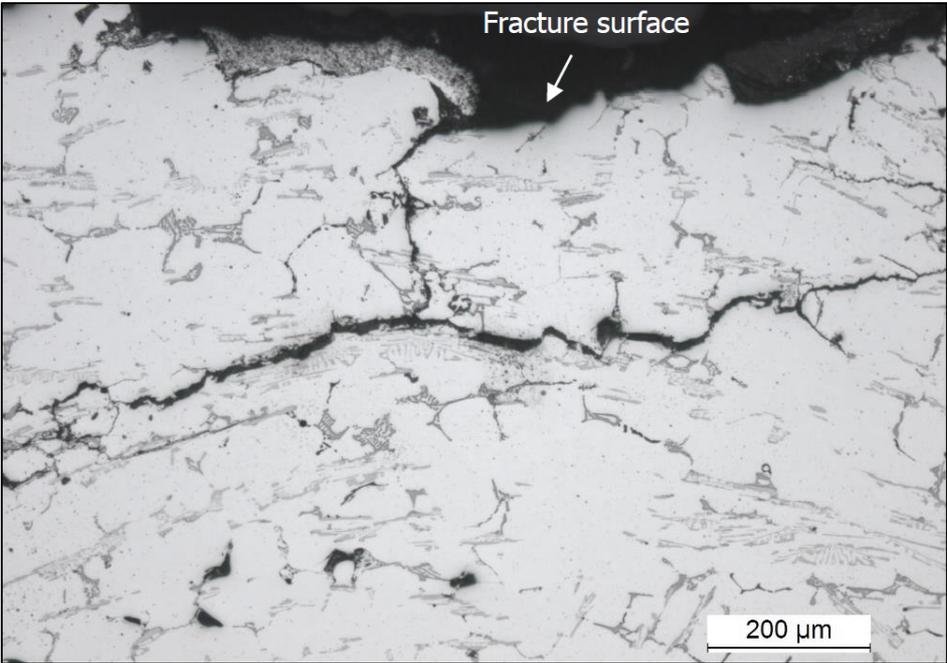
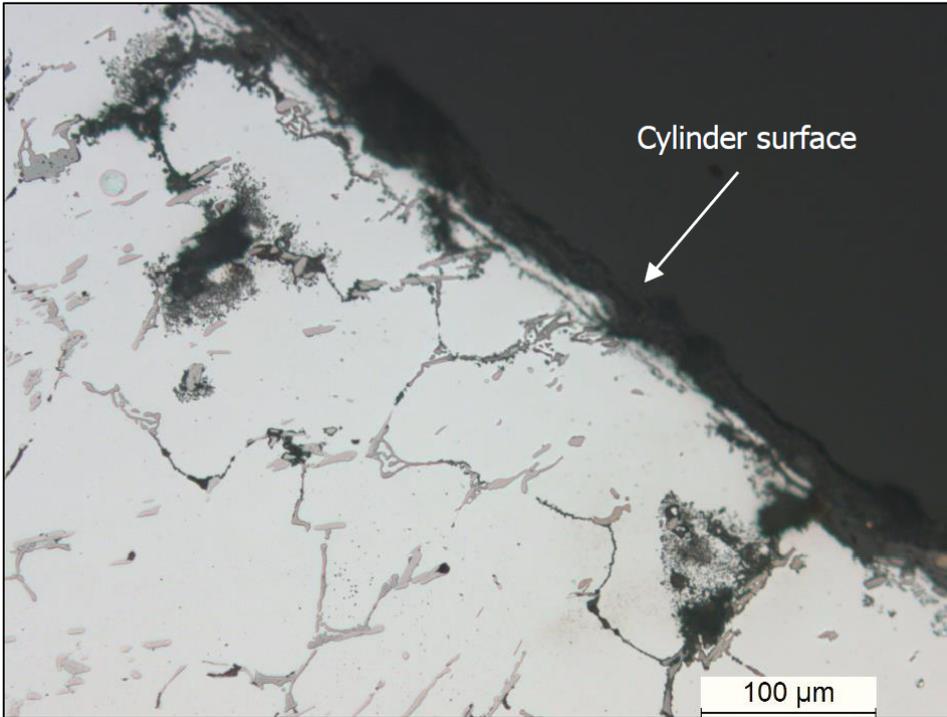
Appendix 2

Intercrystalline corrosion were black lines and clusters along the grain boundaries in the microstructure of the fractured surface of cylinder no. 2 head.

Intercrystalline corrosion initiated small geometrical notches reducing the resilience and strength of the cylinder.

A visual examination of the fracture indicated a fracture progression affected by both corrosion and fatigue.
