Havarikommisjonen
Accident Investigation Board Denmark

Statement 2024-193

Serious incident to N959CS (Textron Aviation Cessna T206 H) in Nuuk (BGGH) on 25-3-2024

ISSUED MAY 2024

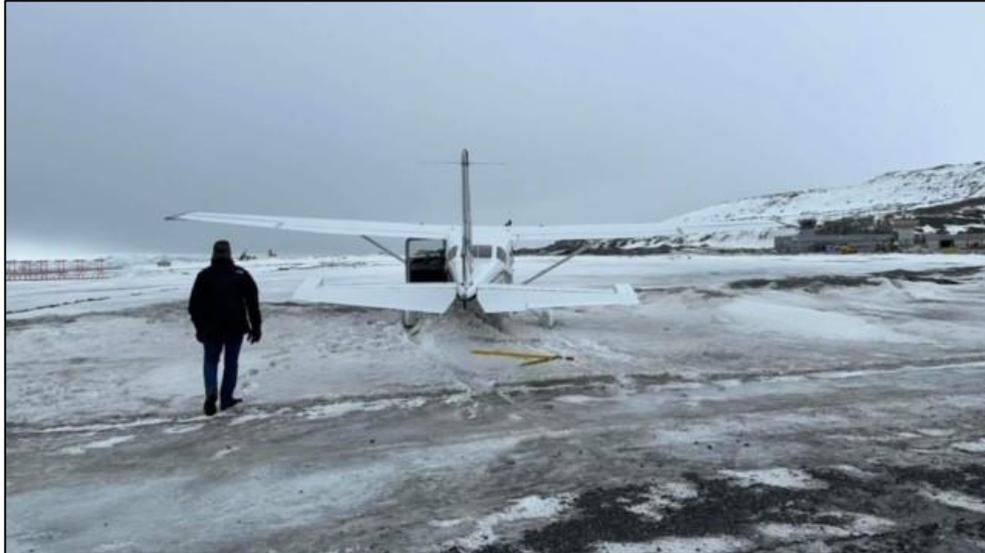
On the second approach, the aircraft touched down approximately 300 metres after the runway threshold, and the pilot activated the toe brakes to stop the aircraft, but without any effect.

While decelerating slowly, the aircraft continued rolling down the runway. Shortly before the end of the runway, the left brake started working intermittently.

At low speed and slightly left of the centreline, the aircraft overran the runway. The aircraft continued rolling approximately 20 metres before hitting a 25 centimetres high soft snow bank and stopped.

Figure 1. The aircraft stopped in a low snow bank.

It was the pilot's opinion that snow and ice, accumulated in the aircraft wheel spats (wheel fairings) while operating on ground in CYR, froze en route and prevented braking during ground roll in BGGH.
