Havarikommisjonen
Accident Investigation Board Denmark

BULLETIN

LANCAIR IV P

SE-XRU

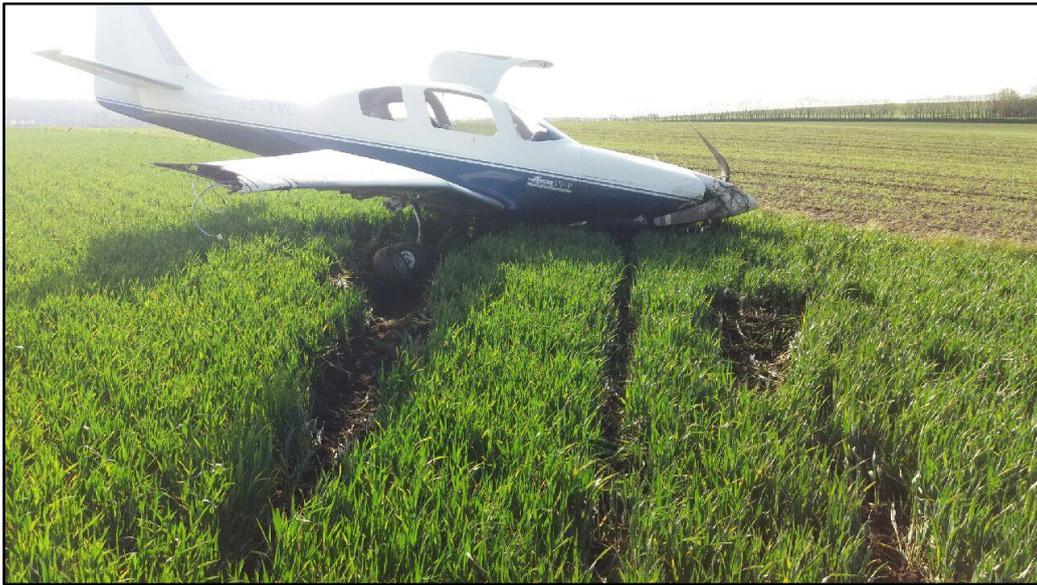
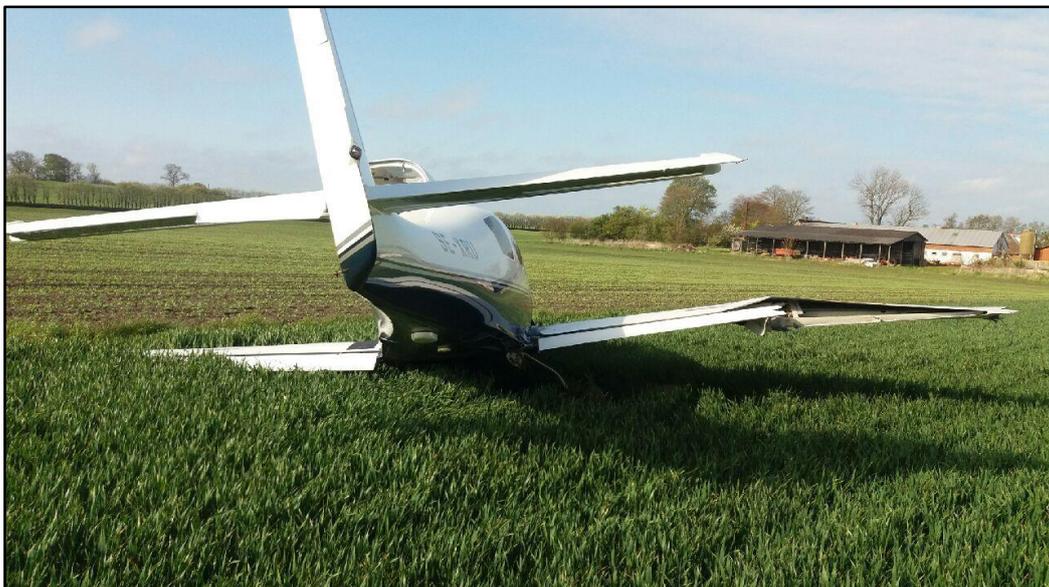
The crops had a length of approximately 40 to 50 cm.

There was no traces of engine oil on the ground below the aircraft.

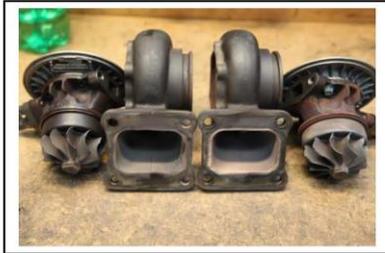
Turbo and transition exhaust port.

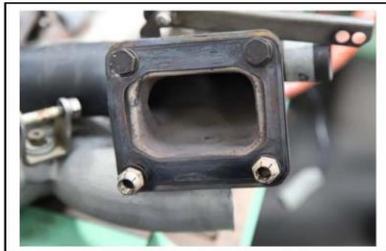
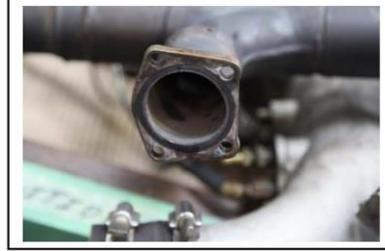
Exhaust pipe

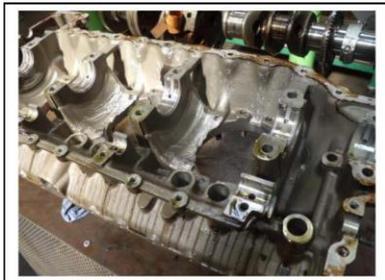
Camshaft bearing bridge

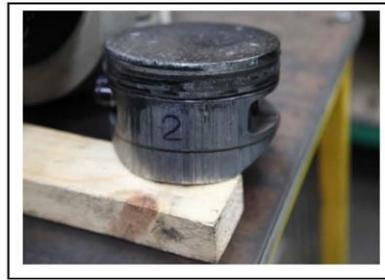
Piston cyl.#2

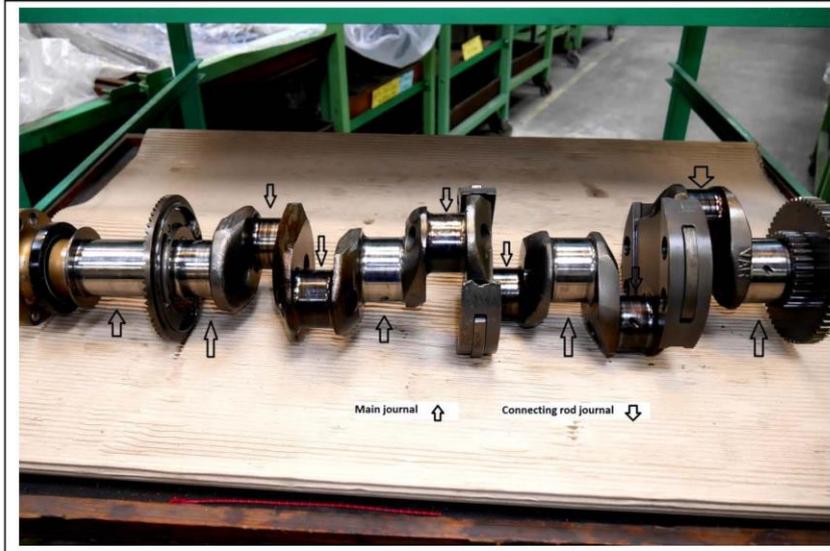
Main and connecting rod journal

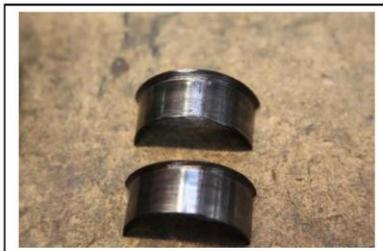
Connecting rod bearing

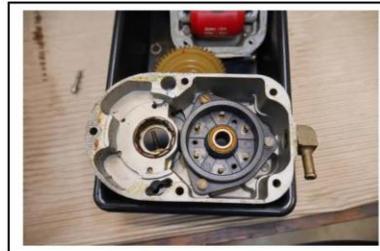
- Magnetos, p/n 10-500556-101
- s/n G129902D, tested, no remarks, checked for gasket for press. installation, disassembled.
No remarks.
- s/n J160005D, not tested due to damage, only checked for gasket for press. installation.
No remarks.
- none of them showed sign of mal-function on distributor block.

Magneto

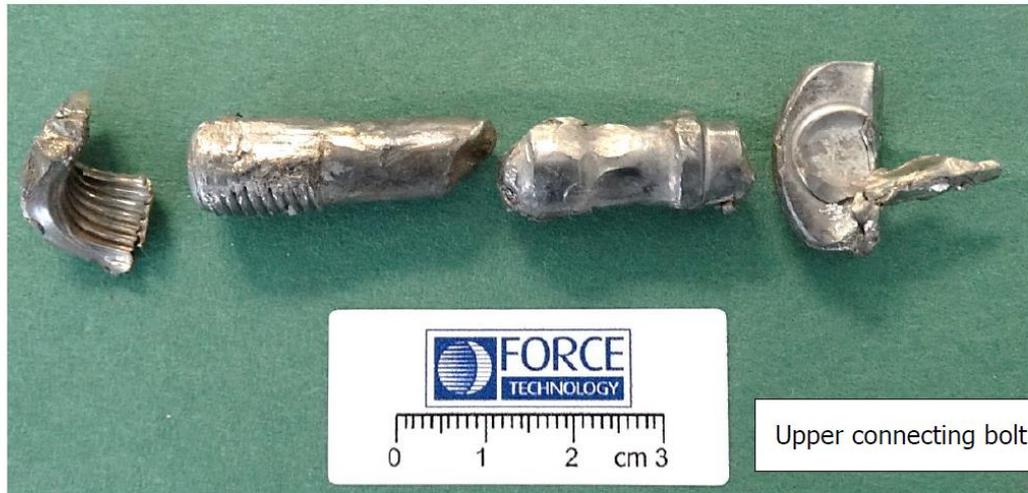
The bolts were broken in several places, and bolt heads and nuts were heavily battered from contact with surrounding bodies and surfaces, c.f. Figures 1-6 in Appendix 1.

Examination of the fractures revealed failure modes by overload due to axial, shear and bending loads. There are no signs of bolts being loose prior to failure. Likewise, there are no signs of pre-existing material defects being responsible or contributory to the fracturing. The overall appearance indicates bolt failures caused by collateral damage rather than being involved in the cause and origin of the engine problems that prompted the emergency landing.

The fracture mode is overload imposed in the course of escalating engine problems.
The fracture in the bolts is due to consequential damages.

Figure 1 Parts from the upper connecting rod bolt and matching spiral lock nut after cleaning.

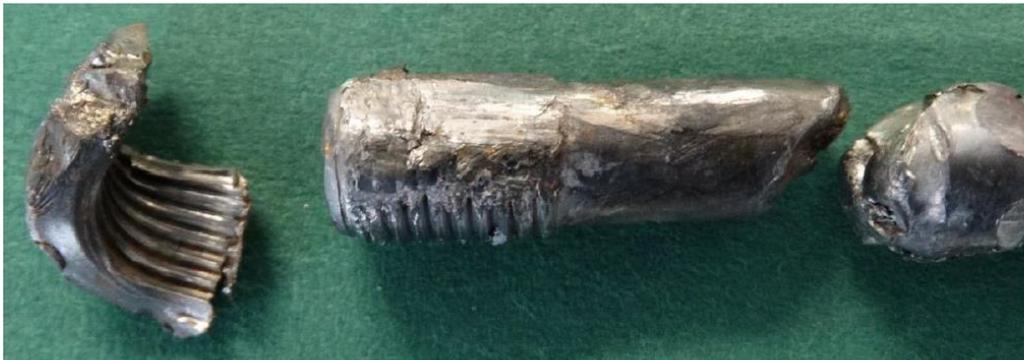
Figure 2 Close-up of part from Figure 1.

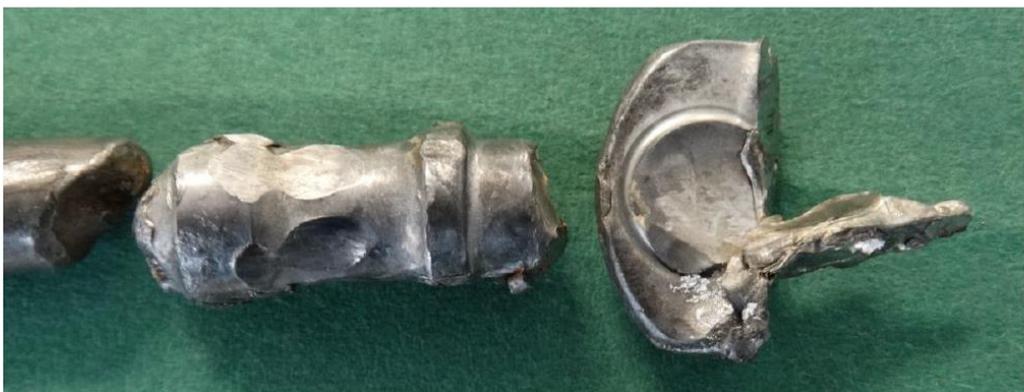
Figure 3 Close-up of part from Figure 1.

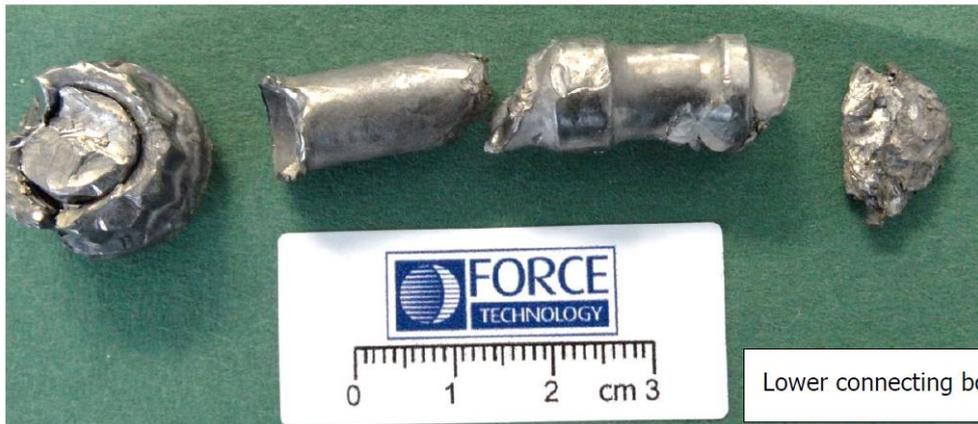
Lower connecting bolt

Figure 4 Parts from the lower connecting rod bolt and matching spiral lock nut after cleaning.

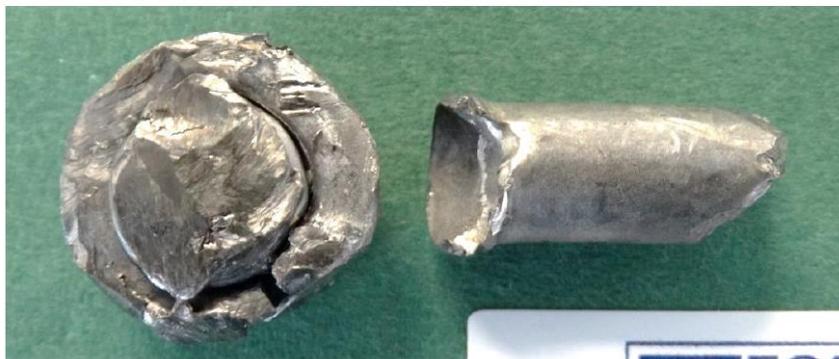
Figure 5 Close-up of part from Figure 4.

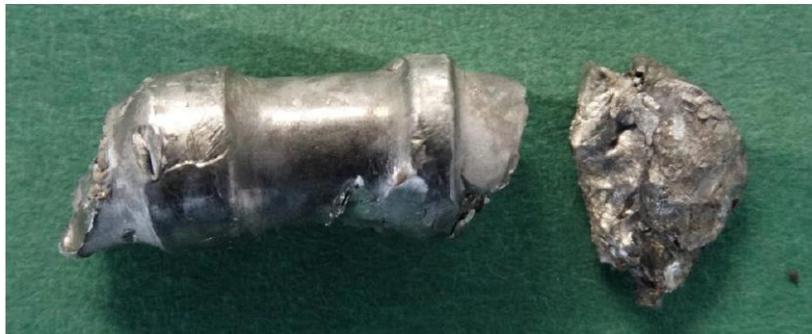
Figure 6 Close-up of part from Figure 4.
