**Havarikommisjonen**  
Accident Investigation Board Denmark

# **BULLETIN**

**Serious incident**

**BOEING MD-82**

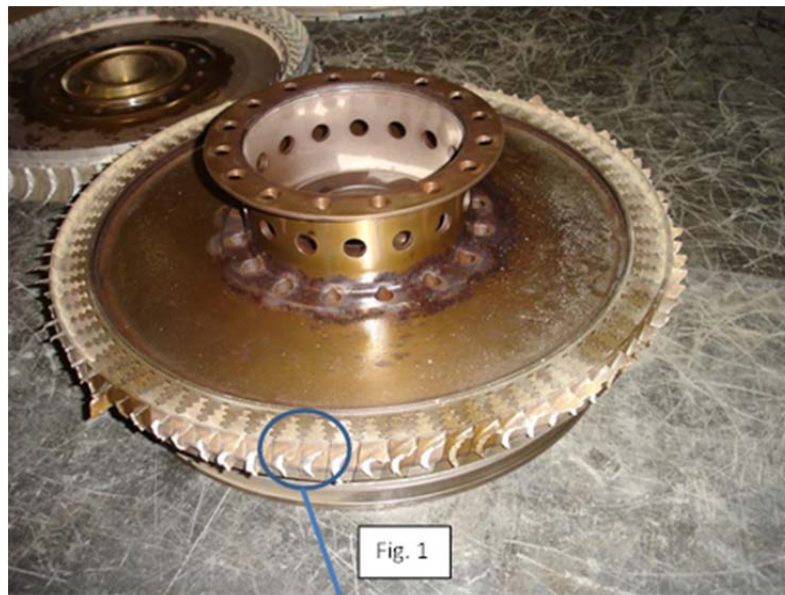
The visual examination of the engine revealed that all 3<sup>rd</sup> stage low pressure turbine (LPT) 88 blades were fractured at or near the airfoil root above the flowpath platform. See figure 1.

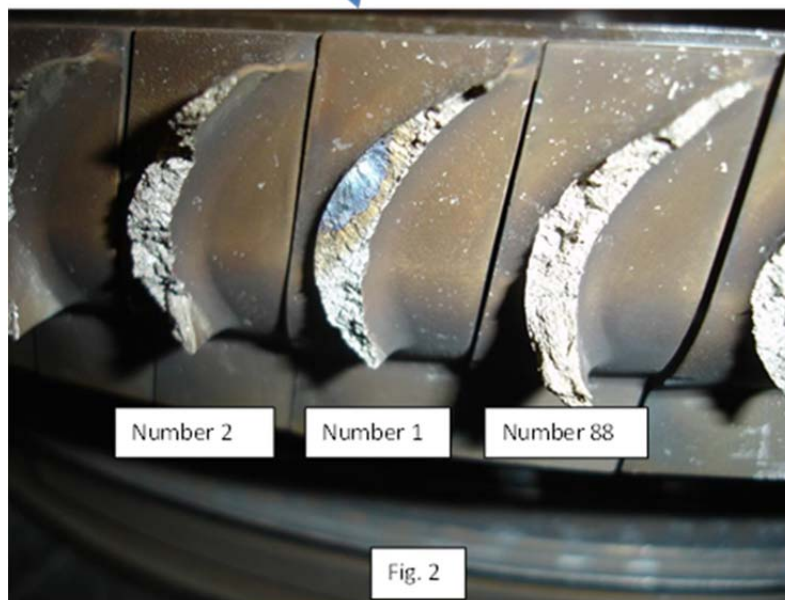
The examination revealed that one of the 3<sup>rd</sup> stage LPT blades (blade number one) had signs of heat and fatigue in the fractured area, see figure 2.

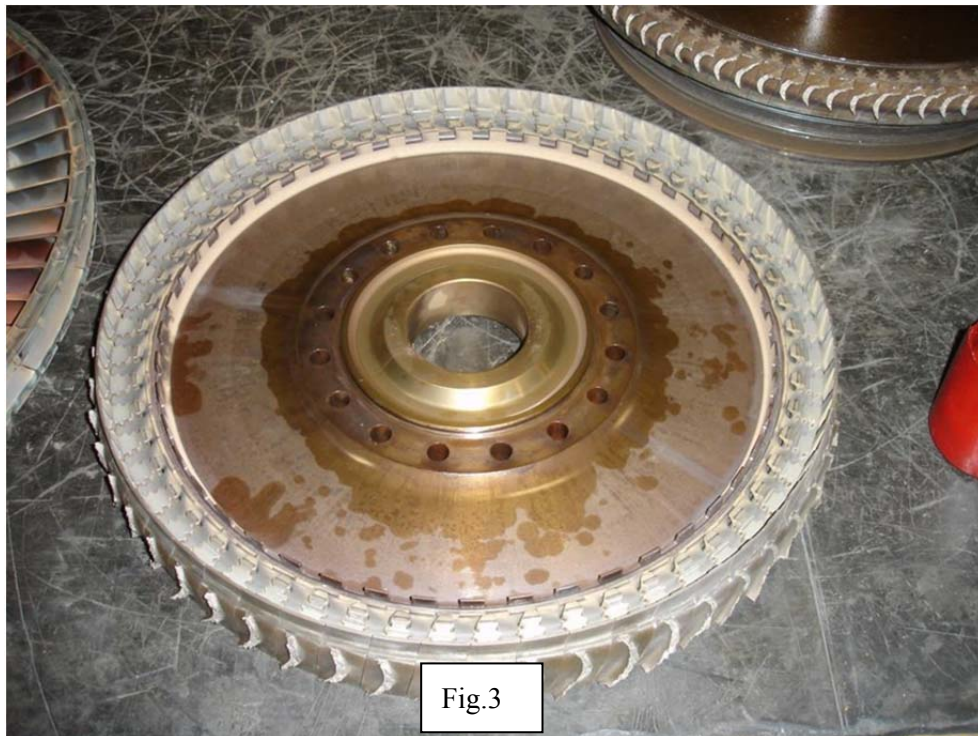
All 4<sup>th</sup> stage LPT blades were fractured at the blade airfoil roots. See figure 3.

The remaining parts of the 4<sup>th</sup> stage LPT disk blades did not reveal any evidence of fatigue.

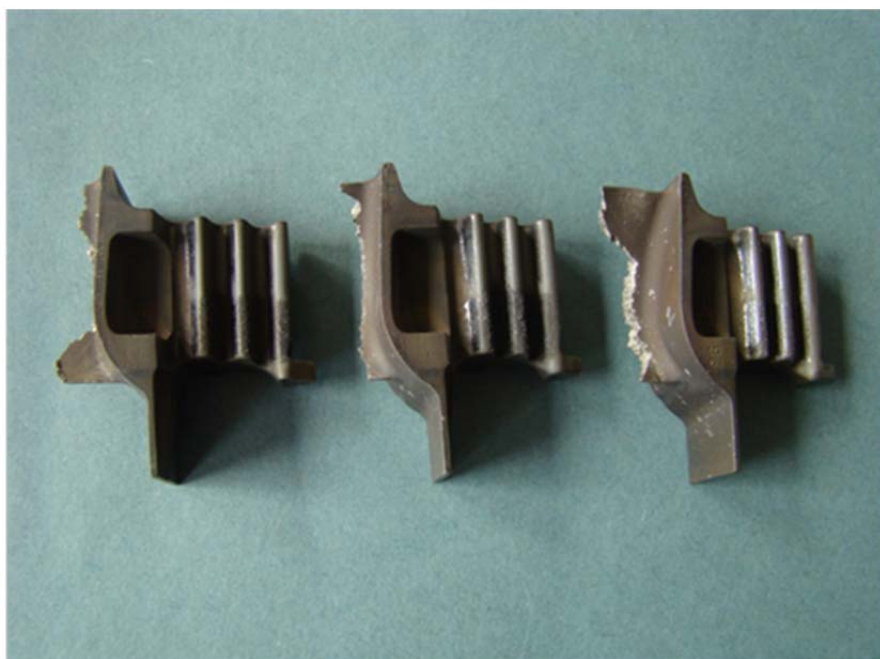
Fig. 4

The suspected blade (number one) and the blades next to (number 88 and number two) were removed from the disk and examined. The three blades are shown in figure 4.

LPT 3<sup>rd</sup> stage blades. From left: Blade 2, 1 and 88.

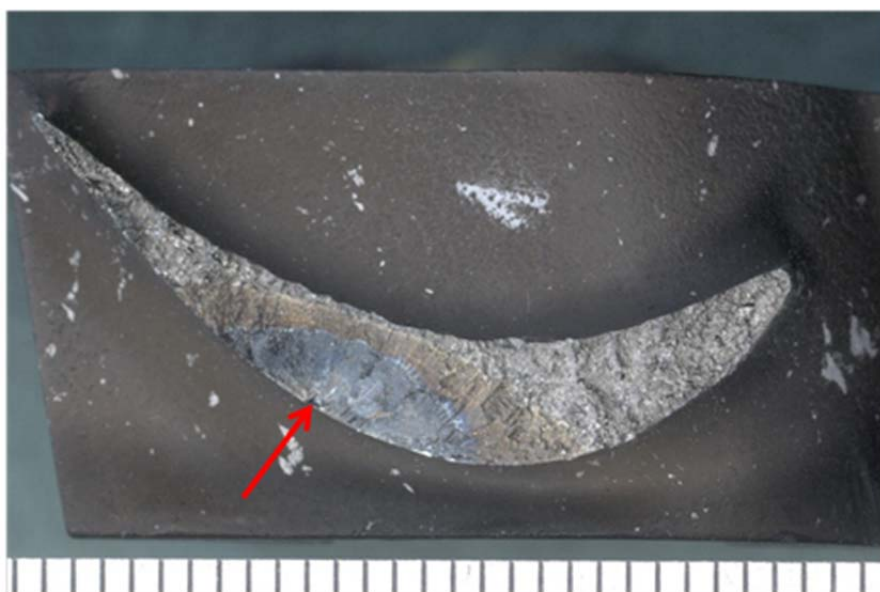
Fig. 5

Clear signs of fatigue were observed on blade number one. The fracture surface was oxidized to various degrees and beach marks were visible.

The fatigue crack initiation point is marked with an arrow in figure 5. The fatigue part of the fracture was relatively plane and smooth, whereas the final fracture was rough and serrated. Fatigue crack showed in figures 6 and 7 with various magnifications.

Blade 1.

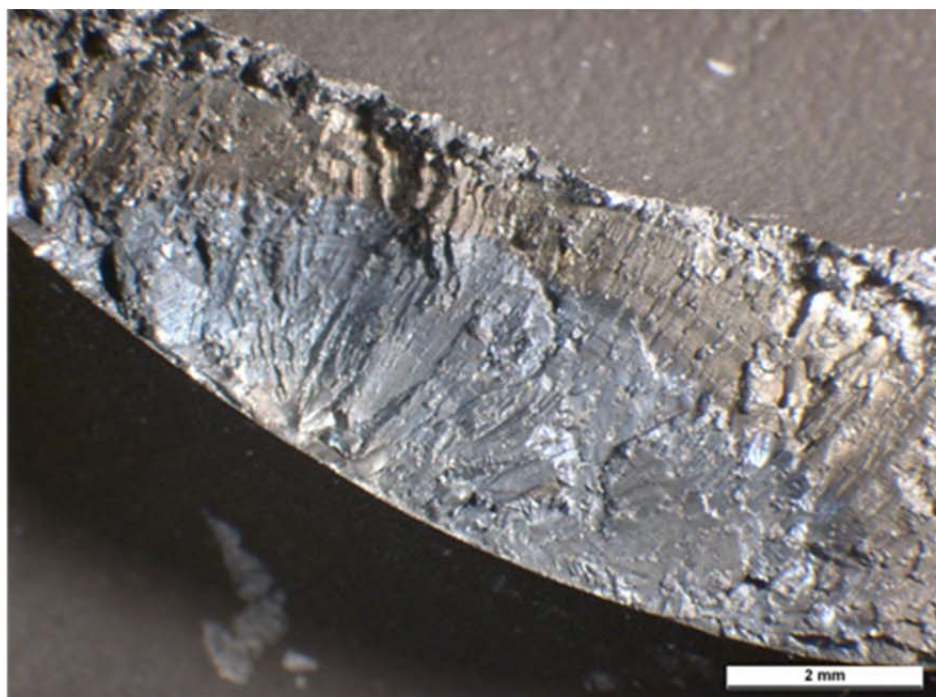
Fig. 6

In the yellow tinted part of the fracture surface (figures 5, 6 and 7) faint signs of fatigue striation were observed. An example is shown in figure 12.

Blade 1. Enlarged section of figure 5.

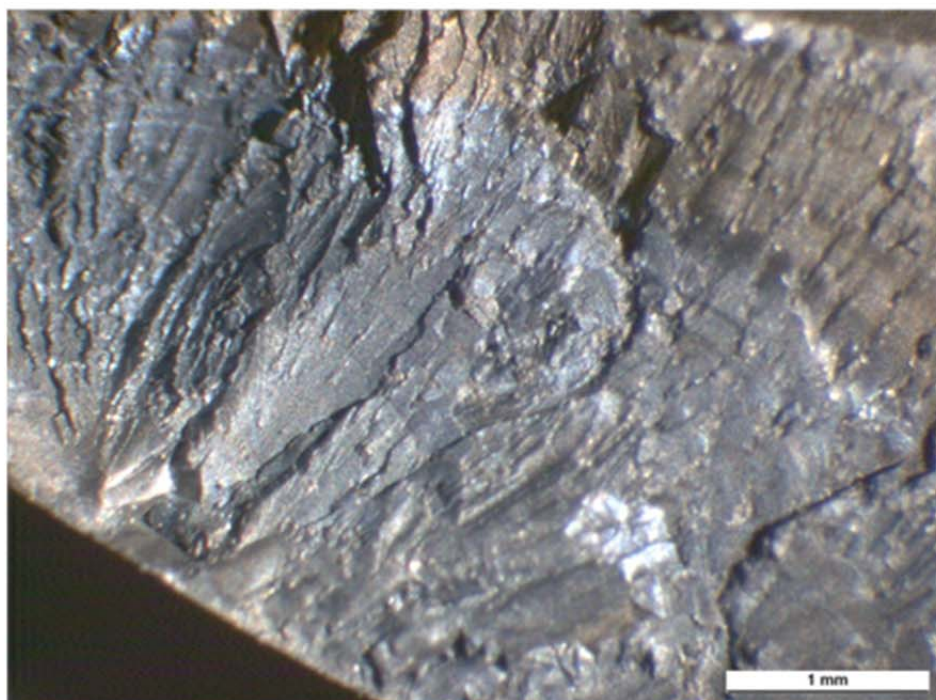
Fig. 7

Blade 1. Enlarged section of figure 6

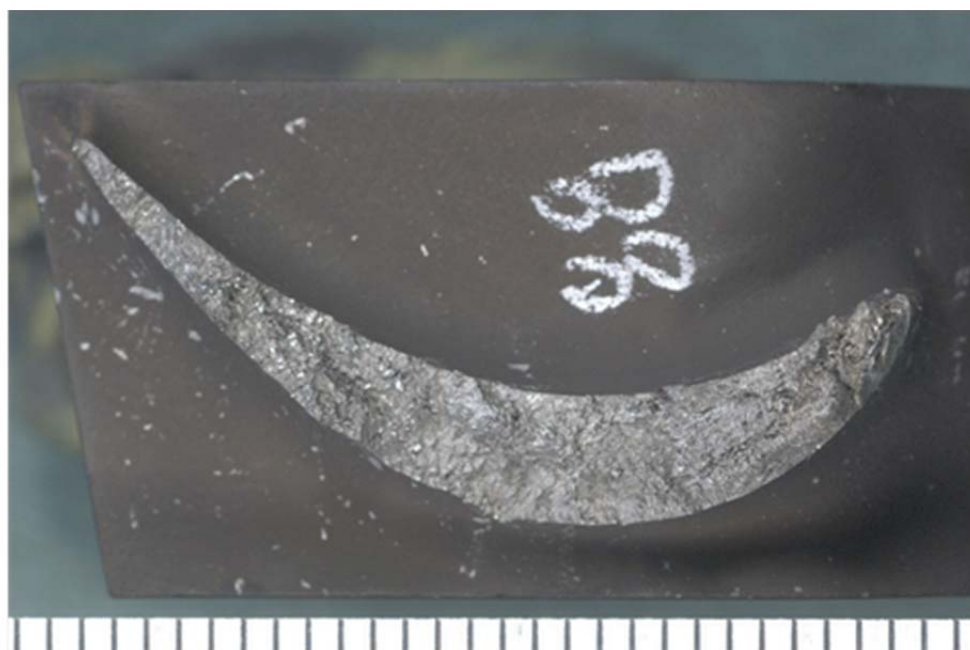
Fig. 8

Blades number 88 and number two are shown in figures 8, 9 and 10. There were no signs of fatigue. In the stereo microscope in some parts of the fracture surfaces dendrite-like appearances were observed as illustrated in figure 9.

Blade 88.

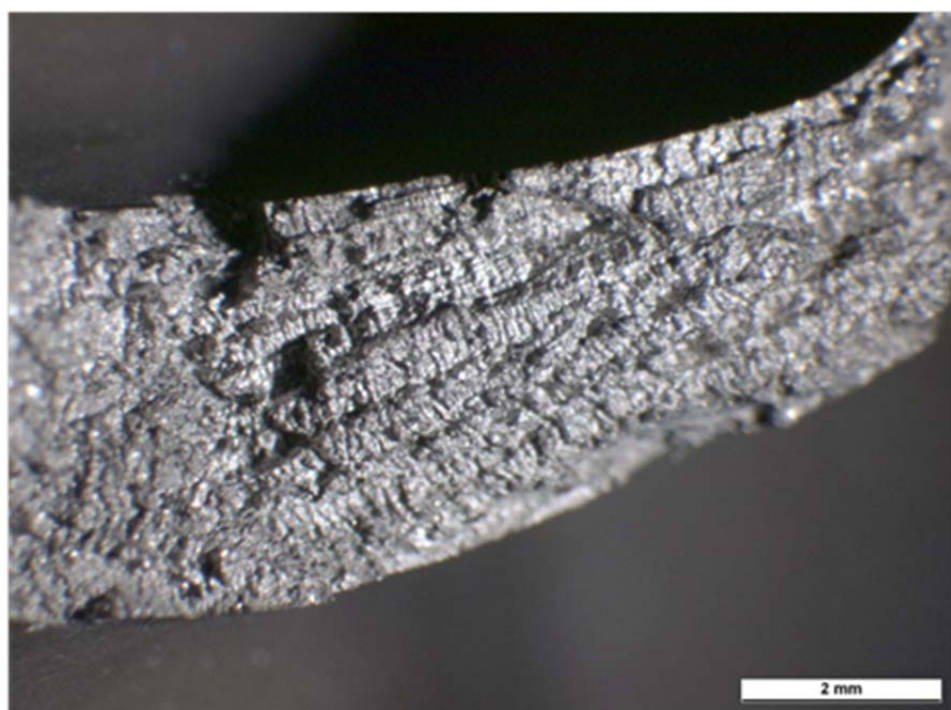
Fig. 9

Blade 88. Enlarged section of figure 8

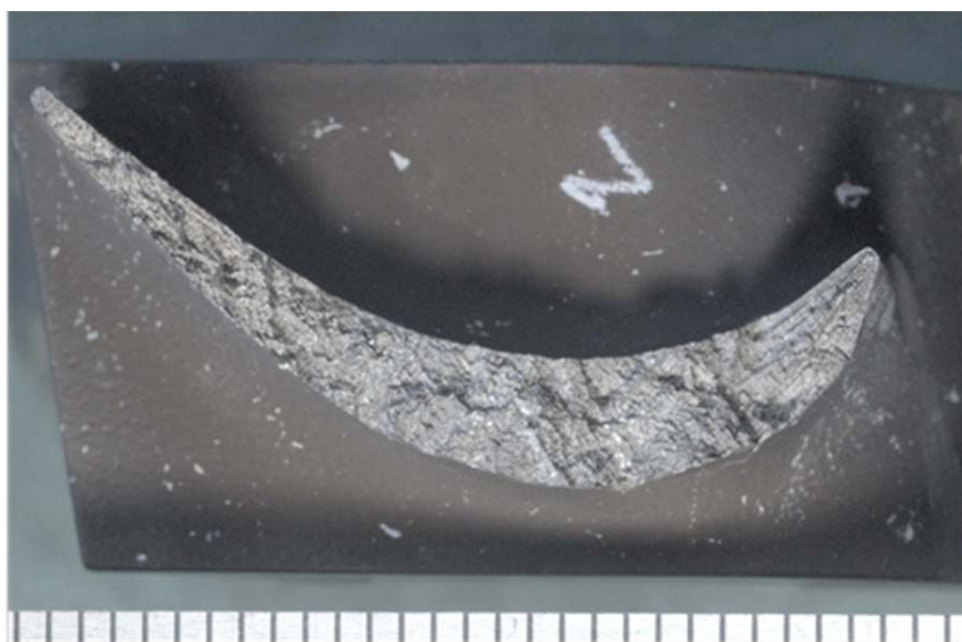
Fig. 10

Blade 2.

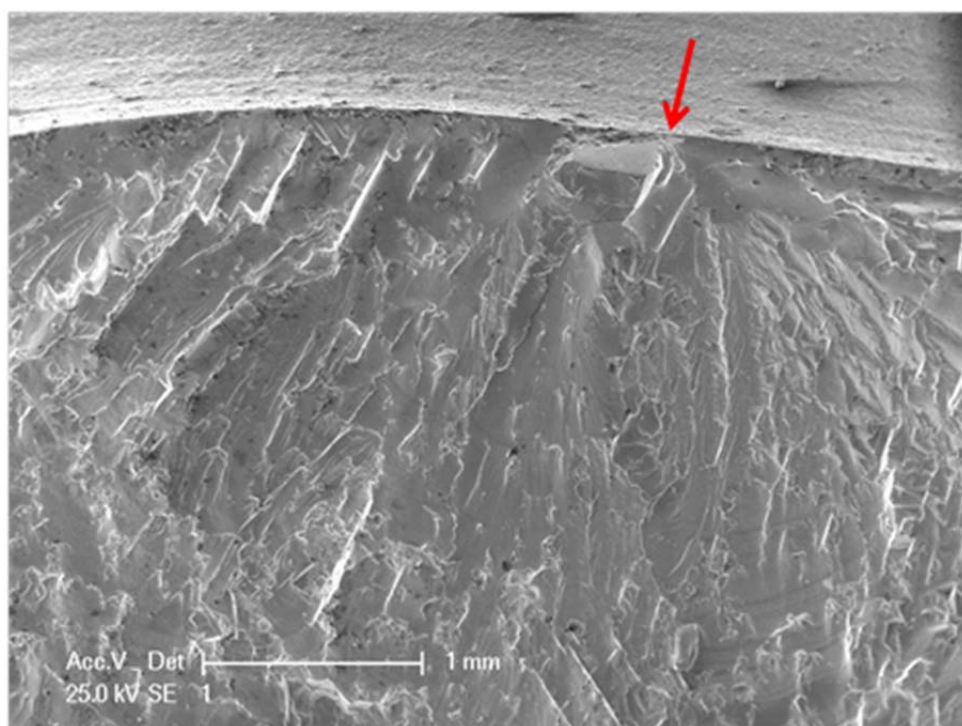
Fig. 11

The SEM revealed a crack initiation area in blade number one (is shown in figure 11). No material defects - which could have caused the crack initiation - were observed.

Blade 1. Fatigue initiation point is marked by arrow.

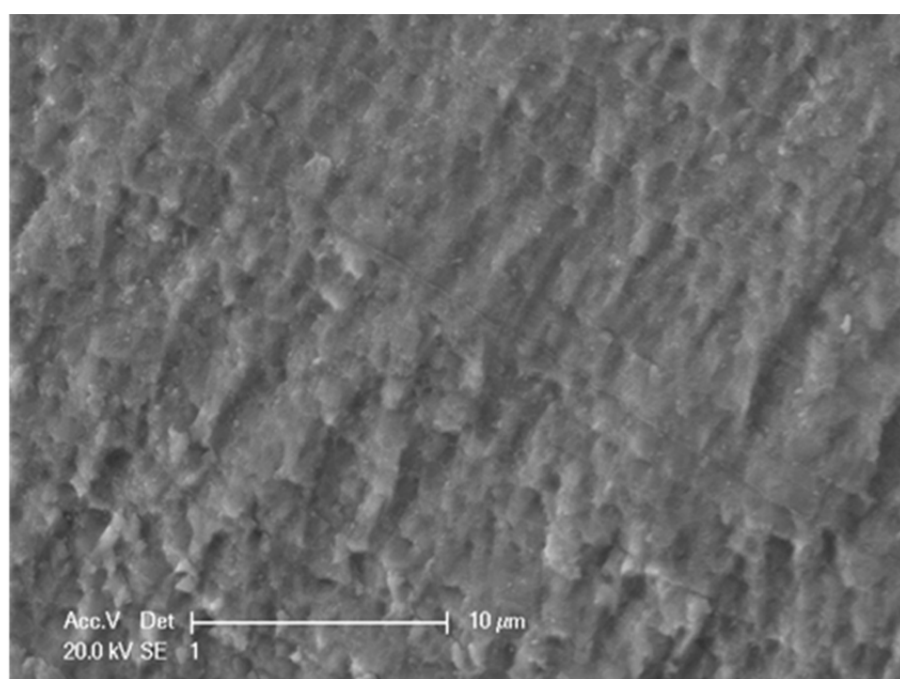
Fig. 12

Blade 1. Fatigue striations.

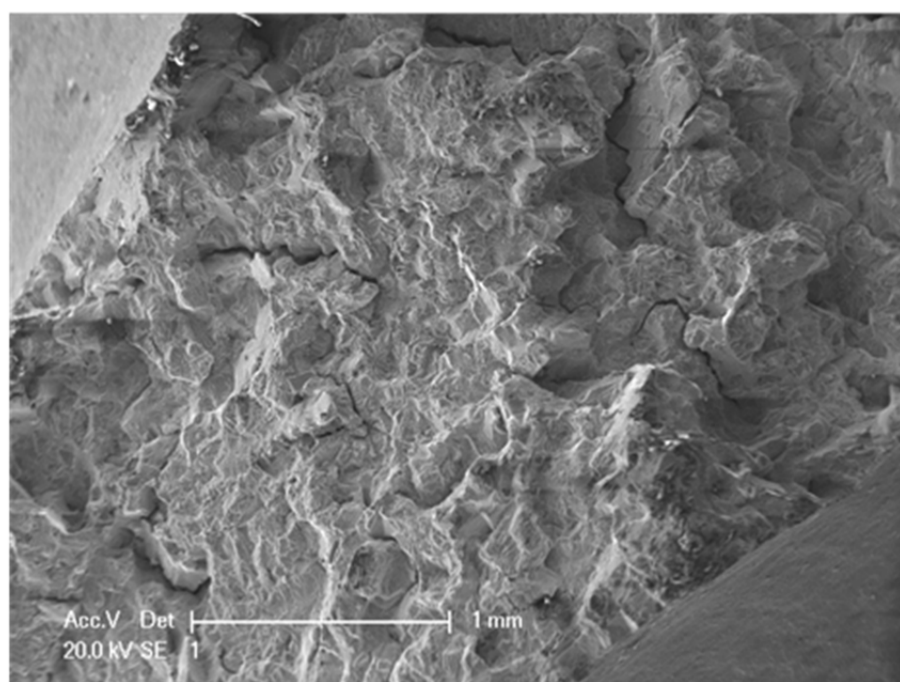
Fig. 13

A part of the final fracture close to the leading edge is shown in figure 13. The rough nature of the fracture surface from this part of the fracture was evident. In higher magnification, dimples, characteristic of ductile overload were observed. Figure 14 shows an example.

Blade 1. Part of the final fracture close to the leading edge.

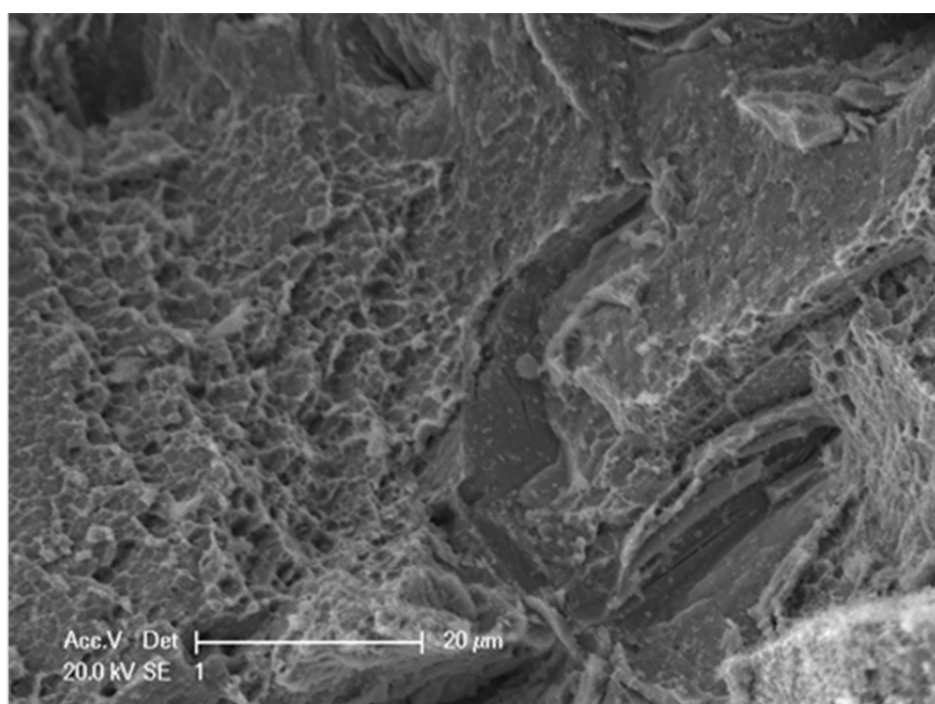
Fig. 14 Blade 1. Enlarged section of figure 13.

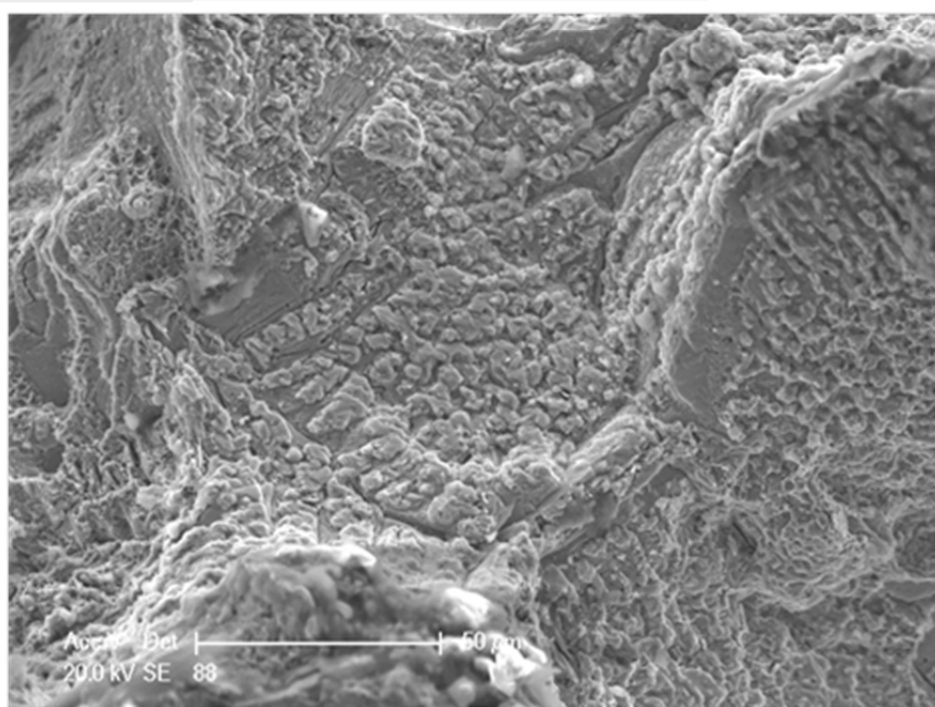
Part of the fracture surface, which in stereo microscope displayed a dendrite like appearance (figure 9), was further examined in SEM. A section of the fracture surface is shown in figure 15.

Dimples, characteristic of ductile overload were observed but no inter dendritic shrinkage cavities were found.

Fig. 15 Blade 88. Section of the fracture surface displaying a dendrite-like appearance. Dimples, characteristic of ductile overload are also seen.

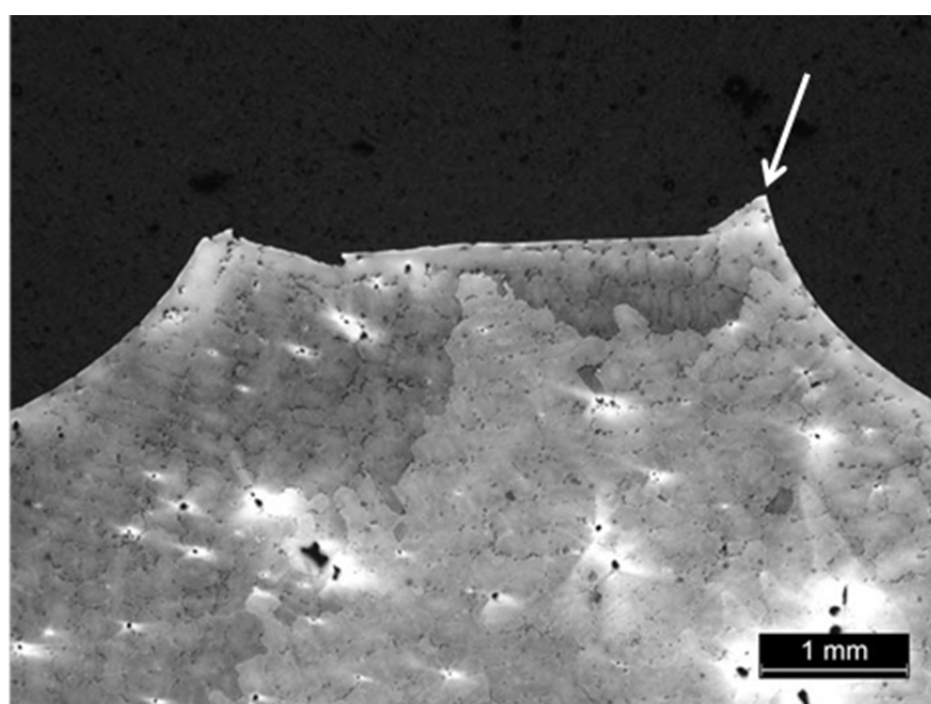
Fig. 16

Figures 16, 17 and 18 show the section perpendicular to the fracture surface in increasing magnification. No material defects or structural abnormalities were observed at the crack initiation shown in figure 18.

Blade 1. Section through the fracture surface in blade 1. Crack initiation at arrow.

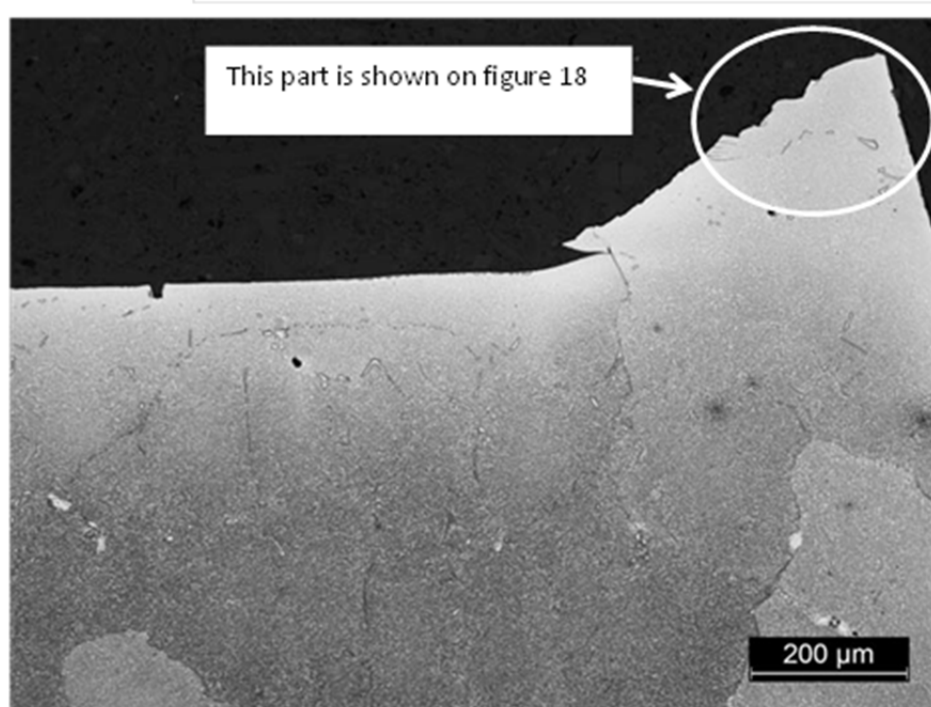
Fig. 17

Blade 1. Enlarged section of figure 16

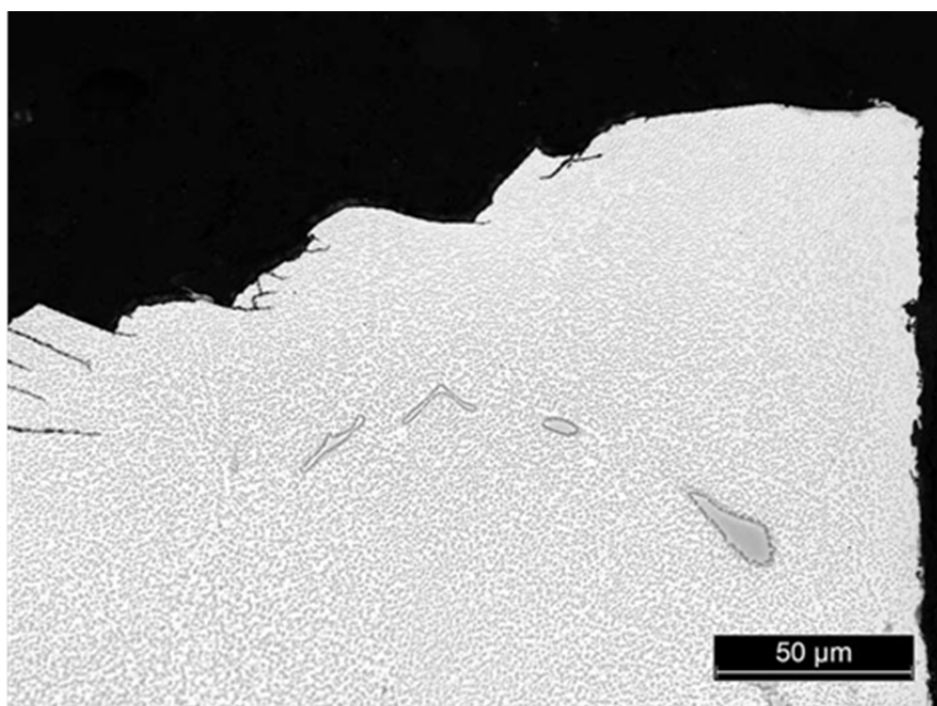
Fig. 18 Blade 1. Enlarged section of figure 17.

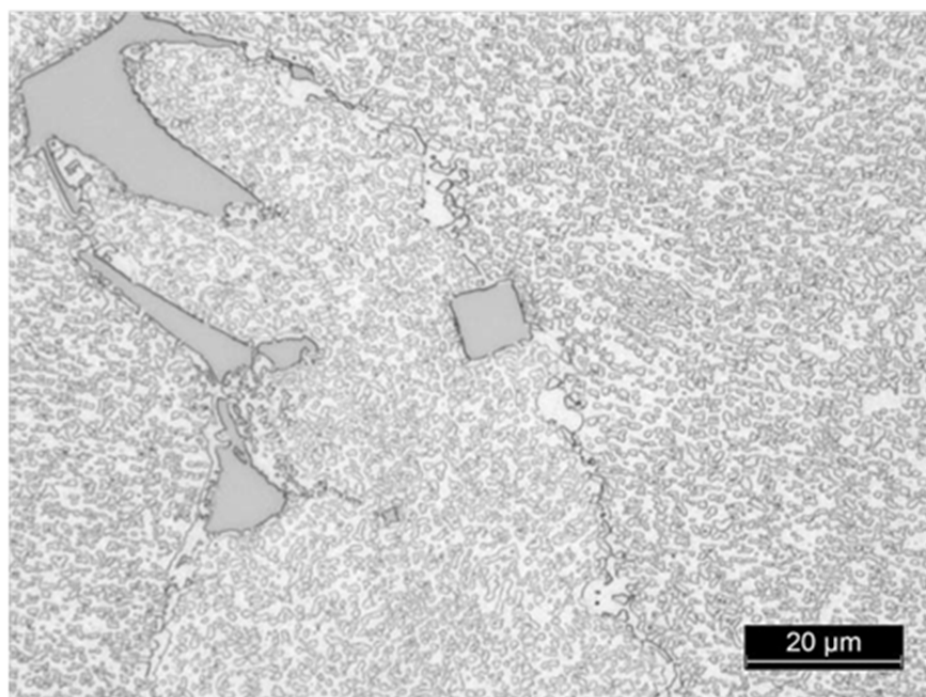
The structure displays primarily carbides in a  $\gamma$ - $\gamma'$  (gamma – gamma prime) matrix. The structure is shown in higher magnification in figure 19.

Fig. 19 Blade 1. The structure of the blade.

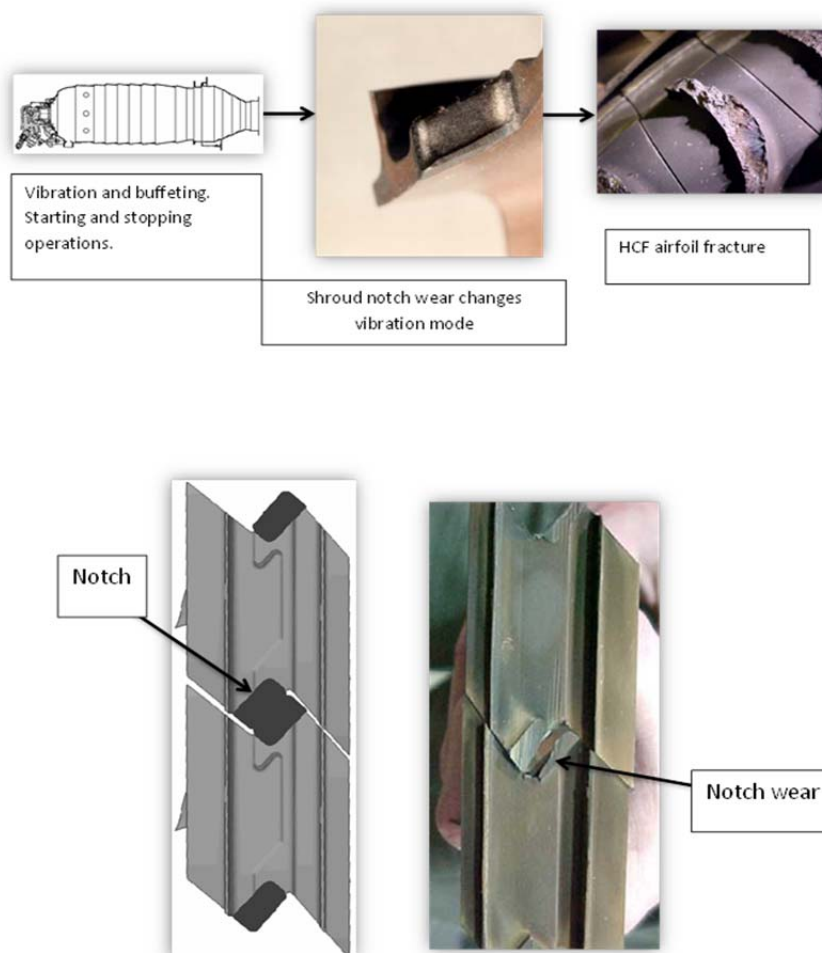
Fig.23

The primary cause of fractured LPT blades was shroud wear.

Figure 23 shows in general the above description in sequence.

Shroud wear = Loss of damping = Fatigue fracture

However, a possible scenario, which might have led to fatigue, might be a result of wear in the mechanical blade interlocking feature during normal operation. This might have led to worn 3<sup>rd</sup> stage LPT blade notches and loss of vibration damping.

However, since a number of JT8D-217C/-219 engines are still in service, the AIB encourages the type certification holder (TCH) of the involved engine type (PW JT8D-217C) that they should evaluate the need for mandating shroud notch wear inspections on stage 3 LPT blades. Currently these inspections are mandatory only at stage 4 LPT blades.
