Havarikommisjonen
Accident Investigation Board Denmark

BULLETIN

18-08-2013

D-FWME

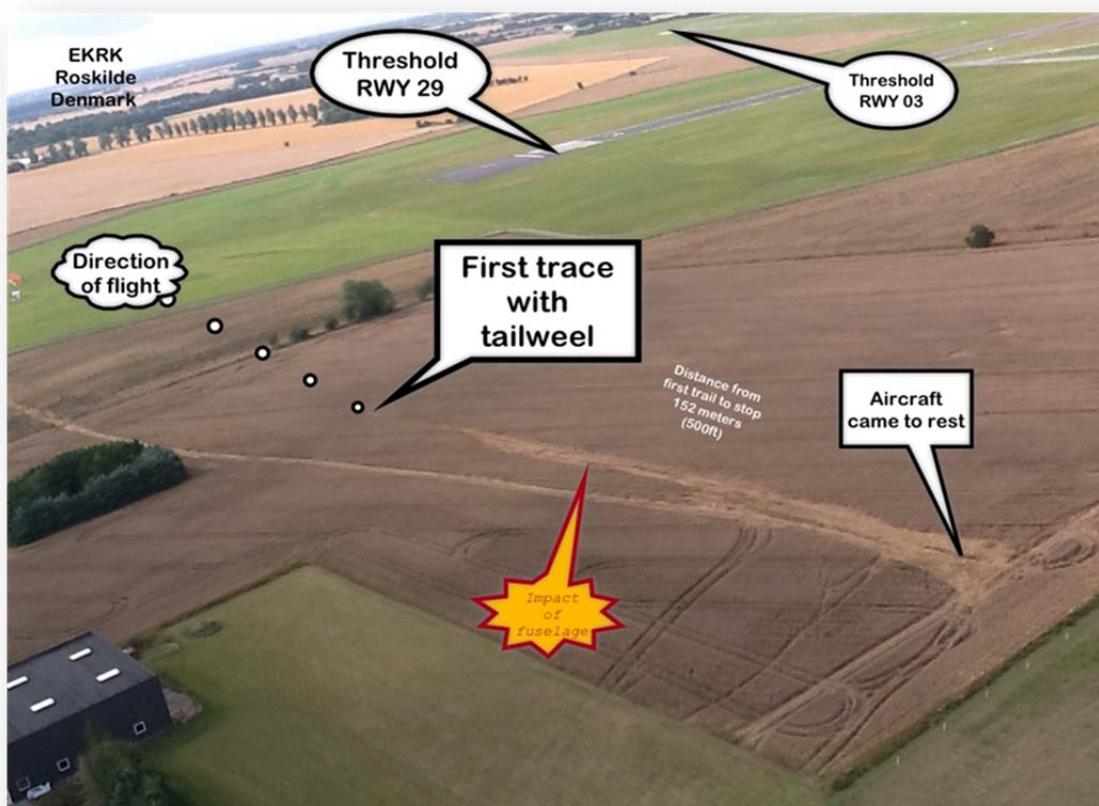
Accident site

The aircraft first contact with the cornfield was with the tail wheel.

The total distance from the first wheel contact to the aircraft came to a full stop was 179 meters.

The distance from the first fuselage marks in the cornfield to a full stop was 152 meters.

Propellers slash mark and propeller blade debris was displaced 27 meters after the tail wheel impact and approximately 17 meters along the cornfield.

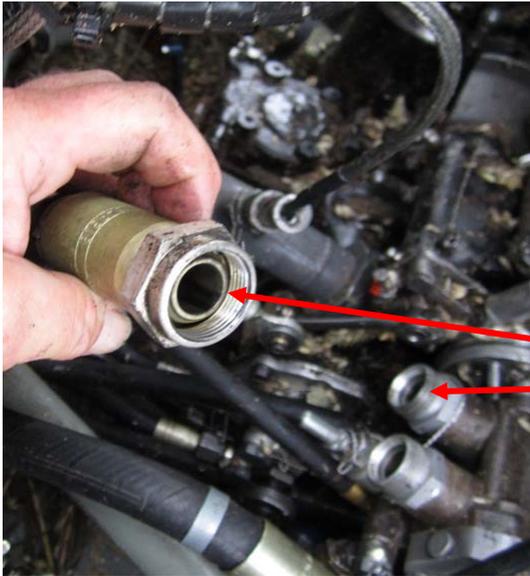
The hose (pictured below) did only contain a few drops of fuel.

The left hand fuel pressure hose and the elbow fitting to the fuel

The accident was caused by fuel starvation as a consequence of inverted flight. The on board fuel system was not designed for inverted flight.

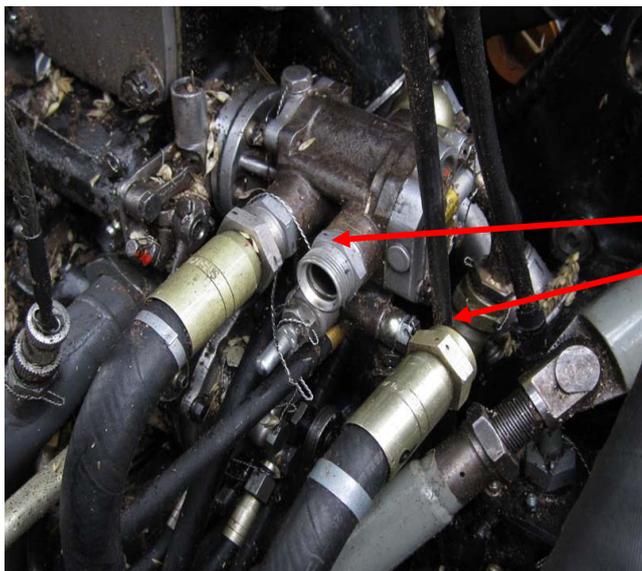
The hose (pictured below) did only contain a few drops of fuel.

The right hand suction hose and the elbow fitting to the injection pump

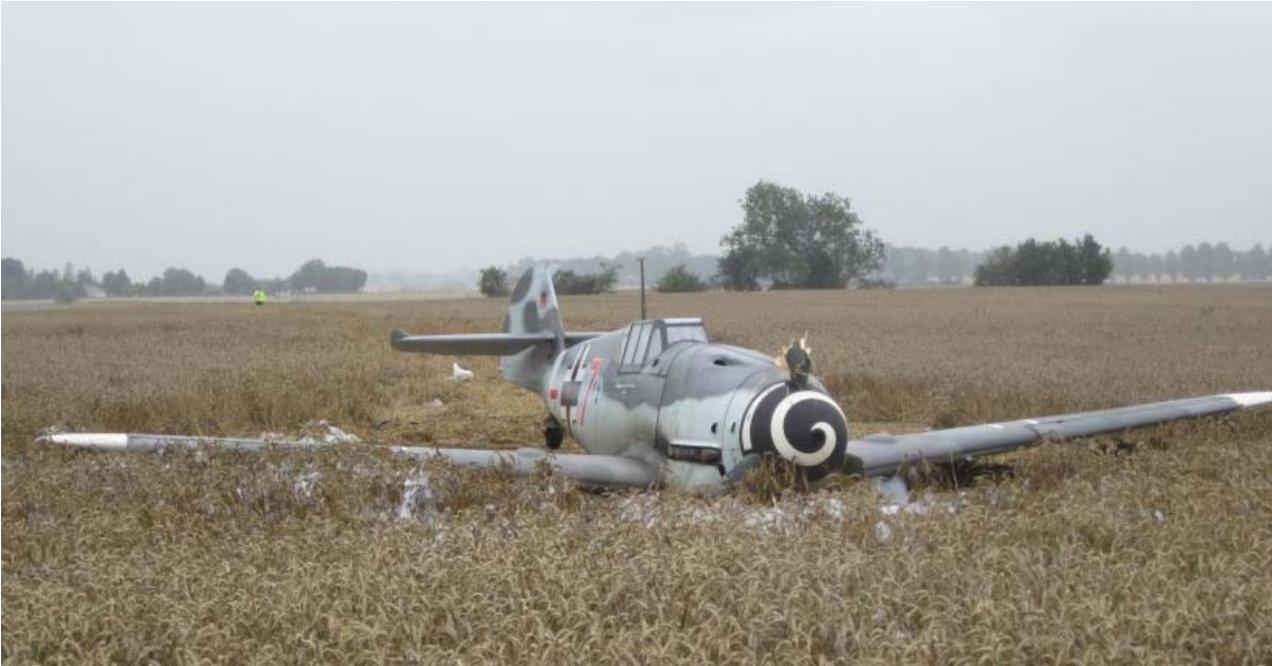
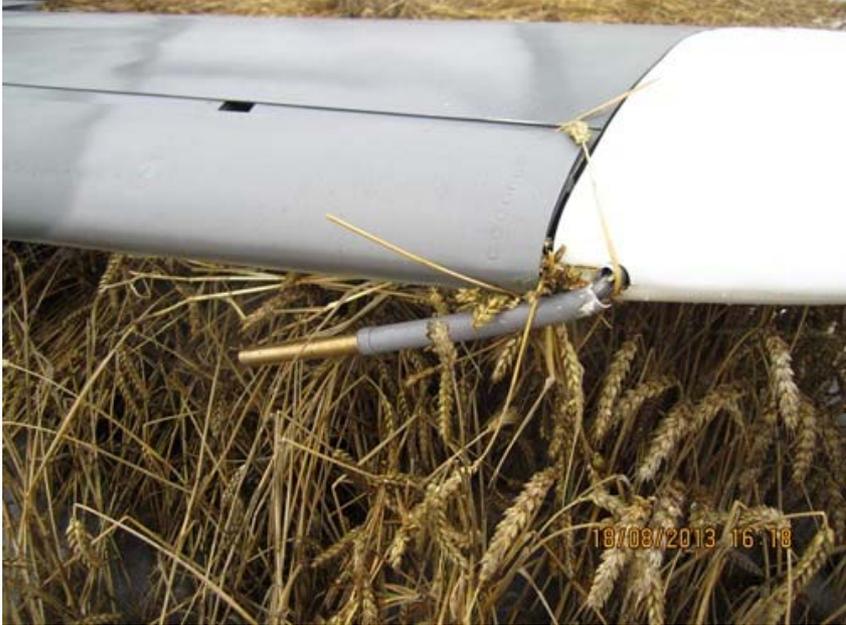
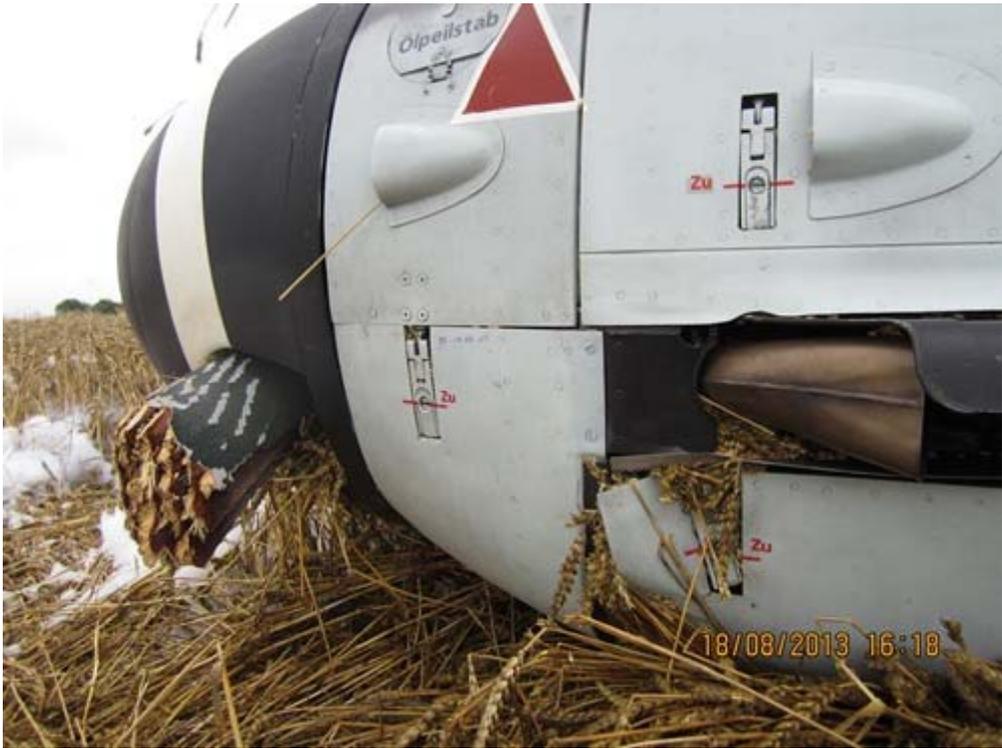
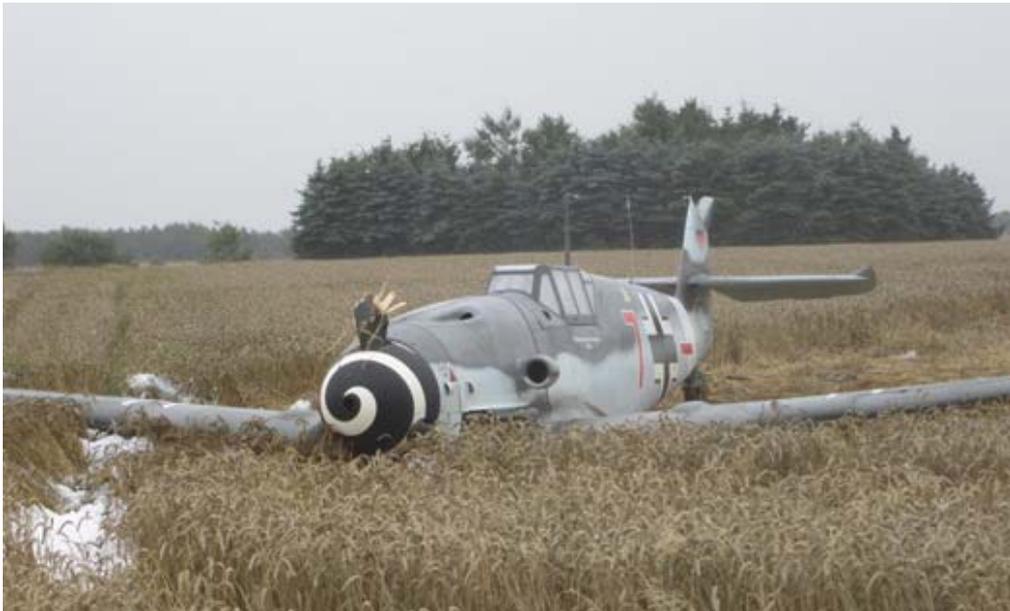
Appendix 1 – Aircraft damage

The aircraft was substantially damaged (See appendix 1)

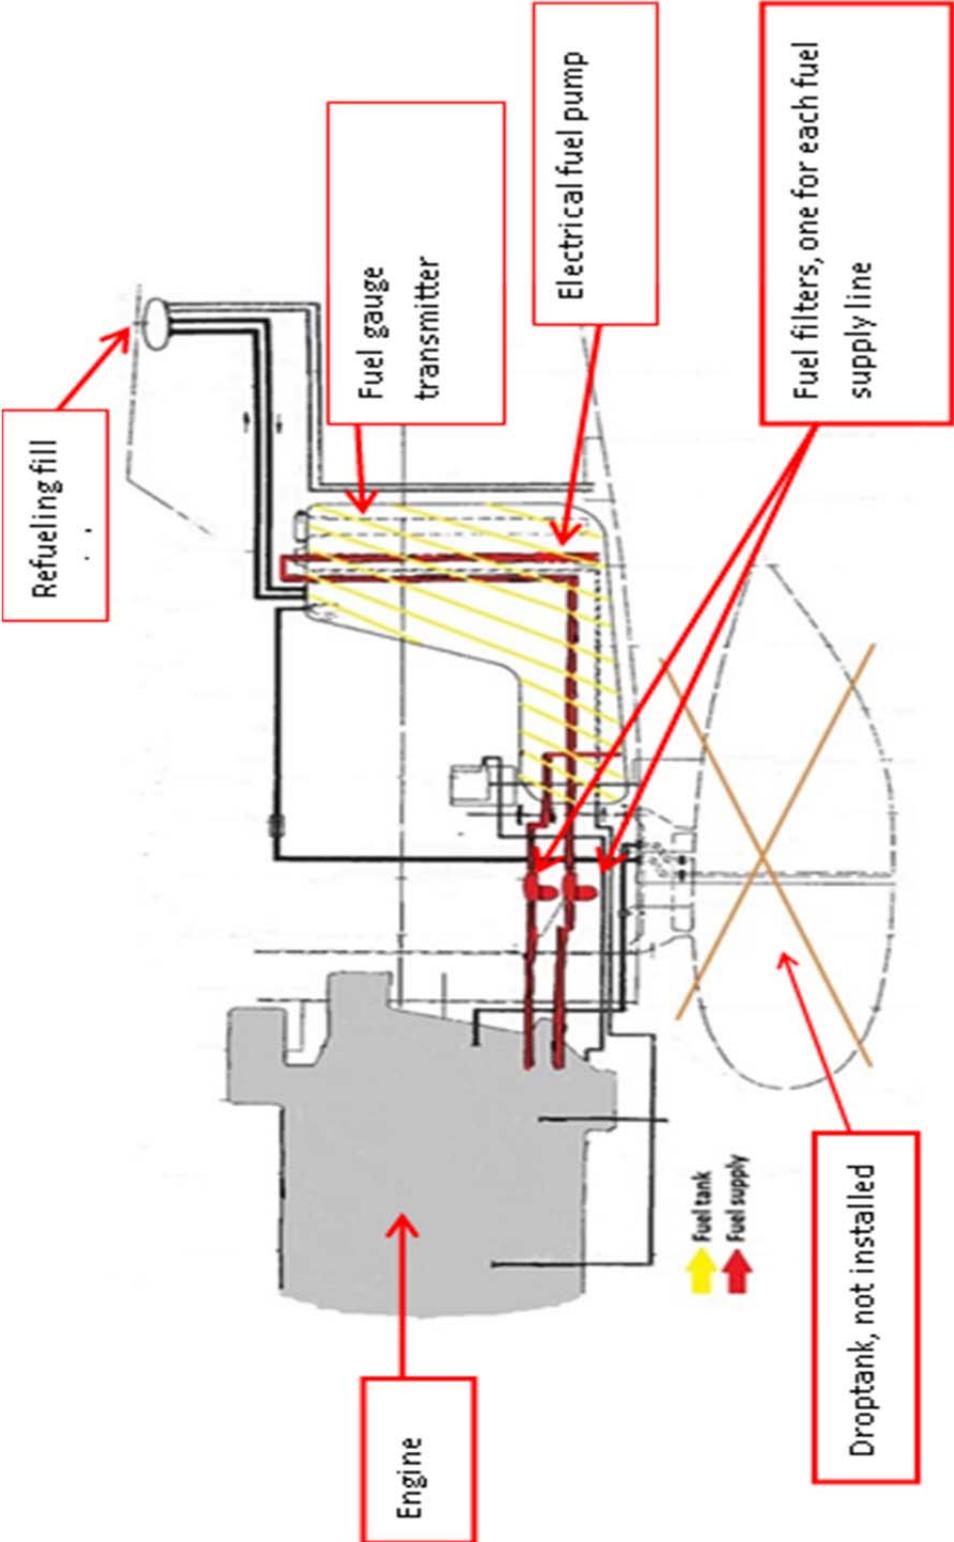
Appendix 2 - Fuel system schematic

The fuel tank was situated behind and below the pilot seat in the cockpit.
The two fuel supply lines in the fuel tank were one in the front and one in the rear of the fuel tank, respectively

The suction point in the front was five mm above the bottom of the fuel tank and seven mm above the bottom of the fuel tank in the rear, where the electrical fuel pump was placed. (See appendix 1).

For that period of time, the fuel stand pipes in the fuel tank were not emerged in fuel and air was sucked into the fuel supply system.

The test of the fuel tank in inverted position and with various amount of fuel verified that the fuel tank and the fuel supply system were not able to deliver fuel to the engine during inverted flight.

1. Rückenflug ist verboten (Inverted flight is prohibited).
2. A detailed description of the aircraft fuel system will be incorporated in the Flight Manual Chapter 7. Flugzeug – und Systembeschreibung (Aircraft and system description.)
