FINAL REPORT

HCLJ510-2012-86	Serious incident		
Type of aircraft:	Boeing MD-82	Registration:	SE-DIL
Engines:	2 P&W JT8D-217C	Type of flight:	Scheduled passenger, IFR
Crew:	5 - no injuries	Passengers:	130 - no injuries 5 - minor injuries
Place of occurrence:	Copenhagen Airport, Kastrup (EKCH)	Date and time:	5.2.2012 at 0738 UTC

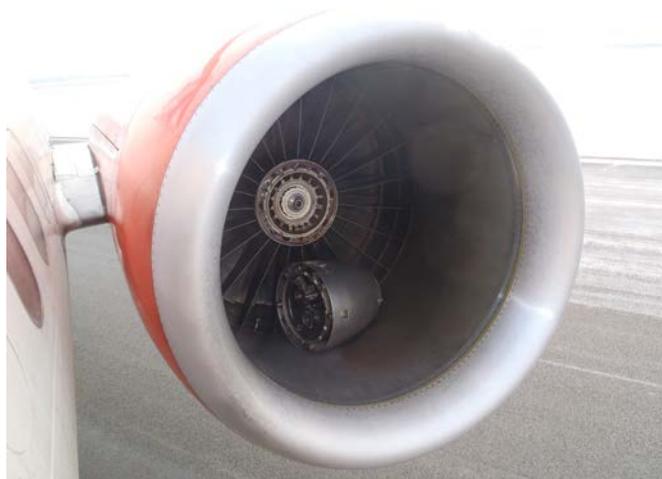
A visual inspection of the left hand engine (ENG #1) air intake revealed that ENG #1 Front Accessory Drive (FAD) with the Nose Dome attached had separated from the engine.

The investigation revealed oil in the engine hot section and exhaust section.

The picture below shows the left engine air intake and the separated FAD and Nose Dome at the inlet guide vanes.

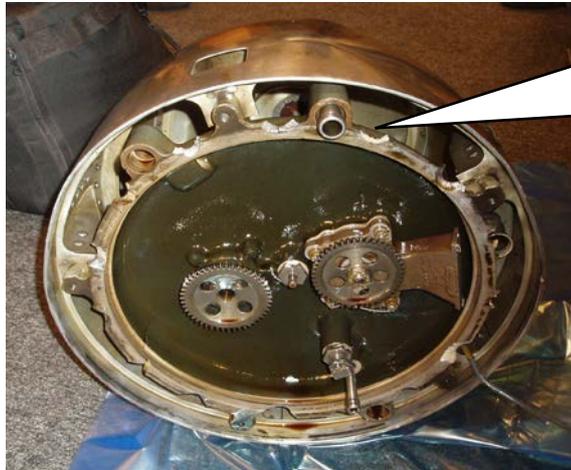
The investigation found the FAD support lugs fractured.

All studs and nuts holding the remains of the 15 lugs were in place at the engine No. 1 bearing housing flange.

FAD separated from
No. 1 bearing
housing flange.
All 15 bolting lugs
were fractured.

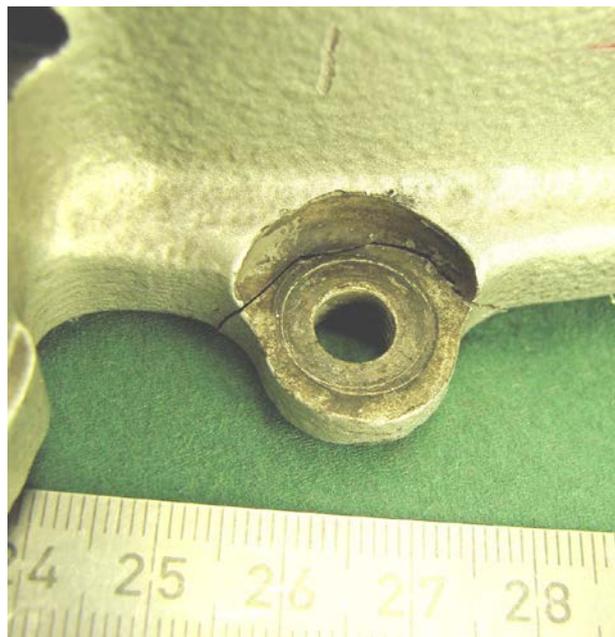
All the fatigue cracks initiated at the sharp edge in the transition from the lug surface to the FAD cover cf. lug 1 shown re-positioned on the picture below.

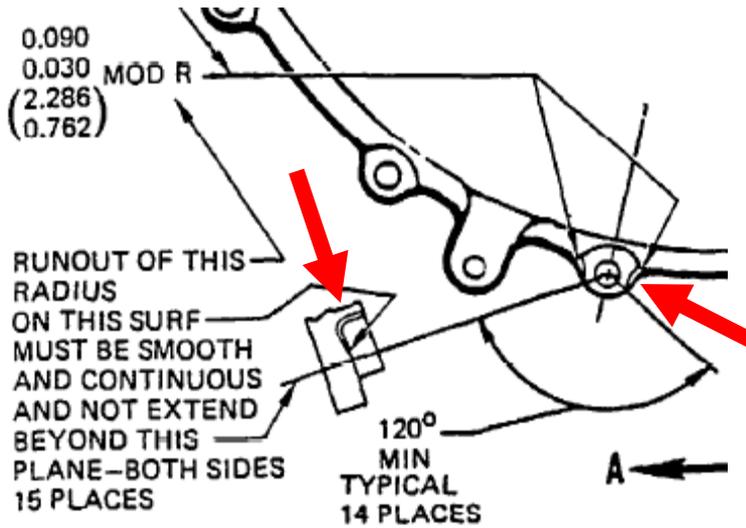
The drawing shown below is extract from SB 5680 Figure 2 Sheet 1.

Sharp edges of the 15 lugs blended to be smooth and continuous (red arrows).

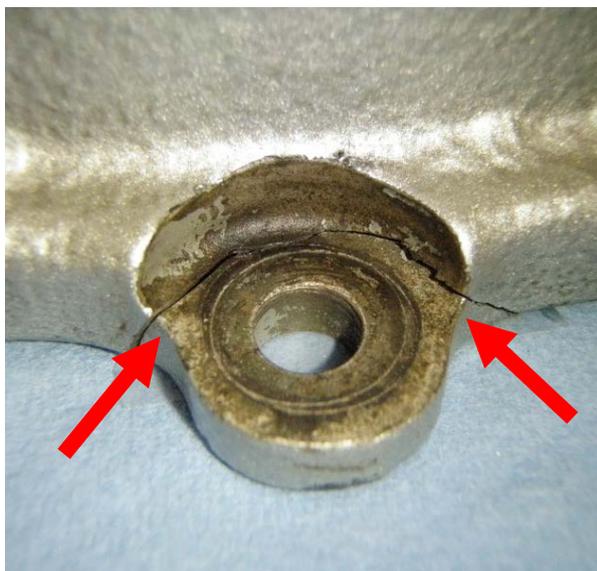
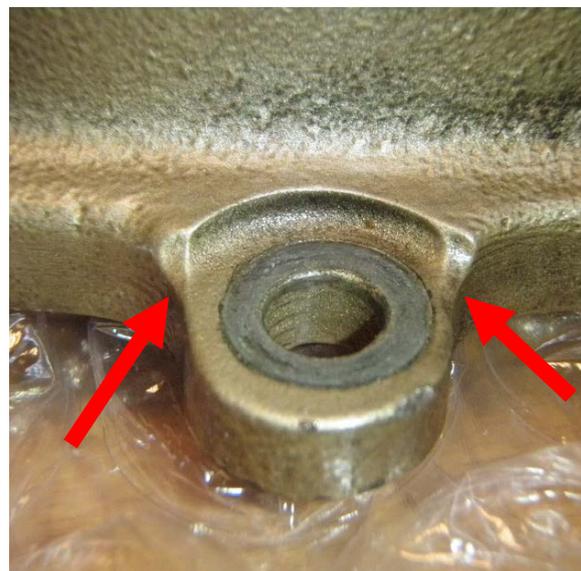
One of the 15 mount lugs from the P/N 805770 FAD is shown below right. The run-out area is smooth and without sharp edges.

Run-out areas are marked with red arrows.

Cracking initiated at the sharp edges at the run-out area of the lugs.

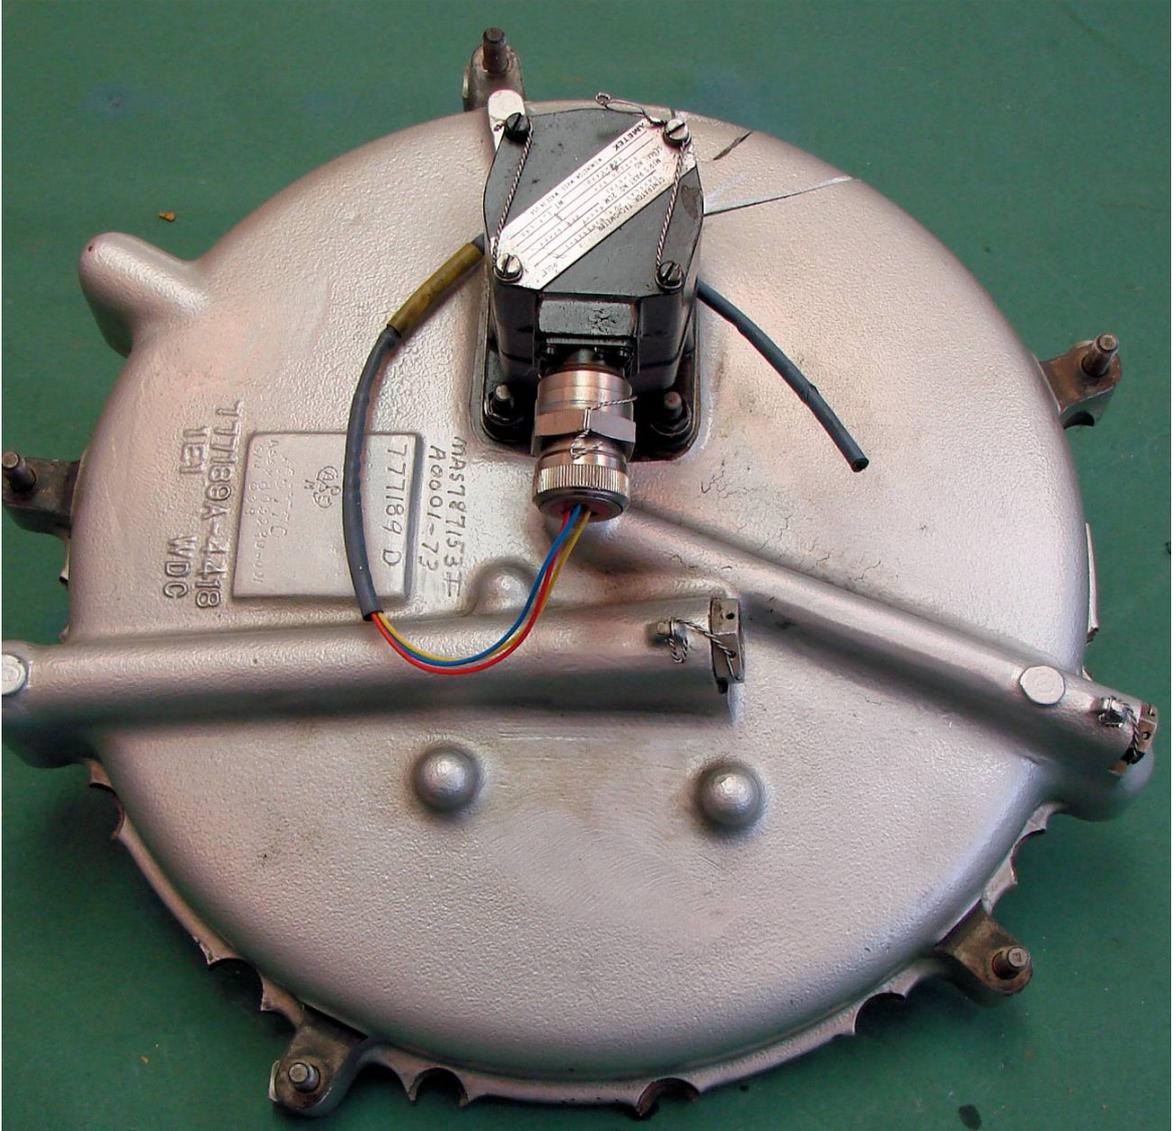
The FAD support assembly is shown in figures 1 and 2. The bolting arrangement for the bullet nose was intact, whereas all 15 mount lugs keeping the front cover in place were fractured. The lugs are shown in figure 3. They are marked 1 through 15 in figure 3 in clockwise direction when viewing in the flight direction.

Figure 1 View of FAD support assembly looking aft relative to flight direction.

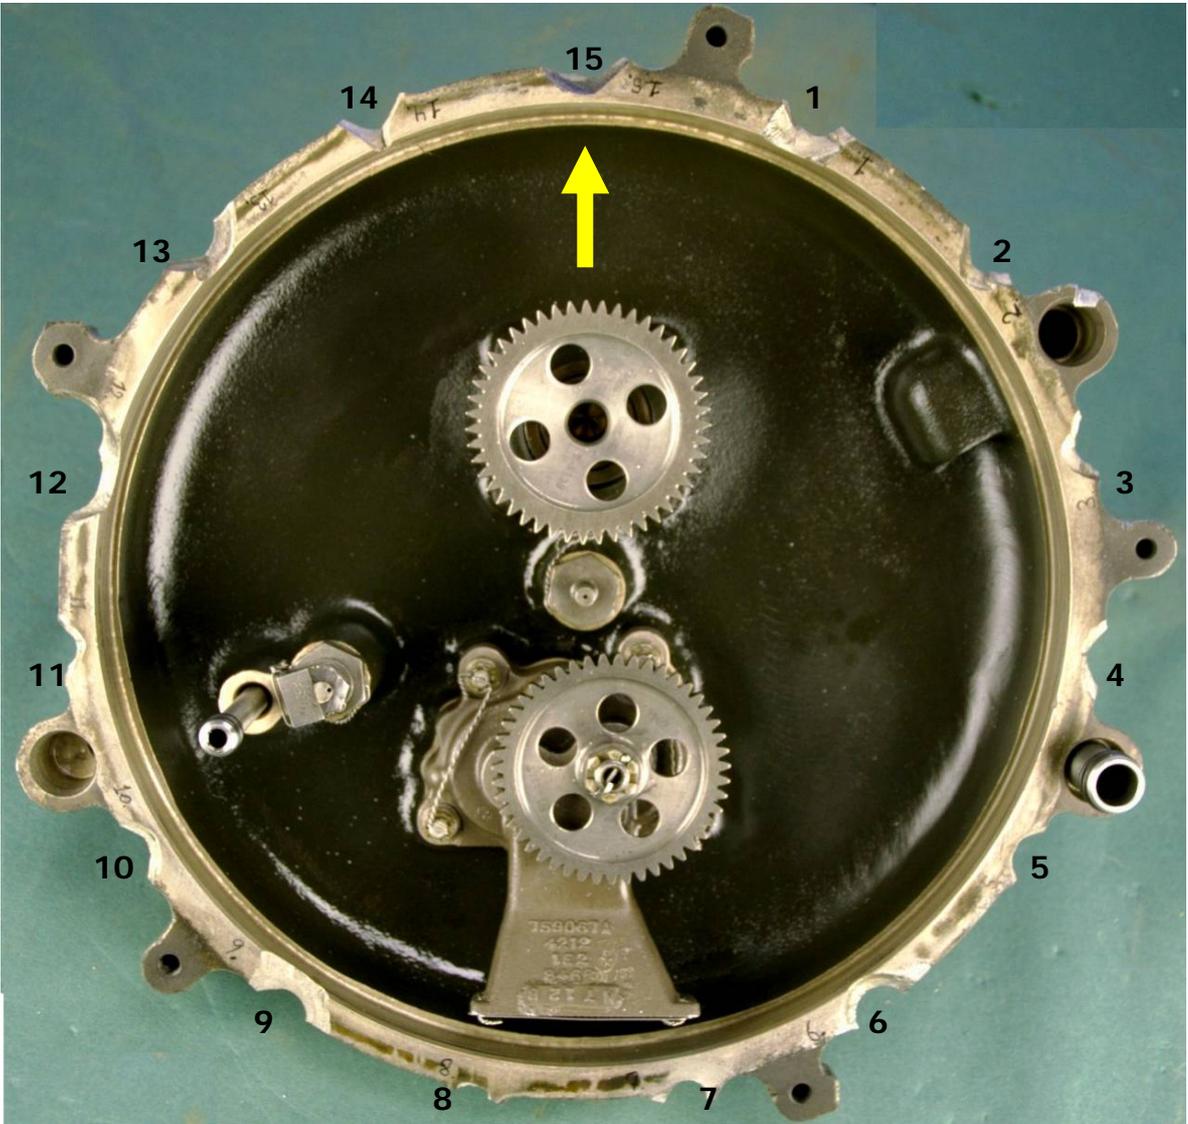
Figure 2 Inside of FAD support assembly. The yellow arrow indicates upwards direction.

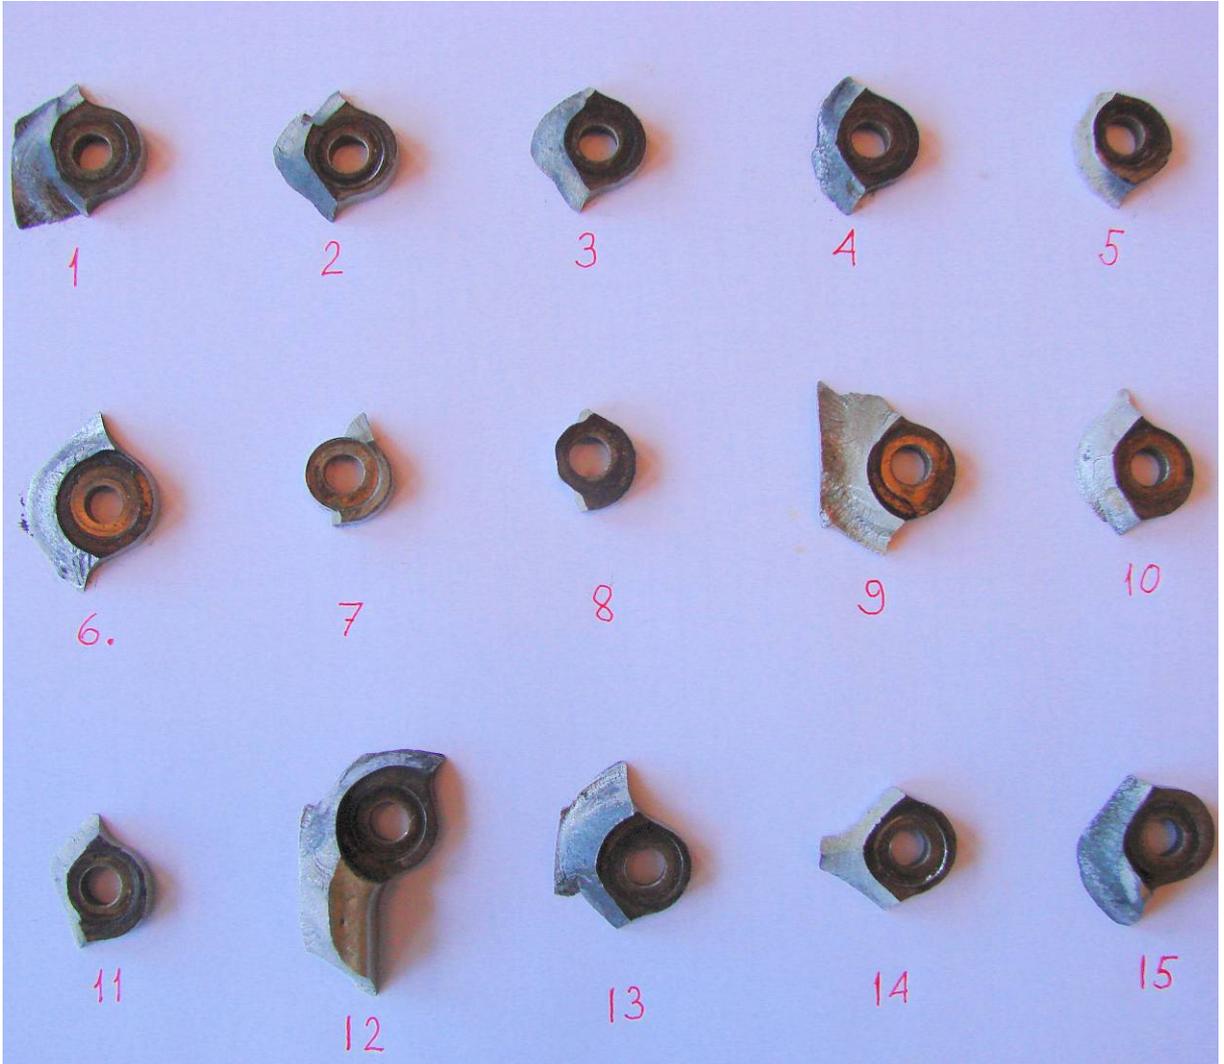
Figure 3 Broken off mounting lugs from the support assembly.

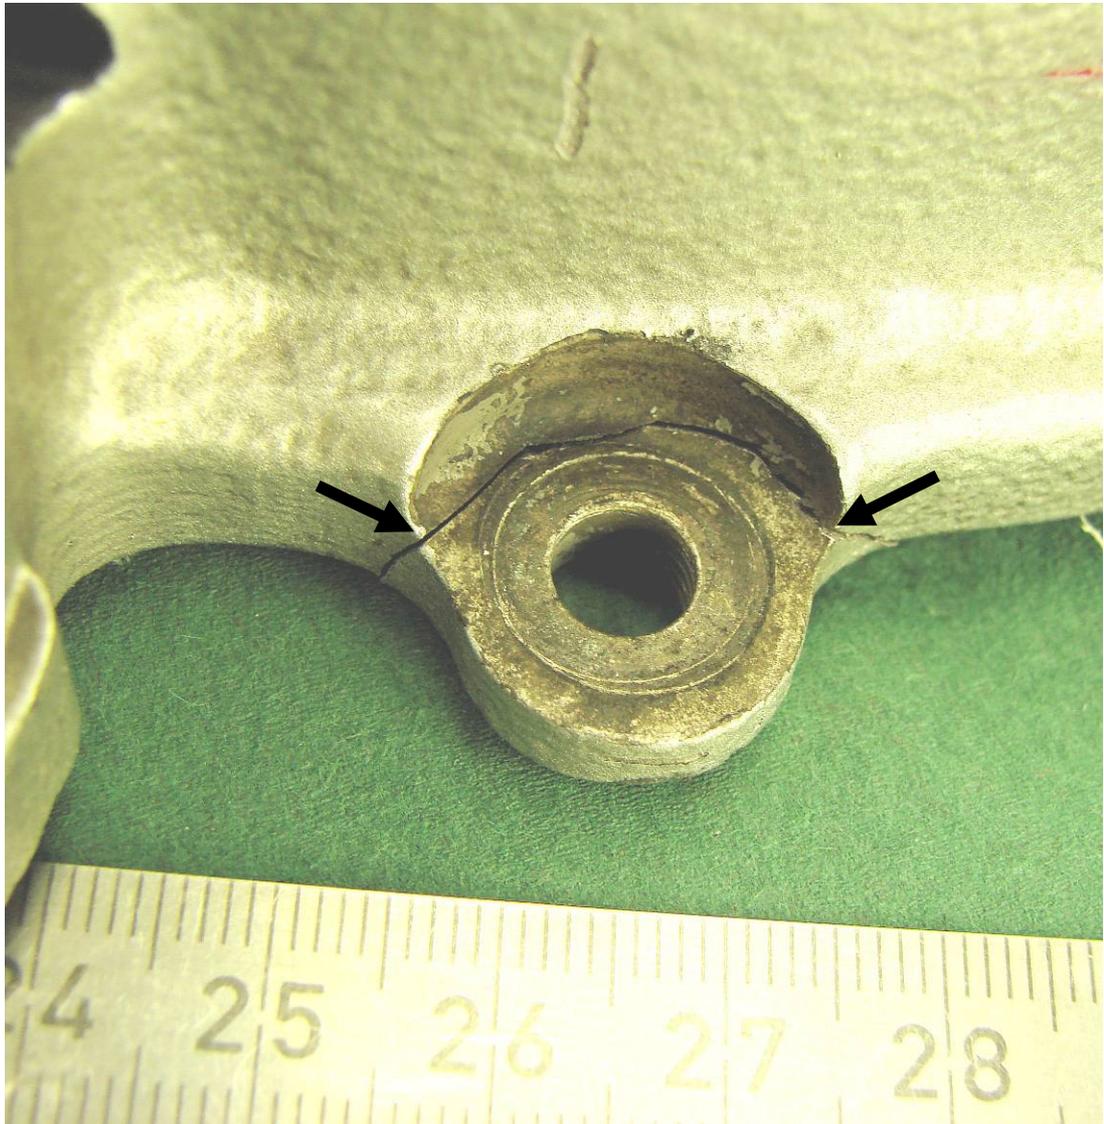
The typical appearance of the fractures in the lugs is represented by lug 1. The overall appearance in figure 4 and the typical crack arrest lines, beach marks, in figure 5 are typical features of fatigue cracking. The cracking initiates at the positions marked by the arrows in figures 4 and 5.

The fatigue cracking always initiates at the sharp edge in the transition from the lug surface to the cover, cf. figure 4.

Figure 4 View of re-positioned mounting lug 1.

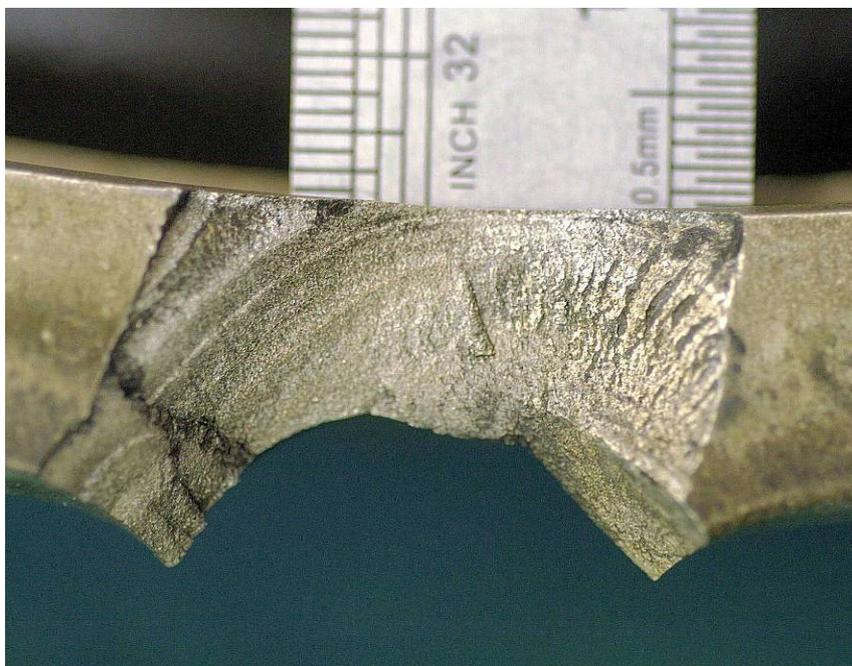
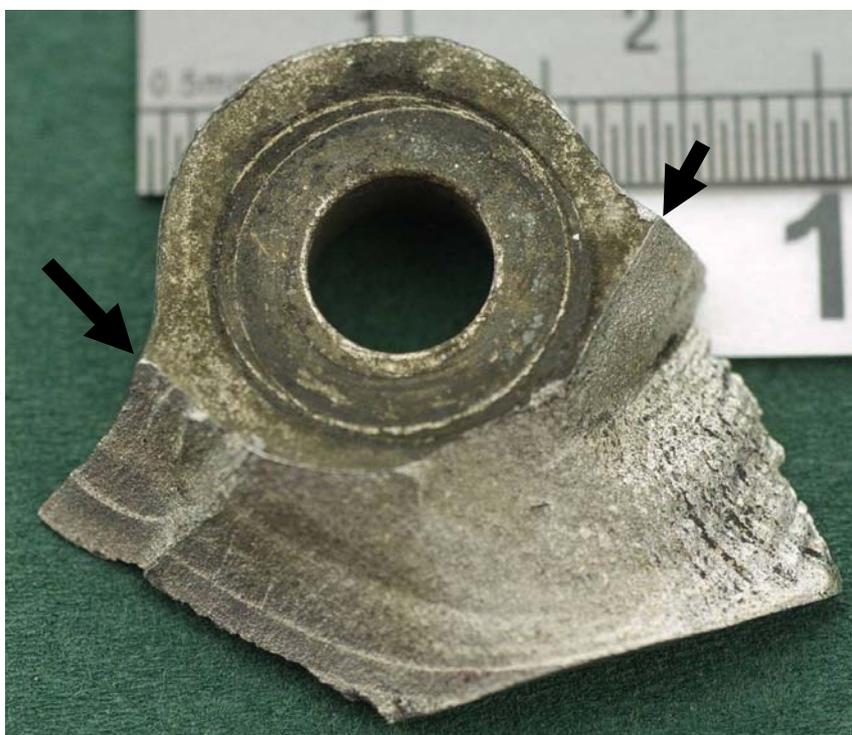
The cracking in lugs 1 and 15 are 100 % fatigue, i.e. no final rupture. Lug 14 has developed a fatigue crack deeply into the cover. These three lugs are presumed to be the first to develop fatigue cracking, whereas lug 7 is the last one developing fatigue. Lug 8 has no fatigue crack but is simply sheared off at the same time as or just after shear off of lug 7.

Figure 5 a&b Opposing fracture surfaces in mounting lug 1. Fatigue cracks have initiated at the positions marked by arrows. The progression of the cracks have left crack growth marks, beach marks, in the fracture surface.

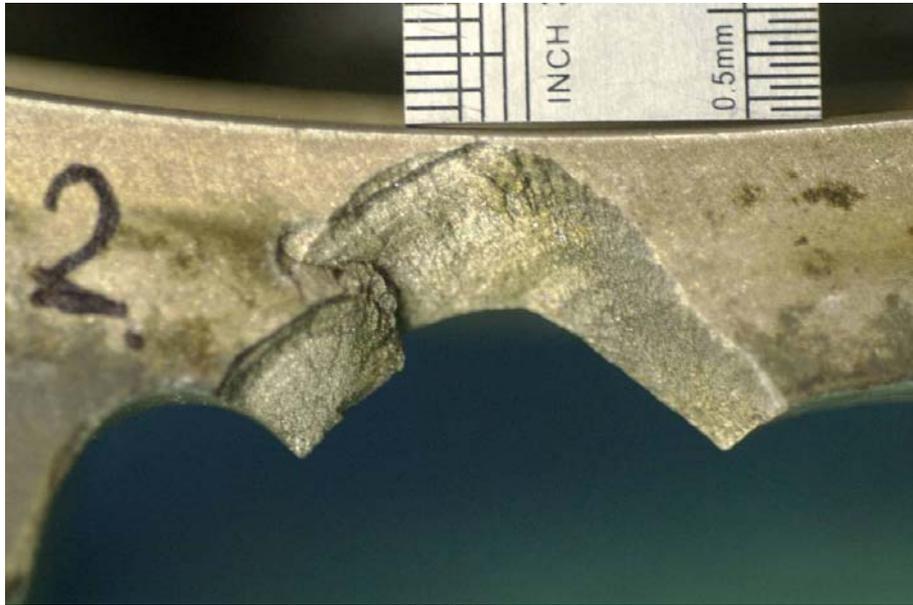
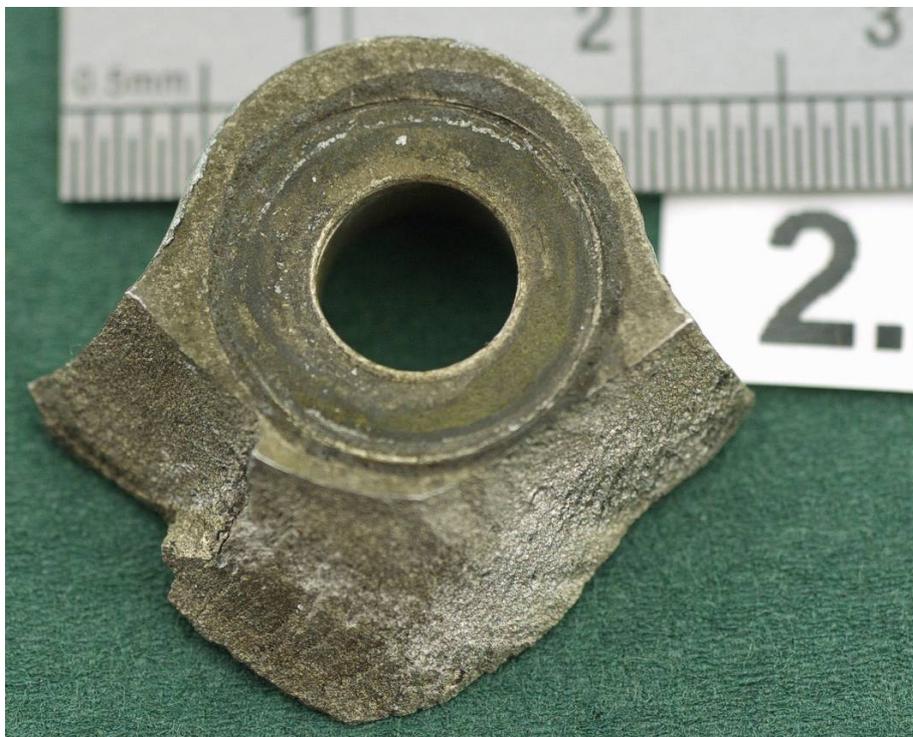
Figure 6 a&b View of opposing fracture surfaces in lug 2.

Figures 6 to 21 show the fracture surfaces in the lugs as well as the washer contact surfaces. The fracture surfaces are all akin to fatigue cracking with the fatigue cracking in general occupying more than 80 % of the fracture surfaces. The only exceptions are lugs 7 and 8. Lug 7 does contain a small fatigue crack but the main part of the fracture is pure shear off. There is no fatigue cracking in lug 8 only shear off failure.

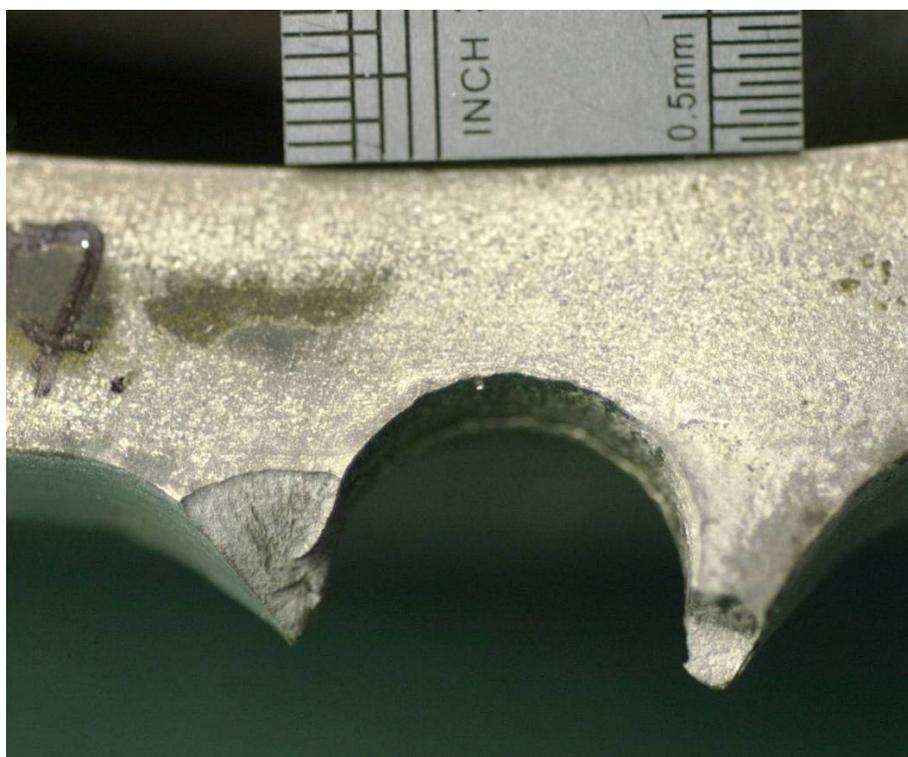
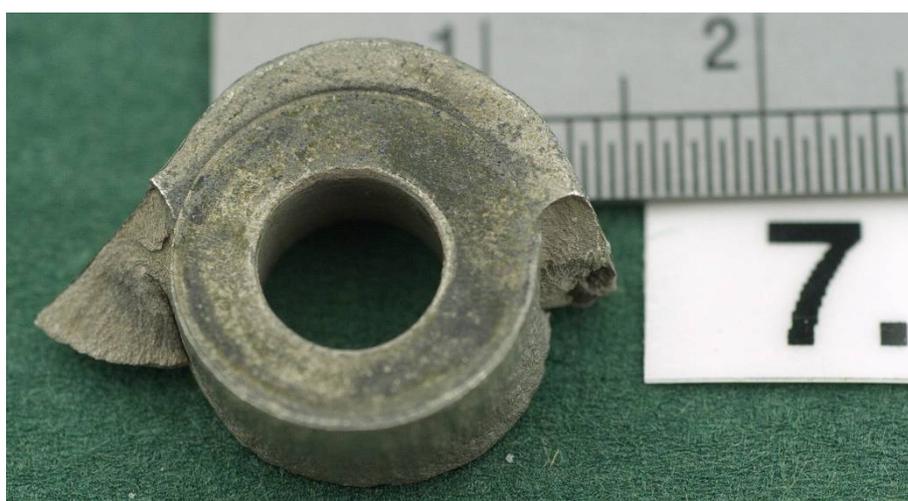
Figure 11a&b View of opposing fracture surfaces in lug 7.

One lug (7) contained a small fatigue crack but the main part of the fracture was pure shear off (overload fracture).

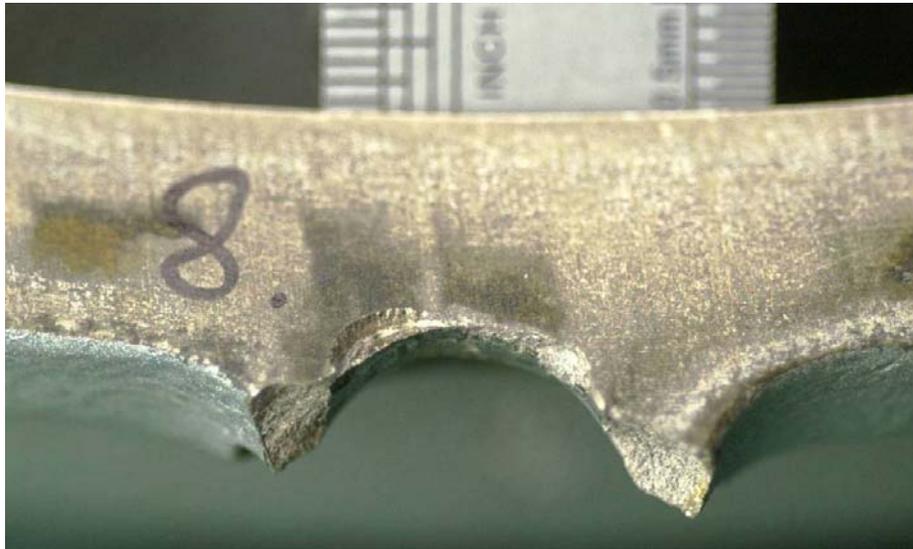
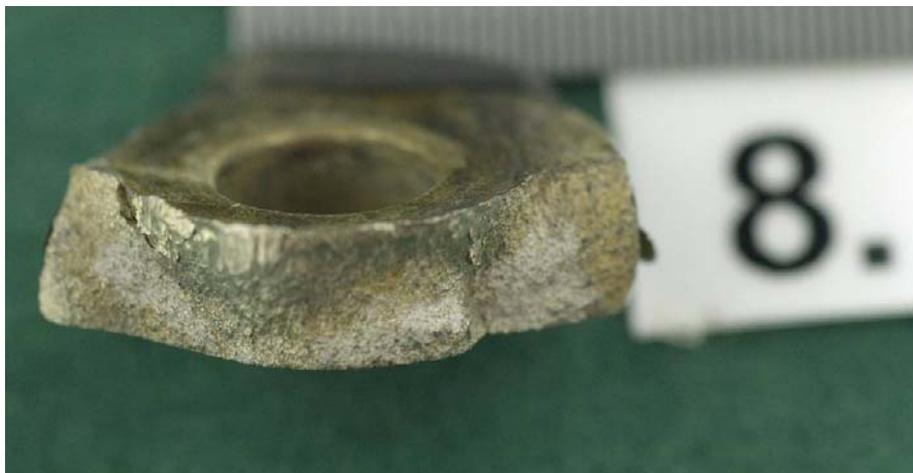
Figure 12a&b View of opposing fracture surfaces in lug 8.

One lug (8) fracture had no signs of fatigue only shear off failure overload fracture type.

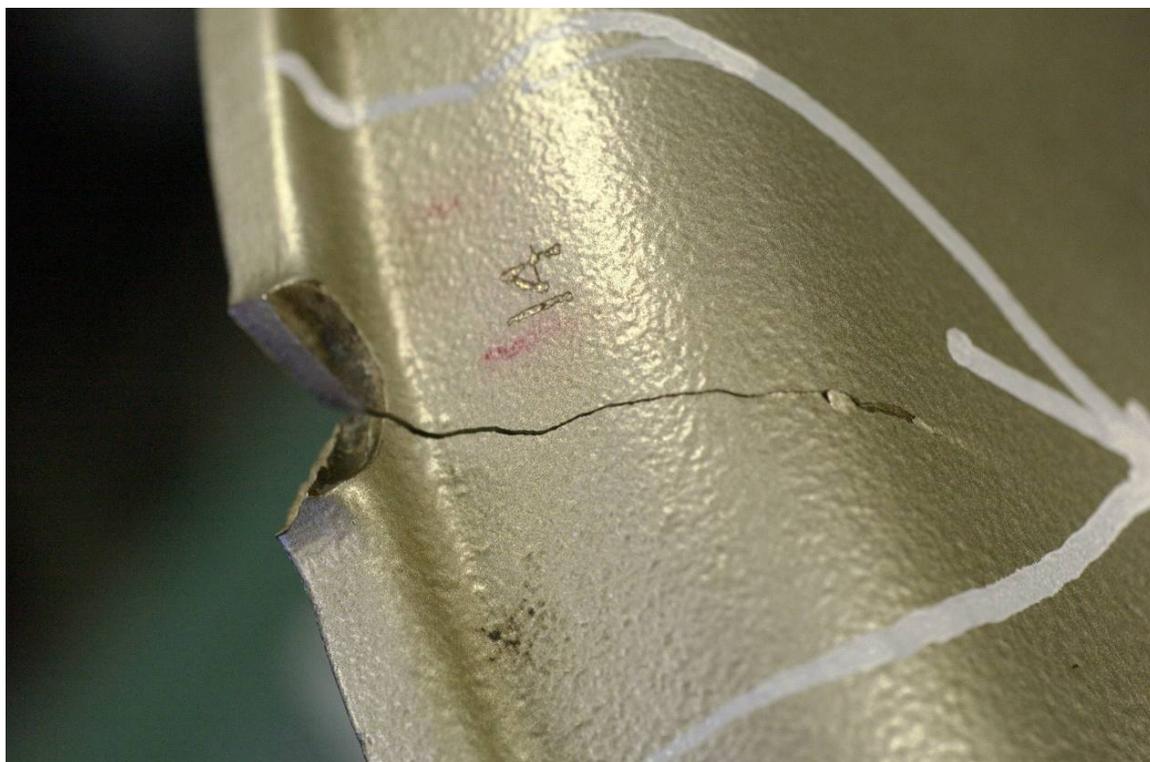
Figure 19 Fatigue crack extension into the cover at lug 14.

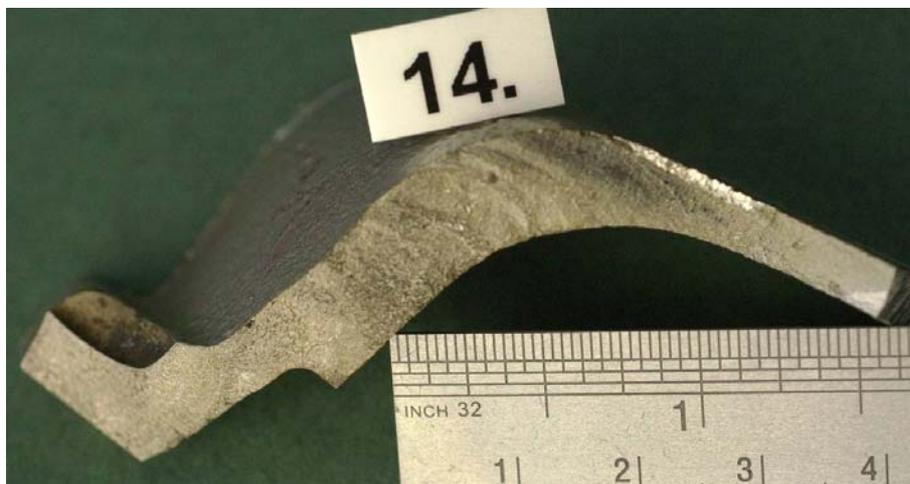
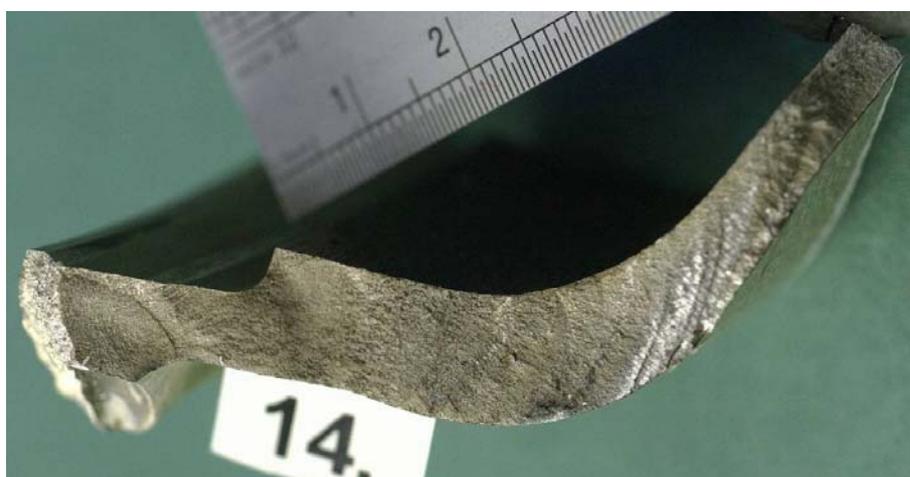
Figure 20a&b Opposing fracture surfaces in fatigue crack extension at lug 14.
