REPORT

HCLJ510-2012-96	Serious incident	
Aircraft:	SAAB 2000	Registration: SE-LOM
Engines:	2 - Allison AE 2100A	Flight: Scheduled, IFR
Crew:	3 - no injuries	Passengers: 47 – no injuries
Place:	Copenhagen Airport, Kastrup (EKCH)	Date og time: 20.3.2012 at 06:10 UTC

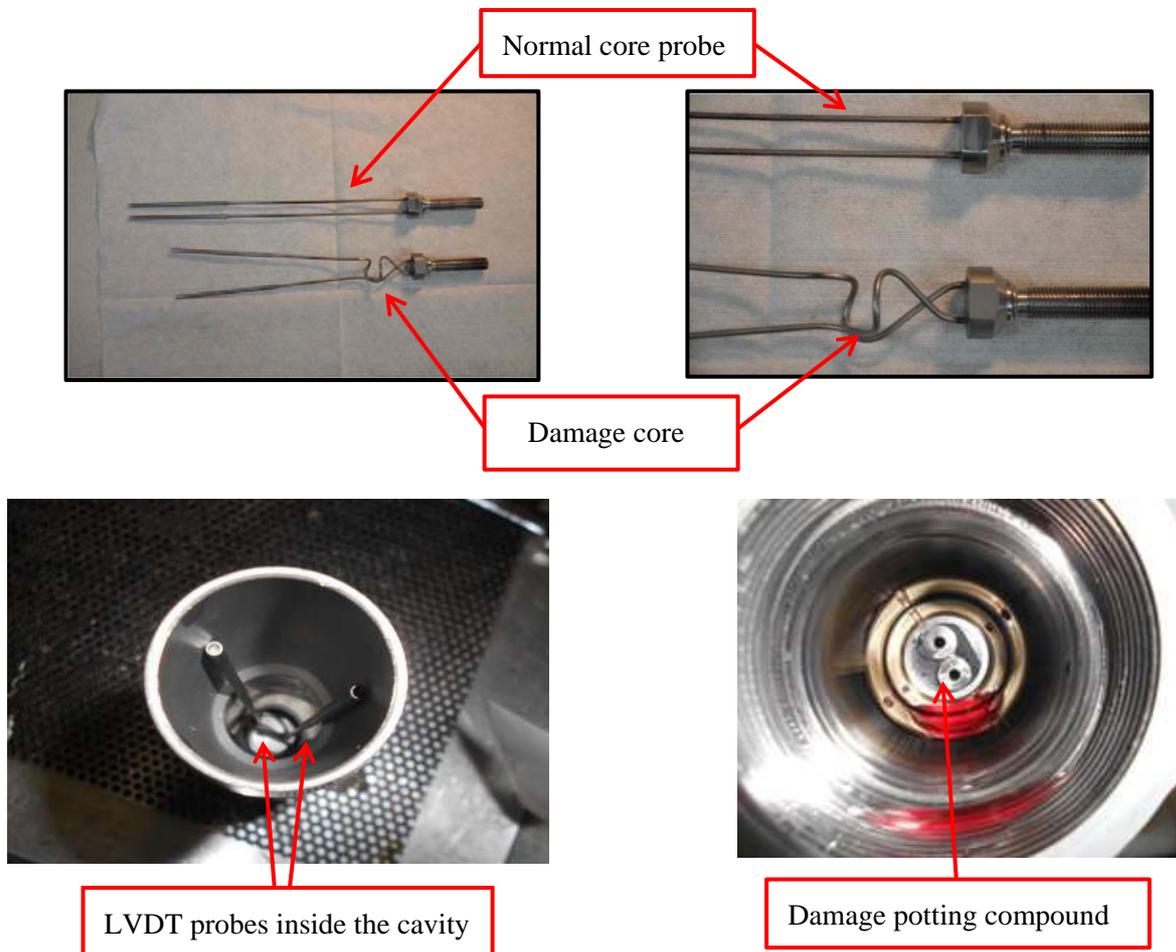
The Servo valve Linear Variable Differential Transformer (LVDT) test was performed, and the unit passed Channel A test. LVDT Channel B failed later in the test due to an open electrical circuit.

A series of resistance measurements of all internal transformer coils was performed. All coils displayed comparable resistance when compared to their matching channel counterparts, except for channel B actuator LVDT coil, which exhibited an open circuit between the coil and center tap pins 14, 15 and 16. The unit was subsequently cooled to a temperature of minus 40 degrees Fahrenheit, and the transformer coils were again tested with similar results.

The unit was subsequently partially disassembled in order to gain access to the LVDT assembly. The piston rod end was removed, revealing the LVDT cavity the two cylindrical ferromagnetic core probes. Both probes exhibited curling damage at their bases. The LVDT cavity and both probes were clean, and free of contaminants.

Examination of the LVDT case revealed that both probe coil sleeves had become displaced about 3 mm longitudinally, and broken out of their potting compound.

The investigation of the outboard actuator revealed a failure in one coil (channel B) of the two coils in the LVDT. This coil failure resulted in invalid positioning output to the SAC monitoring and illuminated the L ELEVATOR DEGRADE warning on EICAS.

Furthermore, the LVDT probes were found bended in the LVDT cavity where the coils were placed. The bending of a probe would not necessarily degrade the elevator function.

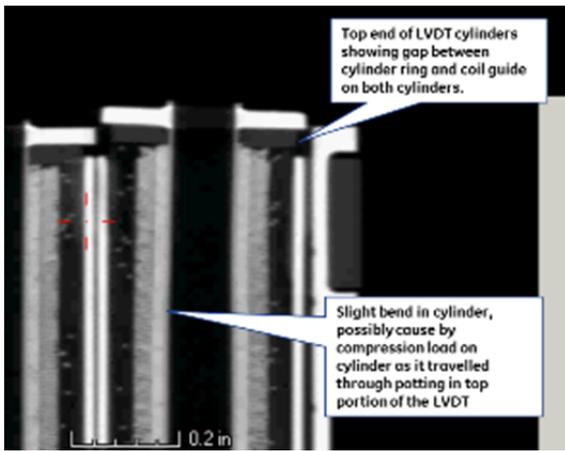
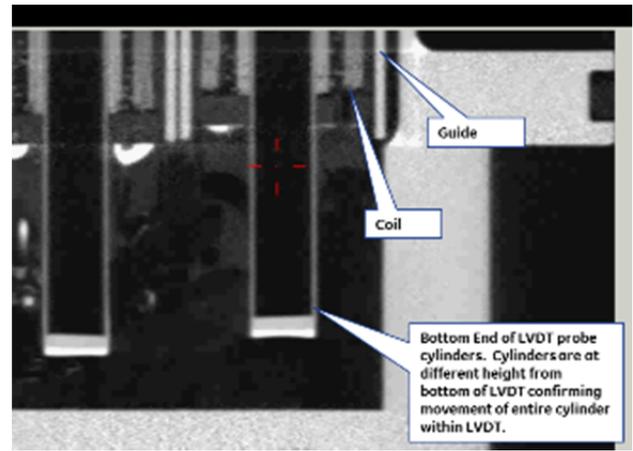
The failed LVDT cavity was sent to General Electric (GE) - Advanced Manufacturing Technology Lean Labs for a resolution digital imaging.

During the Lean Labs resolution digital imaging test, there was no identification of the root cause for the damage to the LVDT probes. However there were a couple of areas identified for additional evaluation during destructive inspection:

- Potential damage to the bottom of one of the LVDT
- Void potting at the bottom of the LVDT
- Slight bend in one of the probes cylinders
