Final Report

HCLJ510-2012-148

Serious incident to Eurocopter AS350 B3
Registration OY-HUB
At Nyhavn, Mestersvig, Greenland
On 25 August 2012

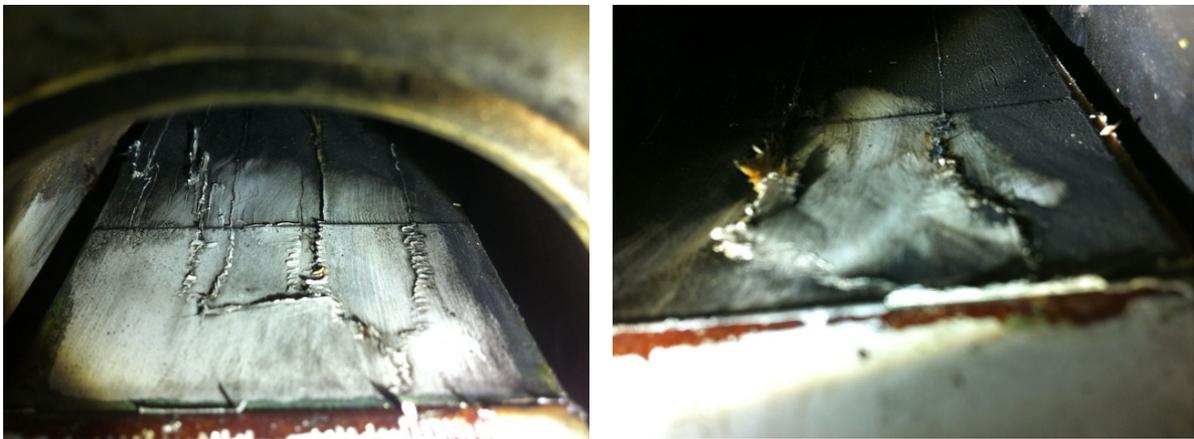
The tail rotor longitudinal hank - made of resin-impregnated glass roving - was damaged (delaminated) at the blade root areas.

This hank constituted the tail rotor blade spar.

The damage to the hank is shown on the pictures below.

The in flight opening of the Spacepod door caused a foreign object damage to the tail rotor. This was probably caused by the missing seat cushion or parts hereof.

In this case the foreign object damage caused a powerful vibration and a sudden left yaw movement of the helicopter.

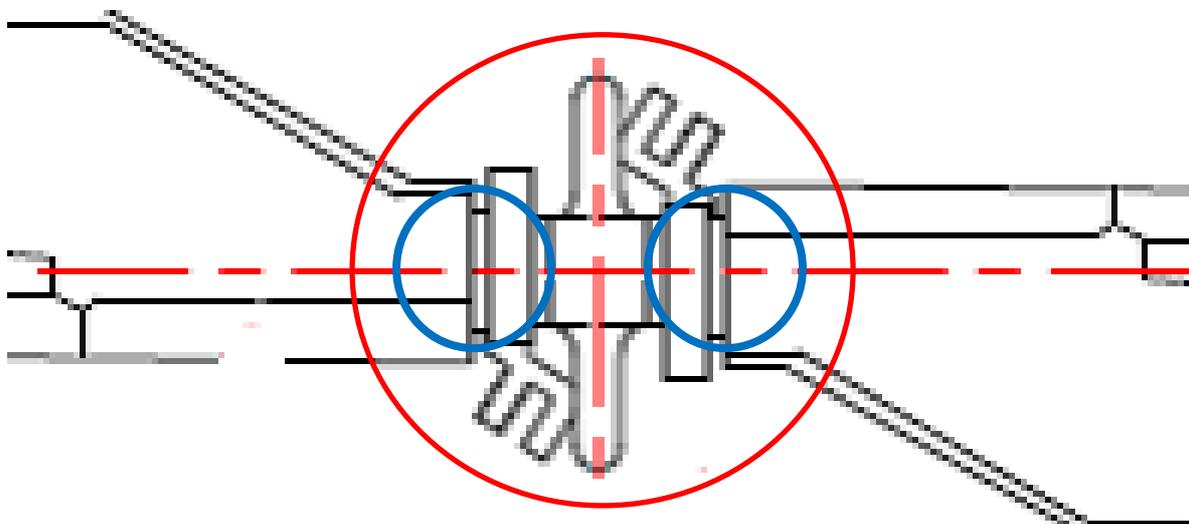
The tail rotor hub, the longitudinal hank and the blade root areas are shown in the red circle on the drawing below.

The damaged areas of the longitudinal hank are marked with blue circles.

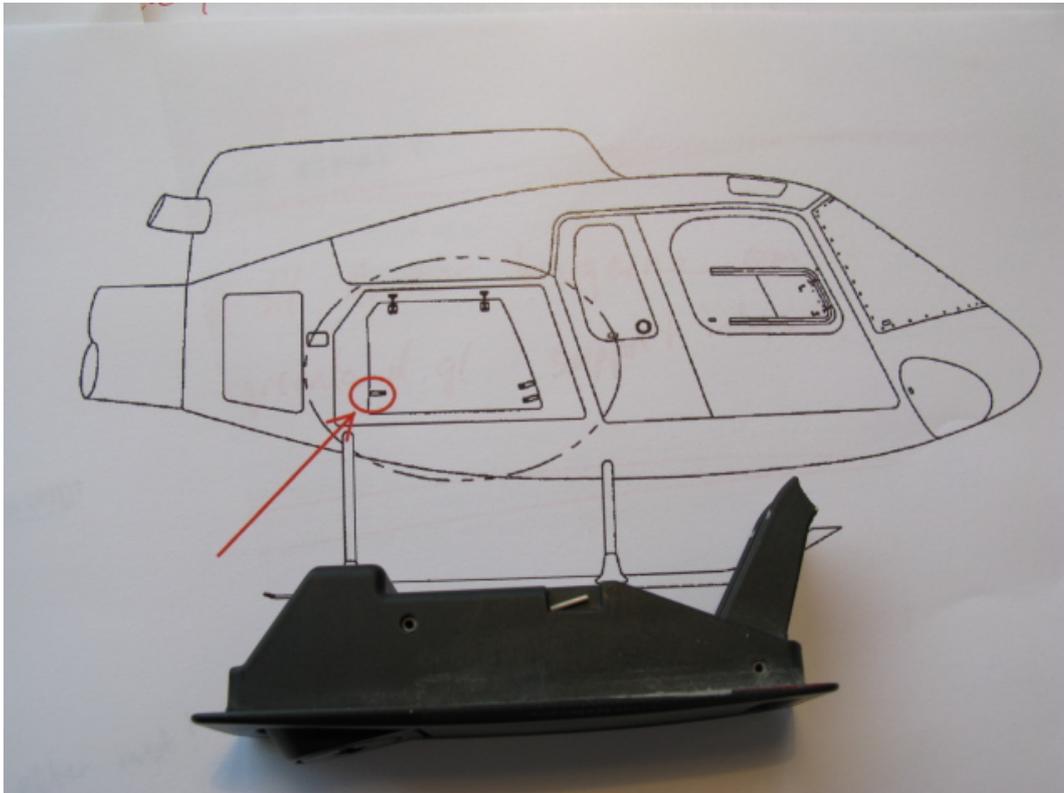
The aft door latch (shown on the picture below) was broken.

The AIB-DK is of the opinion that this scenario most likely damaged the aft door latch striker arm (foreign object damage).

The AIB-DK could not determine when the aft door latch striker arm broke. It is possible that this happened when the door was forced open.

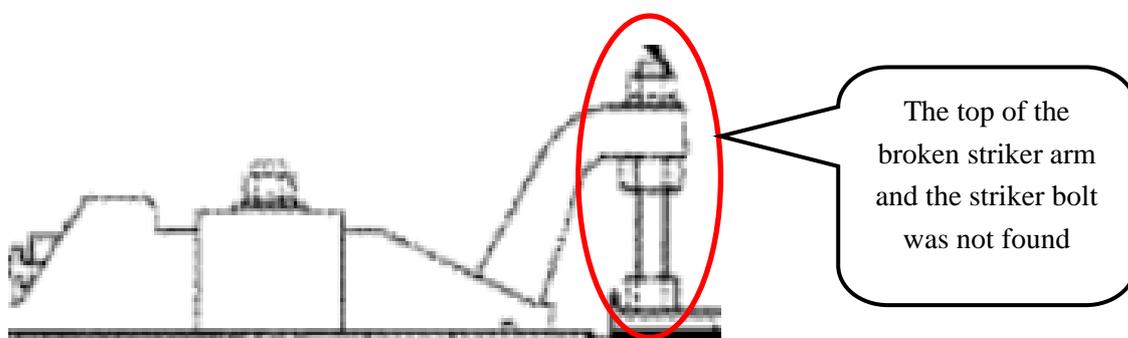
The missing part of the aft door latch is shown in the red circle on the drawing below.

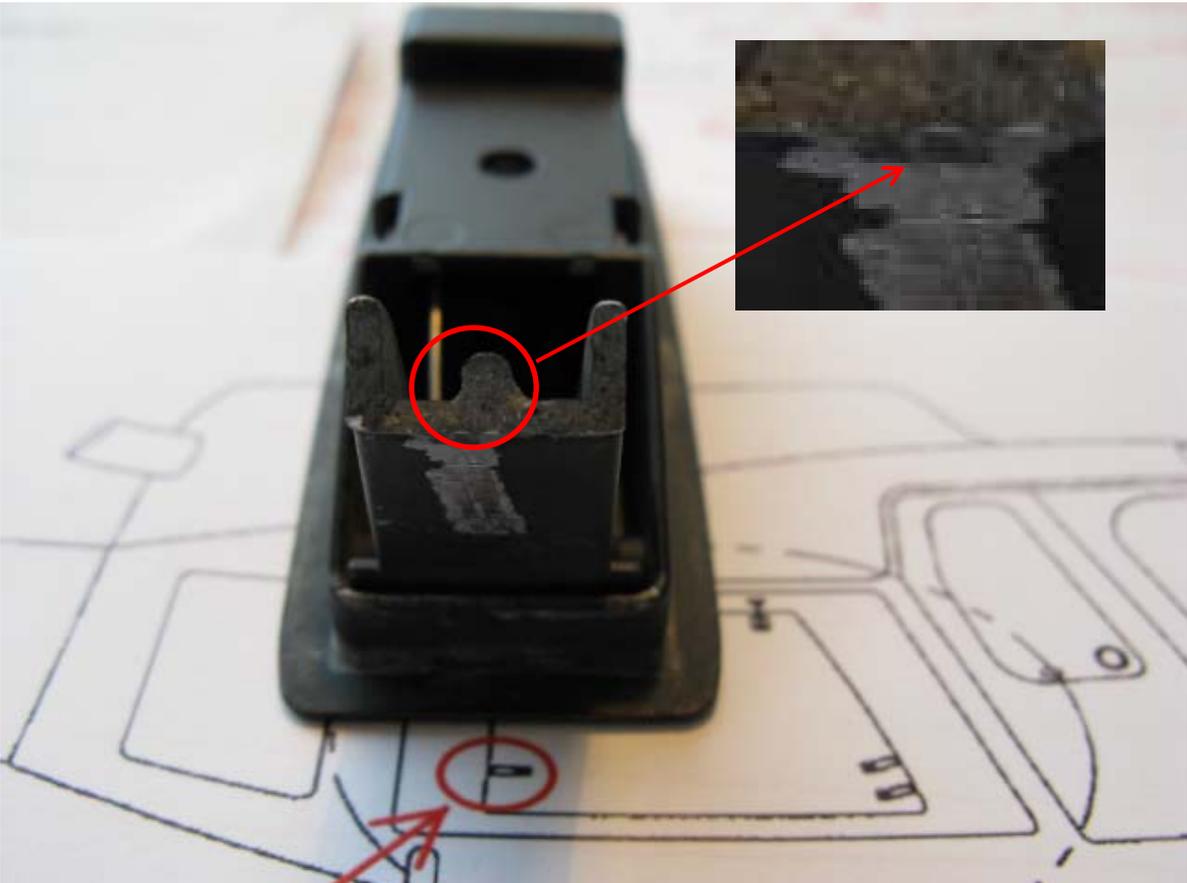
There was a scratch mark on the remaining part of the door latch striker arm (picture below).

The fracture initiation point is shown in the red circle.

The fracture initiated from a pressure mark in the aluminum casting which is shown at the segment of the picture.

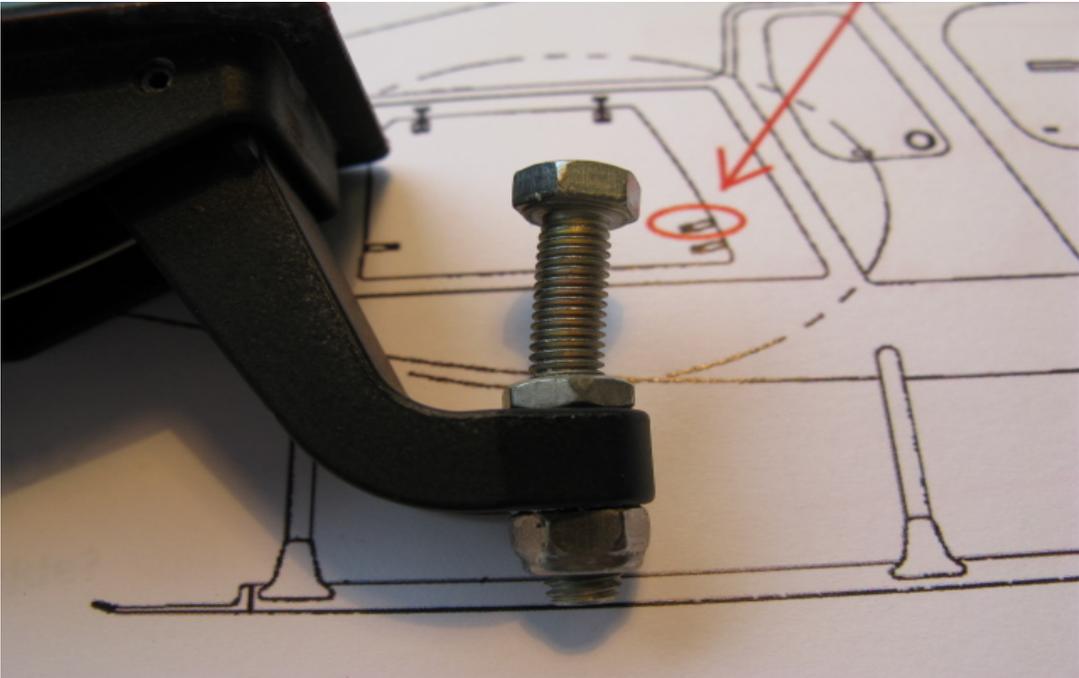
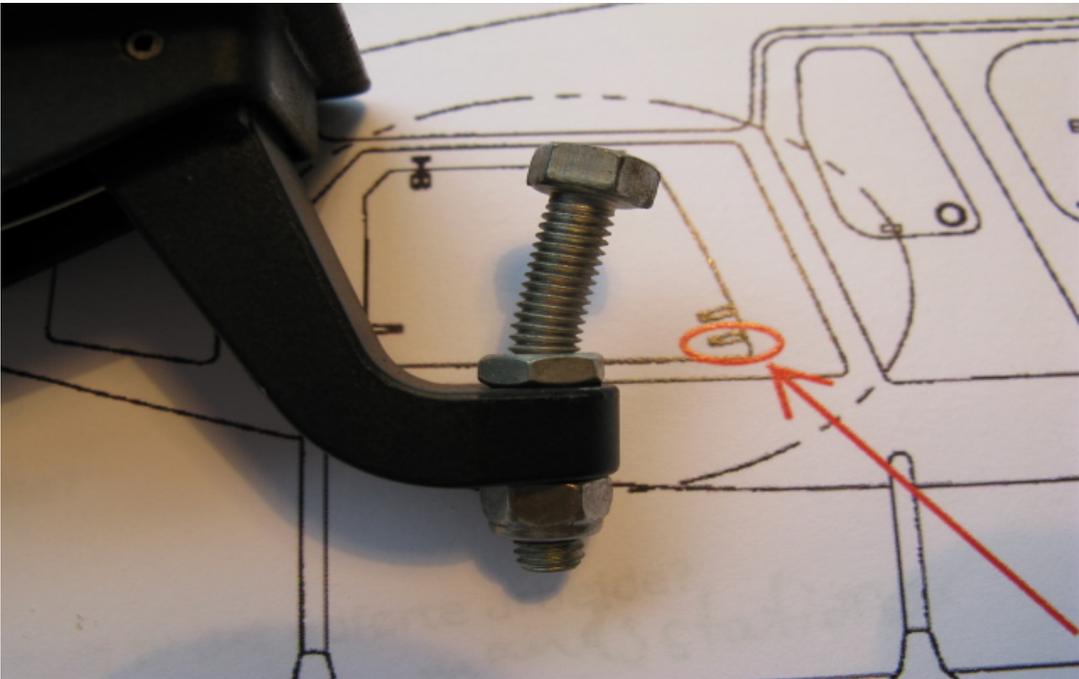
The forward upper and lower door latch adjustable striker bolts were bended as shown on the pictures below (latches shown upside down).

The door latches were not protected against objects stored in the cargo room (foreign object damage).

The striker bolts could catch objects between the striker bolt and the striker arm when closing the door.

The AIB-DK can not exclude that some of the door latch damages (bended bolts) were caused by the door forced open by the air flow around the helicopter in flight.

The operator of the serious incident helicopter has been in contact with the Spacepod manufacturer with the aim of a protection of the door latch installation against foreign objects.

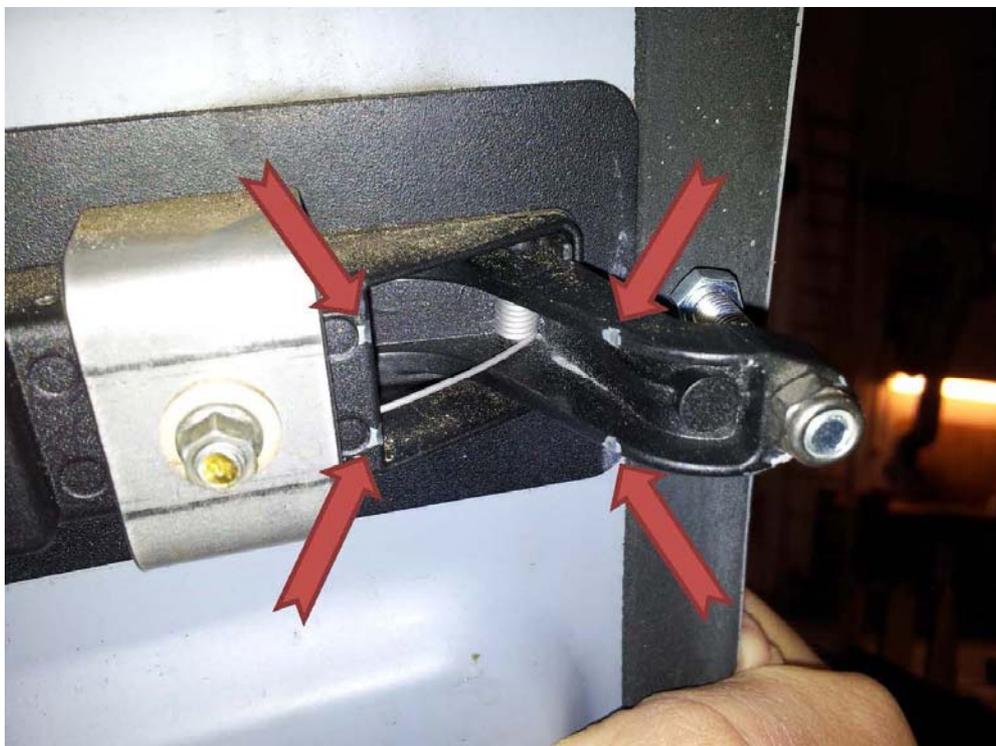
The picture of the door latch shown below was taken from the inside of the cargo room of another AS 350 than OY-HUB.

As illustrated, the door latches were unprotected against foreign object damage.

The red arrows show impact marks created when the door latch is opened and the striker arm is forced open by the spring.

This type of impact marks were not found on the door latches of OY-HUB.
