**Havarikommisjonen**

# **Final Report**

## **HCLJ510-2012-172**

Serious incident to Airbus A319-131  
Registration OY-KBR  
At Copenhagen Airport, Kastrup (Denmark)  
On 21 November 2012

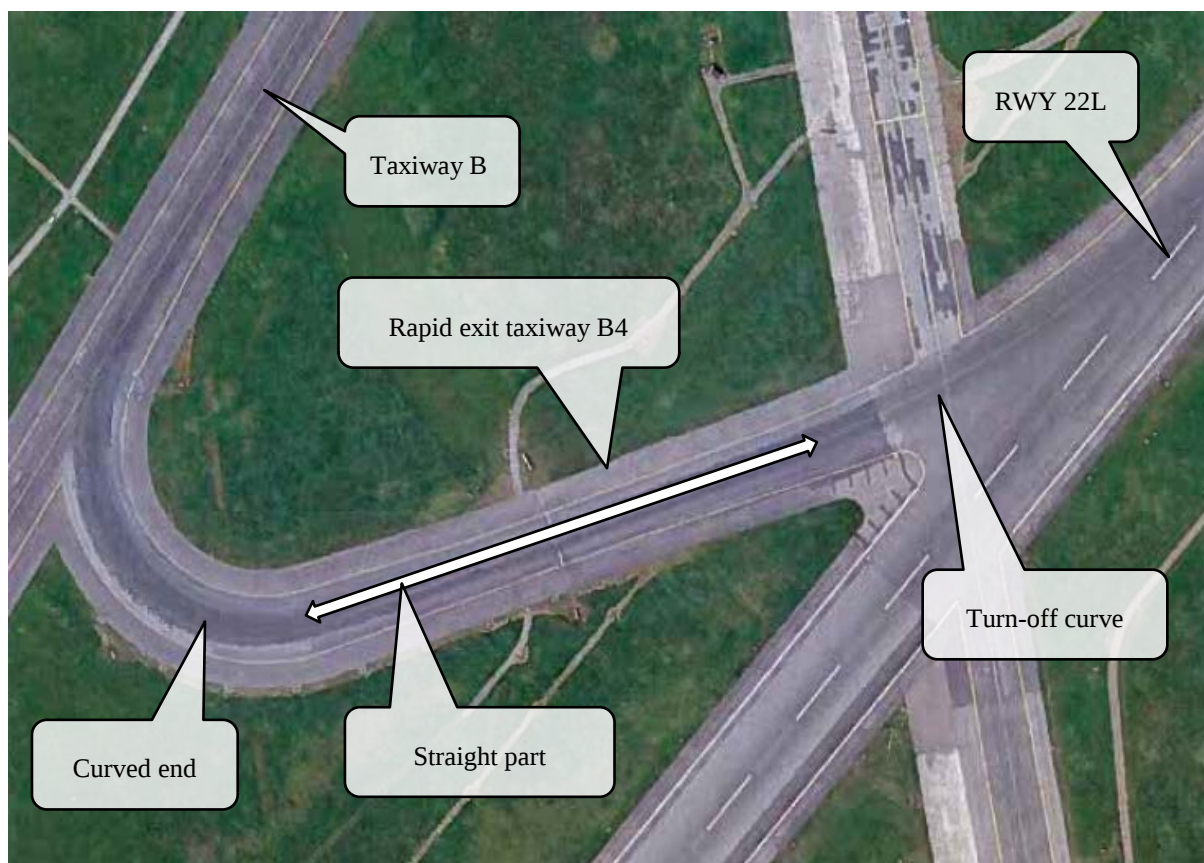
TWY B4 geometry:

| Angle of the turn-off curve: | 30° |
| Radius of the turn-off curve ( <i>R</i> ): | 543 meter |
| Straight part: | 226 meter |
| Angle of the curved end: | 142° |
| Radius of the curved end ( <i>R</i> ): | 76 meters |

In relation to the TWY B4 design the investigation found no deviations from the requirements described in ICAO Annex 14.

*"RWY 22L leaving rapid exit TWY B4, the curved end of TWY B4 is designed for a max 15 knots in dry conditions only. Hotspot chart will be issued SAP in AIP Denmark, AD2-EKCH-ADC".*

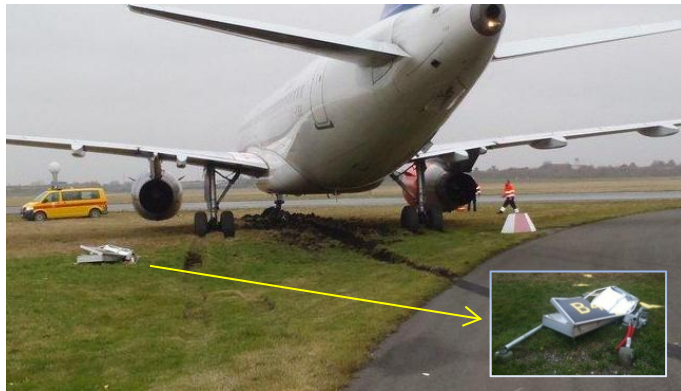
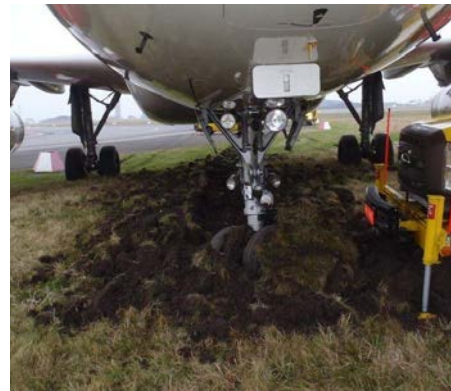
The aircraft impacted the B4 location and B direction sign located in the grass area close to the taxiway (left picture below). The nose landing gear was covered with dirt but undamaged (right picture below).

Broken parts of the B4 location and B direction sign were found inside the engine behind the air inlet fan.

The left engine air intake and the lower engine cowling were damaged.

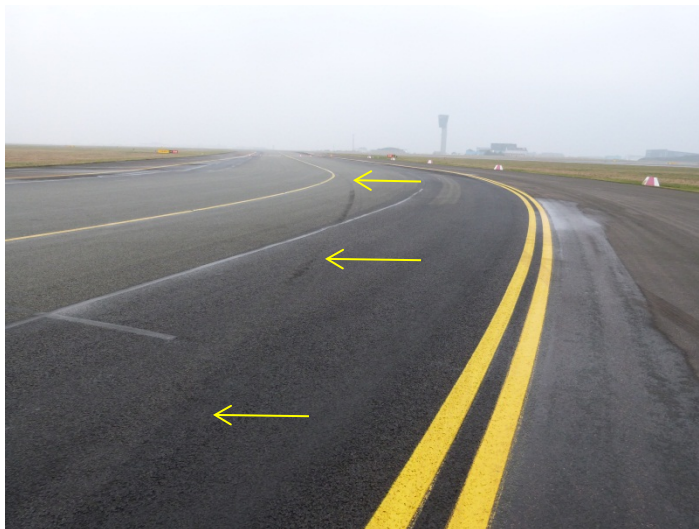
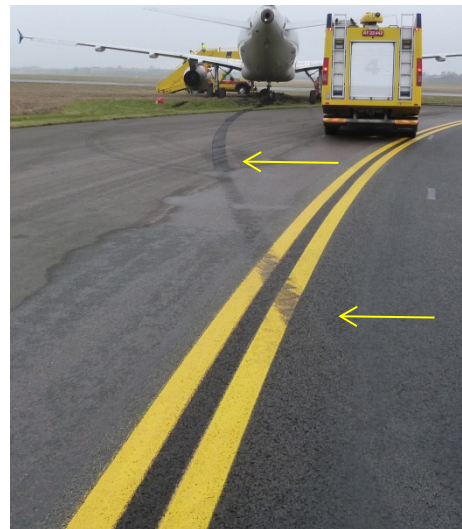
On the pictures below it can be revealed that the nose wheel was skidding on the taxiway asphalt from the point of the beginning of the curved end (at the centerline) to the grass area (marked with yellow arrows).

It appears from the pictures above that the taxiway was damp and drying up.

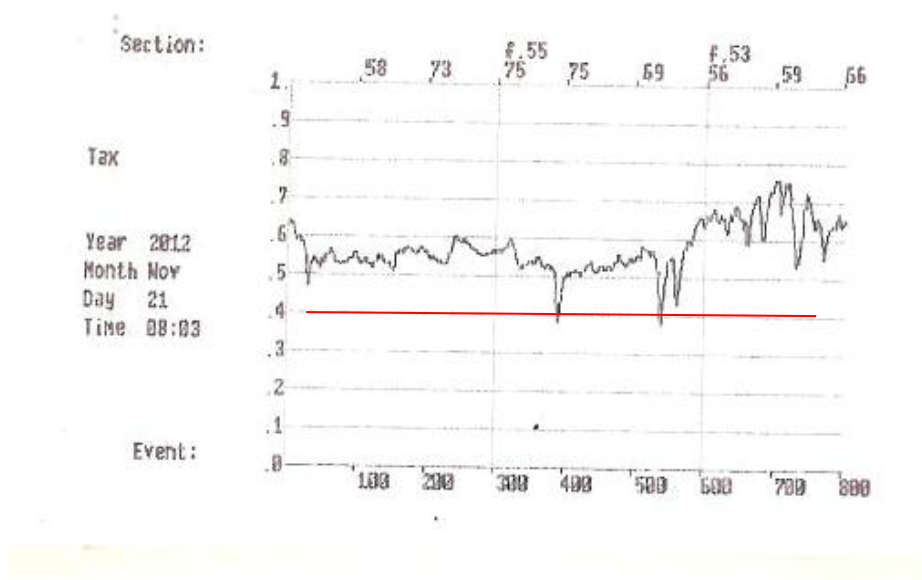
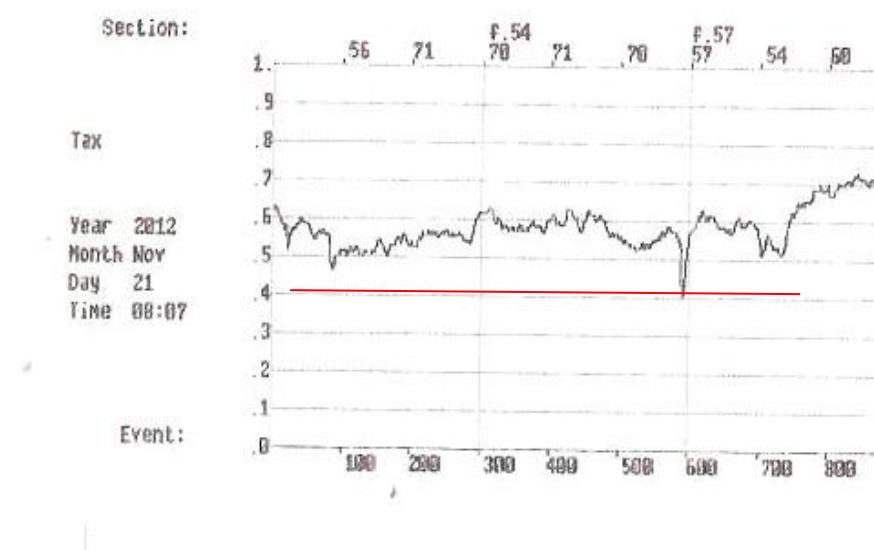
The AIB-DK inspected the taxiway condition immediately after the serious incident had occurred and revealed that the granular asphalt was rough when touched and not slippery.

From the friction test strips shown below, it can be revealed that the friction was good (measured friction coefficient 0.40 and above) Friction coefficient 0.40 marked with red lines.

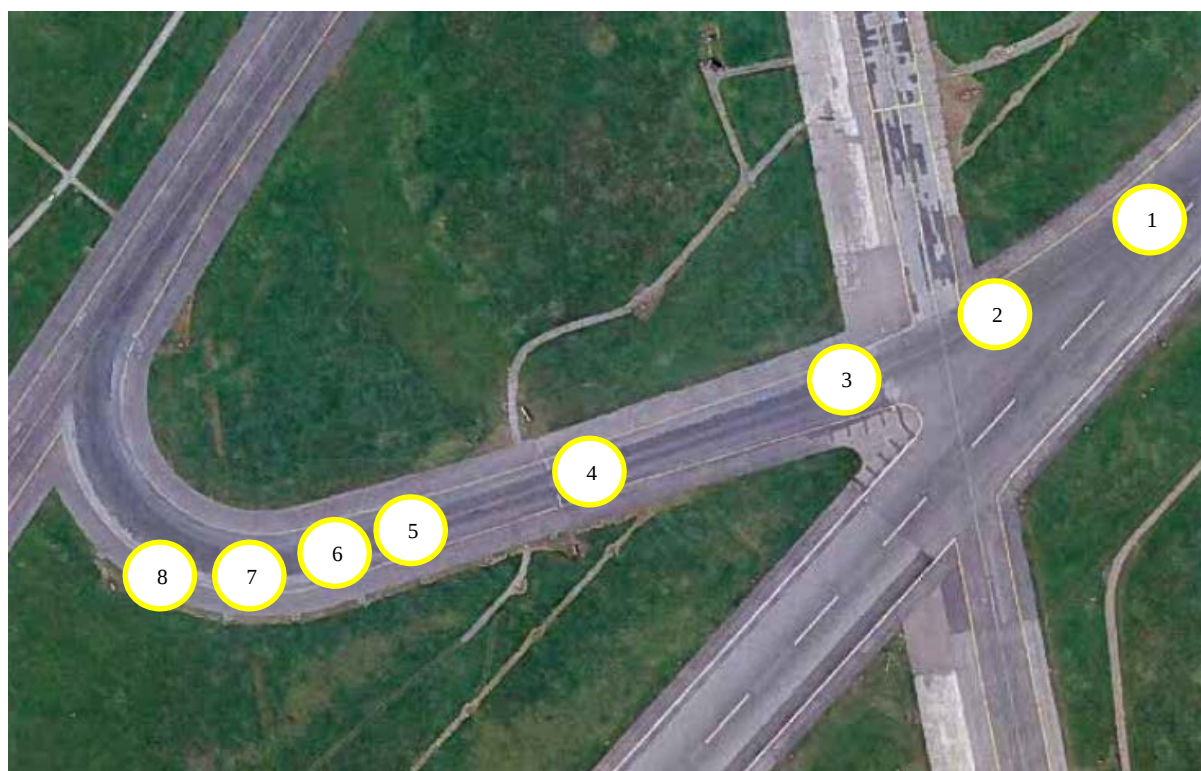
Aircraft Condition Monitoring System (ACMS) data in relation to aircraft position on TWY B4 shown below. The time period between pos. 1 - 8 was 26 seconds.

The brake pressures (not shown) correspond to the brake pedal positions (high units / high pressure).

From the ACMS data it could also be revealed that the CMD deselected both thrust levers when the aircraft reached 60 knots GS. The reversers went to the FWD IDLE position before the aircraft reached the turn-off curve of TWY B4.

Analyzing the ACMS data, the AIB-DK found the aircraft turned off RWY 22L at a ground speed of approximately 45 knots and that braking was performed ineffectually (mostly using the left brake) while the aircraft was rolling on the straight part of B4. The AIB-DK is of the opinion that consistently braking on the straight part of B4 could have prevented the serious incident.

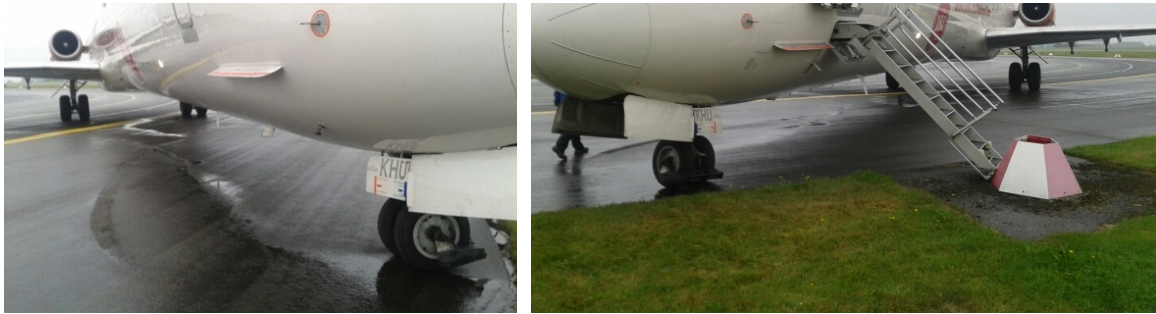
Latest incident was to a McDonnell Douglas MD-87 on 11<sup>th</sup> September, 2012. The aircraft was unable to follow the centerline of the curved end of TWY B4. The aircraft exceeded the left yellow side marking off TWY B4 as the nose wheel was skidding. The aircraft stopped on the asphalt close to the grass area (pictures below).

FDR data showed the following. When the aircraft turned-off to TWY B4, the indicated airspeed (IAS) was 58 knots and the lateral acceleration reached 0,138 G.

When the aircraft skidded off TWY B4, the IAS was 31 knots or below.
