HCLJ510-2012-102	Incident		
Date:	28-03-2012	Time:	Kl. 04:30:00 UTC
Damage to aircraft:	Minor	Place:	EKCH stand G121

Registration:	N-918FD	Phase:	Taxi
Aircraft type:	BOEING - 757-200	Operation:	Commercial Air Transport - Scheduled revenue ops - International - Cargo

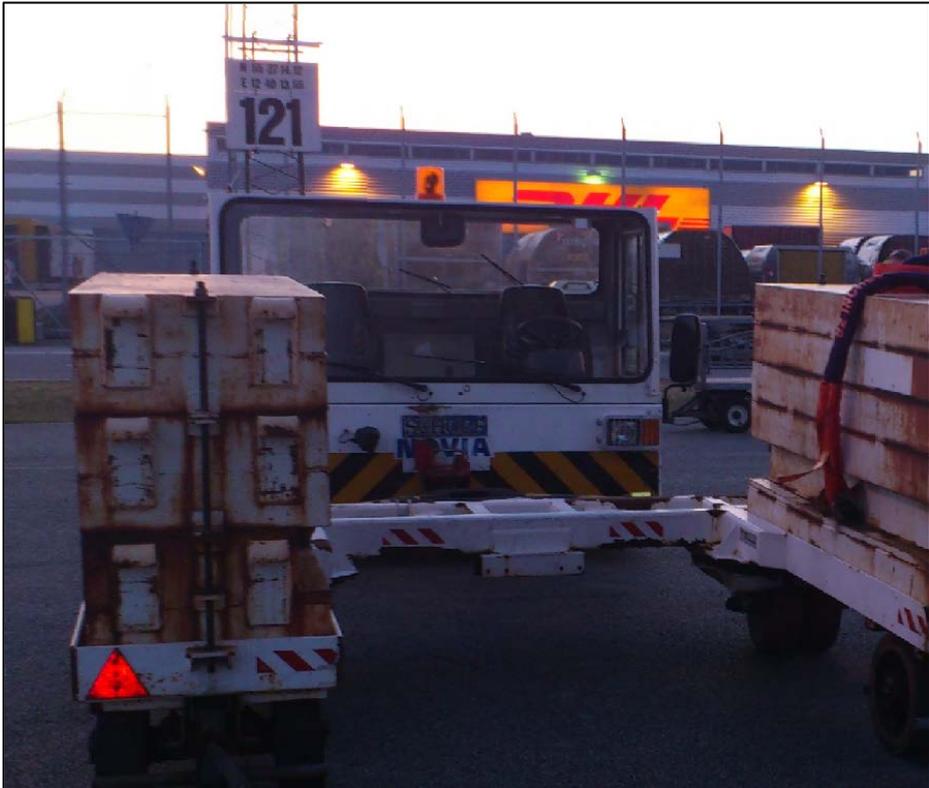
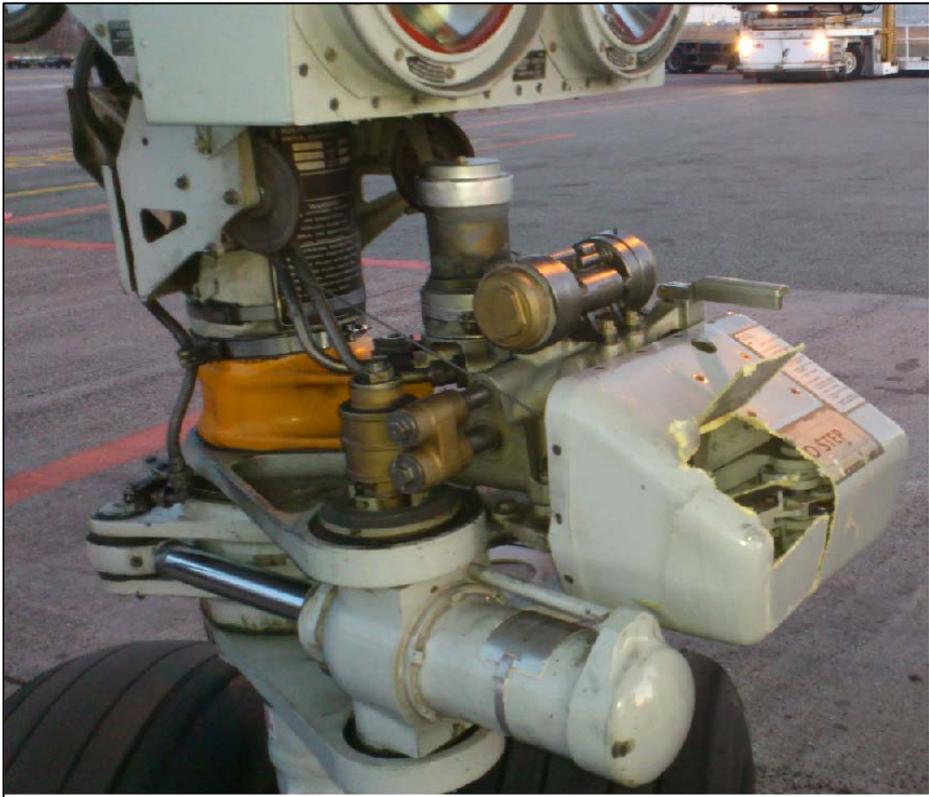
Enclosure 1

The commander looked at the overhead panel where the APU light was located. The commander and the first officer saw that the aircraft was moving; consequently the commander applied maximum braking. The commander noted that the amber parking brake light still was illuminated and that the parking brake lever was sticking. It appeared to be engaged but it was not.

The aircraft had moved approximately 20 meters forward and the nose gear had made contact with the contra weights that was located in front of the aircraft.

The nose gear hydraulic system located at the forward part of the nose gear suffered minor damage. See enclosure 1.

The aircraft was repaired and the parking brake system checked. After the repair the aircraft was checked without any technical remarks.
