## Safety Investigation Report

# ACCIDENT TO VAN'S AIRCRAFT RV-8A REGISTERED OY-L\*\* AT GRIMBERGEN ON 30 APRIL 2011

Ref. AAIU-2011-6-Grimbergen-OY-L\*\*  
Issue date: 10 July 2012  
Status: Final

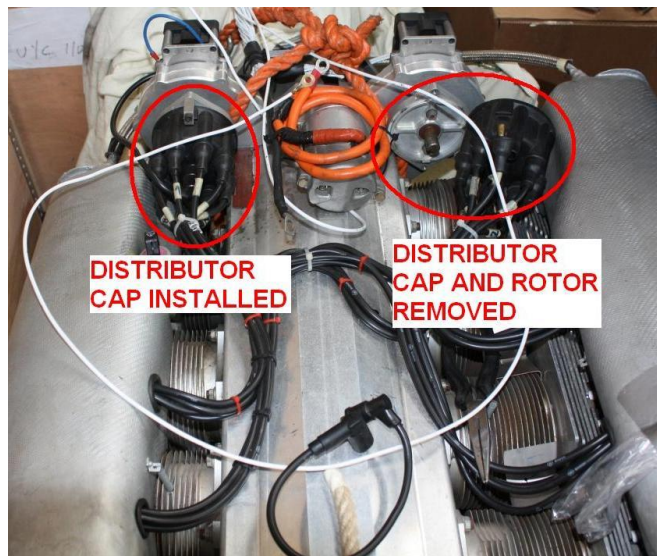
We removed both distributor caps and we found that there was no clearance between the new rotors and the distributor caps.

**Figure 3: view of the high tension distributors**

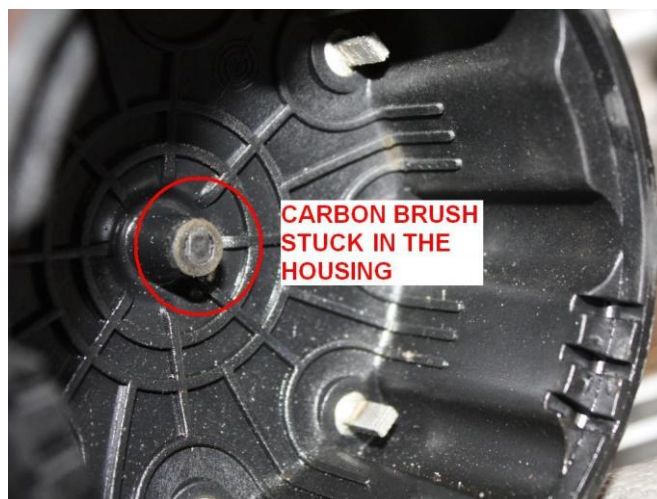
Consequently, the rotors were damaged and the carbon brush of each distributor was blocked inside its housing due to the friction (see figures 4 and 5).

Despite the damage, the distributor caps and the rotors were yet functional and could not explain a sudden and complete engine failure.

However, it is likely that sooner rather than later this would have result in a partial or complete failure of the ignition system.

**Figure 4: Inside of a High Tension distributor cap**

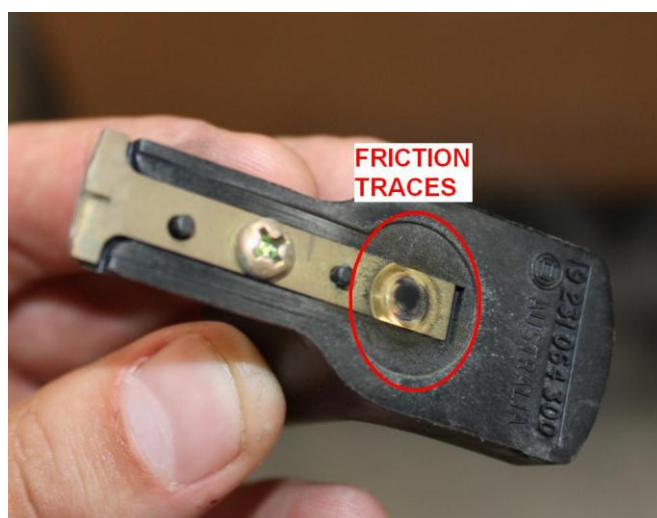
This anomaly was probably not the cause of the engine failure and therefore we didn't investigate the actual cause of the inadequate positioning of the rotors.

**Figure 5: Friction traces on a practically new rotor**

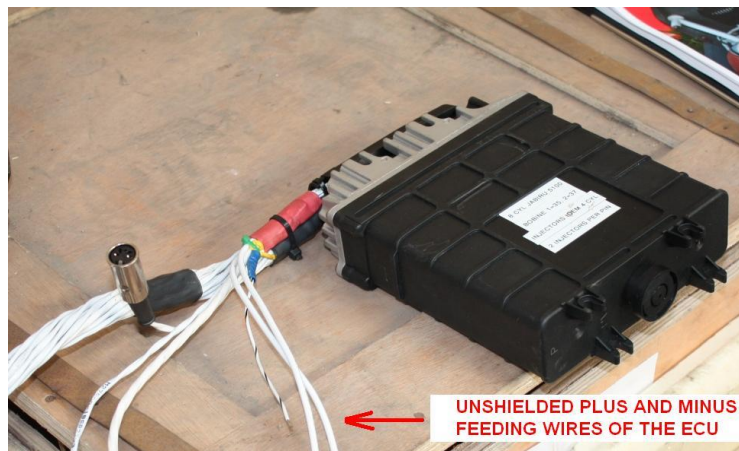
By looking in detail at the ECU loom of OY-L\*\*, we noticed that the both plus and minus feeding wires of the ECU were not shielded.

Figure 4: ECU box and loom

Therefore the possibility exists that the unshielded wires of the ECU worked as antennas, picking up electrical interference, causing the ECU to trip.
