# Havarikommisjonen

## Statement 2023-638

**Serious incident to SE-DMS (Airbus A321-253NX) northwest of the city of Elsinore on 20-12-2023**

**ISSUED DECEMBER 2024**

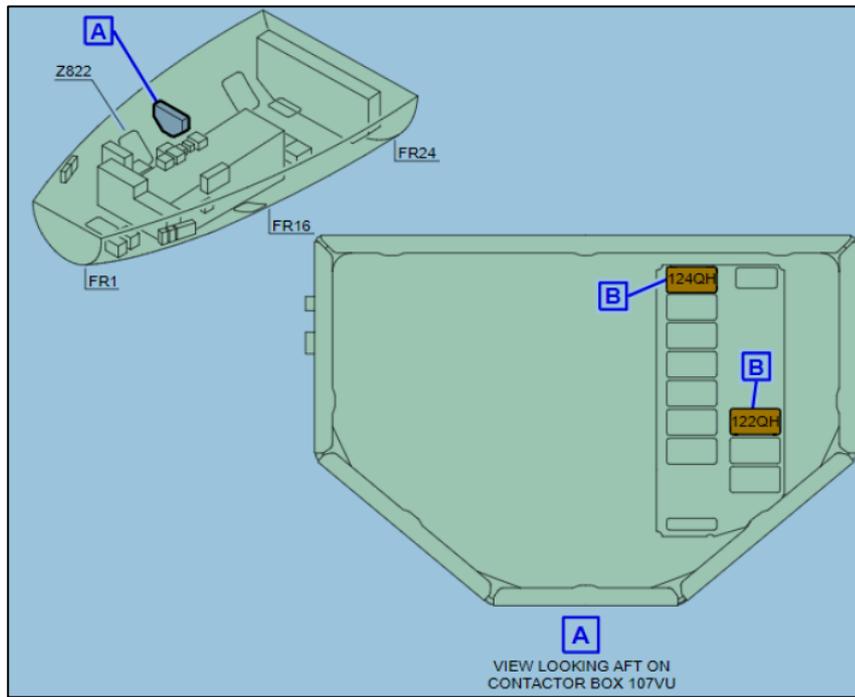
Figure 3. GFI relay (124QH) location.

The GFI relay (124QH) was installed in the avionics compartment under the cockpit floor in the contactor box 107VU.

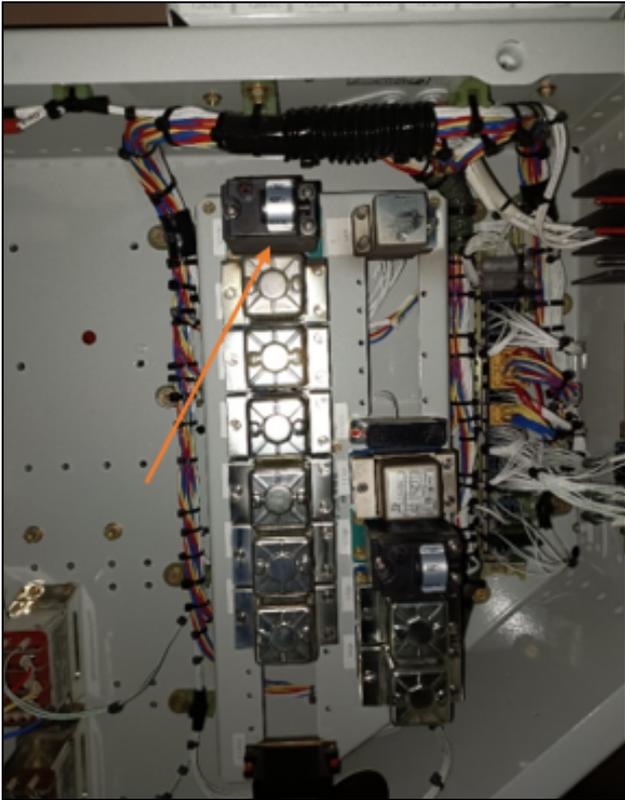
Figure 4. Damaged GFI relay location.

Shortly after engine shut down, maintenance crew inspected the avionics compartment. In the contactor box 107VU, the maintenance crew noticed a GFI relay (124QH) with black soot and a burnt hole in the plastic housing.

The adjacent relay (17QA) had on parts of its casing black soot deposits from the GFI relay (124QH). There were no other damages to this relay (17QA).

There were no other damages to the GFI relay mating installation or wiring in the aircraft. No circuit breakers were in open position.

Maintenance crew replaced the damaged GFI relay (124QH) and the adjacent relay (17QA) with new relays.

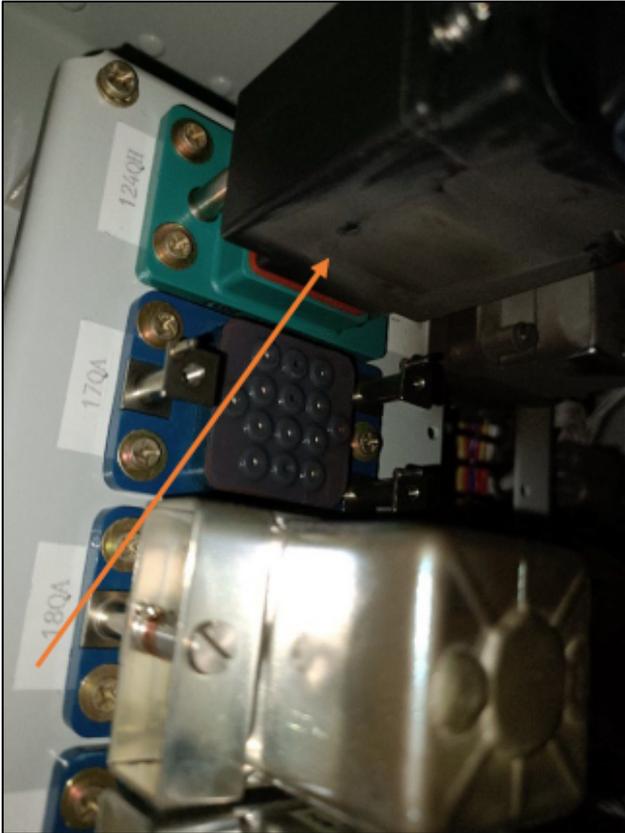
Figure 5. Damaged GFI relay.

The CT scan confirmed that overheating had occurred inside the GFI relay.

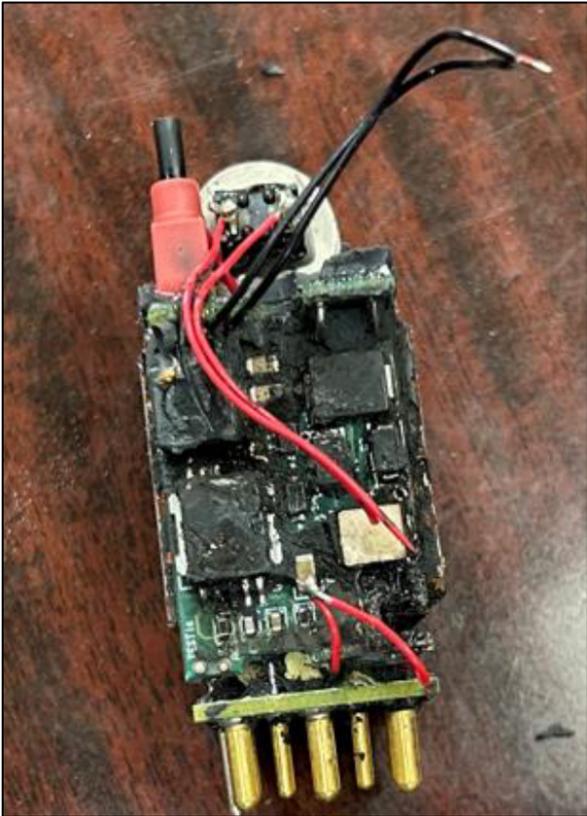
Figure 7. GFI relay disassembled with burnt and damaged components.

The inspections concluded that the capacitor, current limiting resistor, Pulse Width Modulator (PWM) chip, PWM trace wires, Transient Voltage Suppressor (TVS), internal wiring, blocking diode and freewheeling diode had damages often seen after exposure to voltage levels exceeding the design limits.
