Havarikommisionen

Accident Investigation Board Denmark

Report 2020-424

Serious incident to OE-IMI (Dassault Falcon 900EX) in Kangerlussuaq (BGSF) on 3-12-2020.

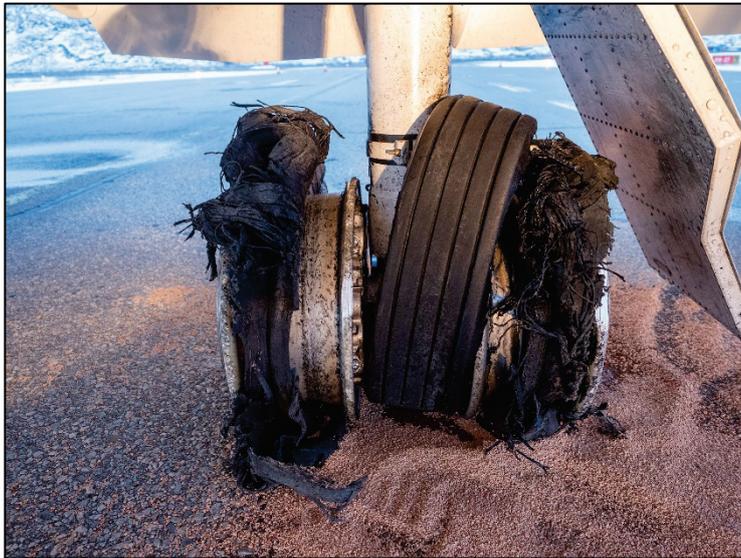
There were damages to the main wheel rims and tires #1 and #2 (LH), the associated hydraulic brake unit lines (LH), the LH Main Landing Gear (MLG) door, and the main wheel tire #4 (RH).

Figure 1. Damages to the main wheel rims and tires and the hydraulic brake unit lines (LH side)

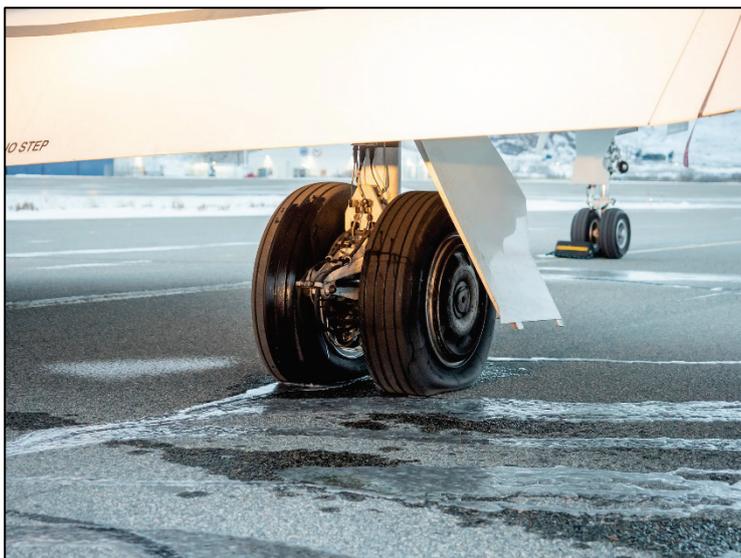
Figure 2. Damage to the main wheel tire (RH side)

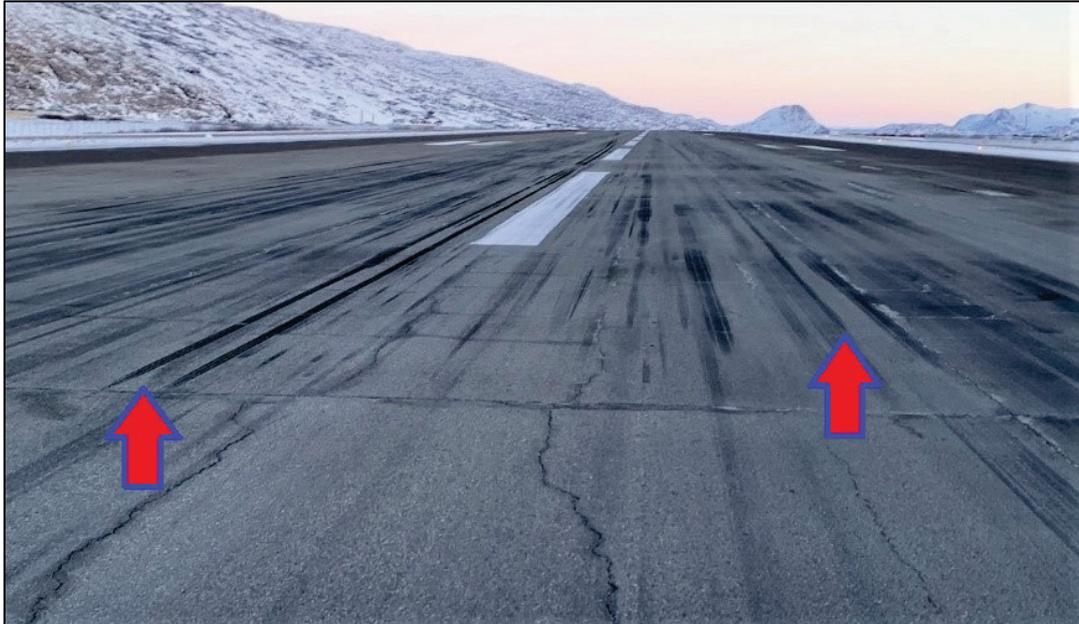
Tire rubber skid marks indicated, that the aircraft touched down approximately 504 m from the threshold on runway 09, and that the main wheels #1, #2, and #4 were blocked at touchdown.

Figure 13. Tire rubber skid marks on runway 09

Scratches on the runway from wheel rim #1 and #2 were still sporadically visible.

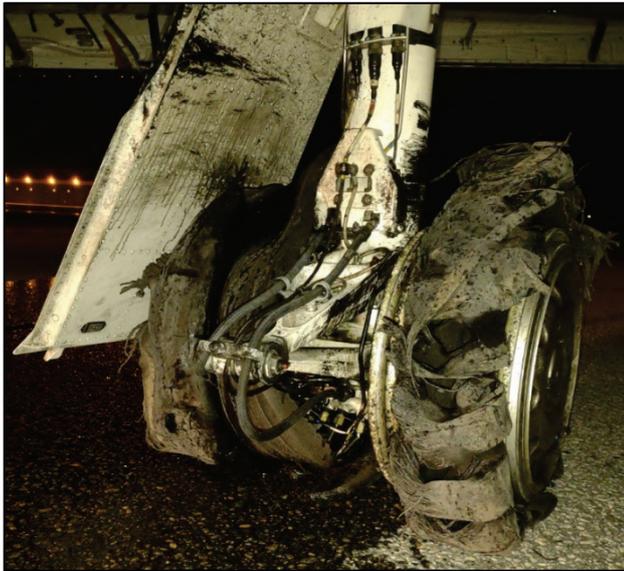
Figure 14. LH MLG

Inspection of the LH MLG revealed that the hydraulic lines for the brakes were damaged, and that hydraulic fluid from both systems had leaked. The spilled hydraulic fluid was visible from the beginning of taxiway C, and a large puddle surrounded the LH MLG.

The LH MLG door was damaged.

Following the repair of the hydraulic lines, the maintenance personnel measured brake hydraulic pressure and found the pressure to be within Aircraft Maintenance Manual (AMM) limits.

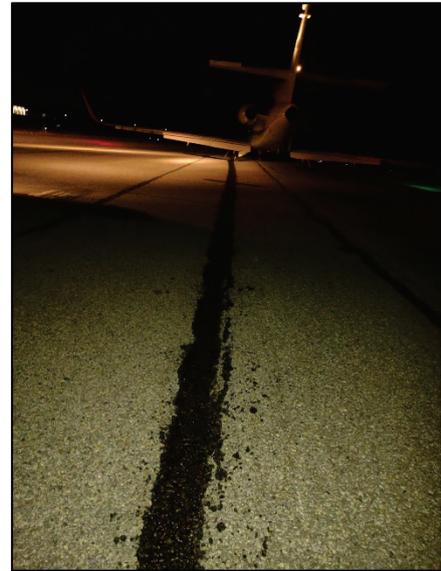
Figure 15. Hydraulic fluid on taxiway C

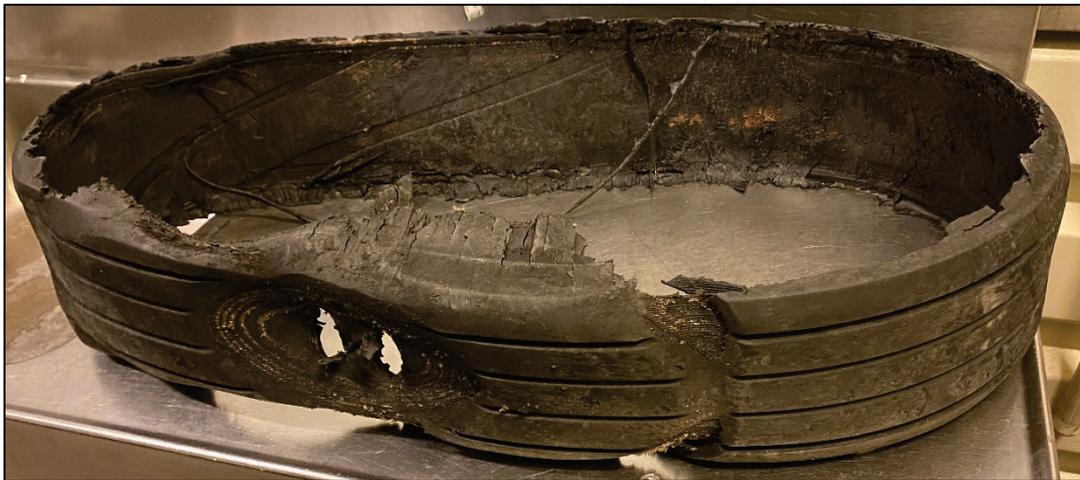
Figure 16. Tire #1

Airport personnel found tire #1 on the runway. An inspection of the tire revealed a significant flat spot.

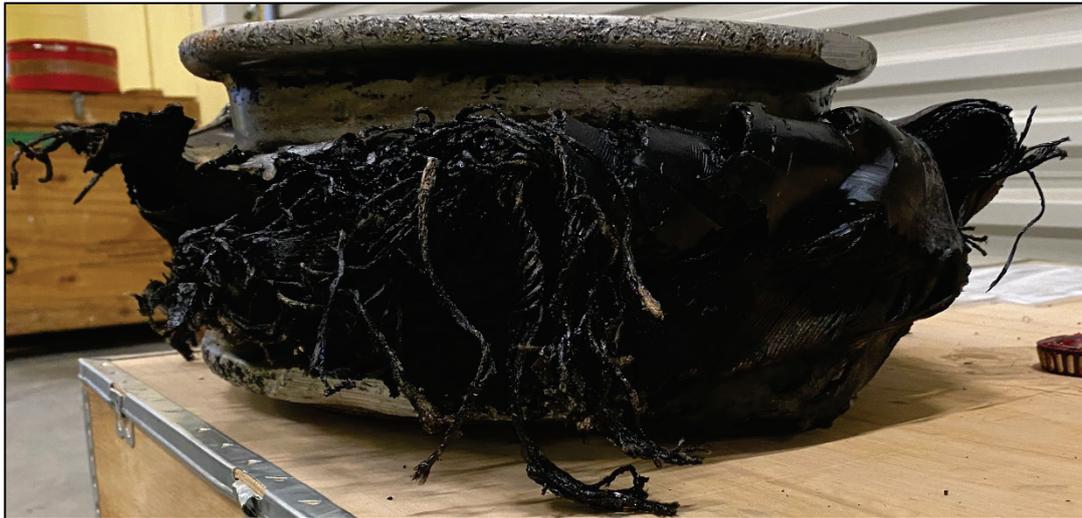
Figure 17. Rim #1

Maintenance personnel removed rim #1. The inspection of rim #1 revealed rub marks on the inboard and outboard side together with small nicks all around the circumference.

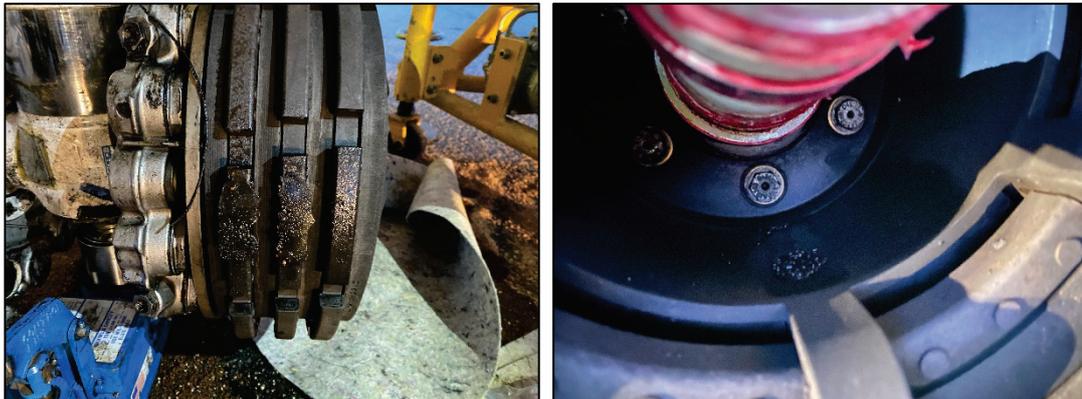
Figure 18 & 19. Brake #1

Maintenance personnel inspected brake #1. Ice was found on the disks and inside the torque tube on brake #1.

The brake had a “rough” sound when rotated. Maintenance personnel removed brake #1 and stored it at room temperature. After a few hours, the ice had melted, and the brake discs were able to rotate without a “rough” sound.

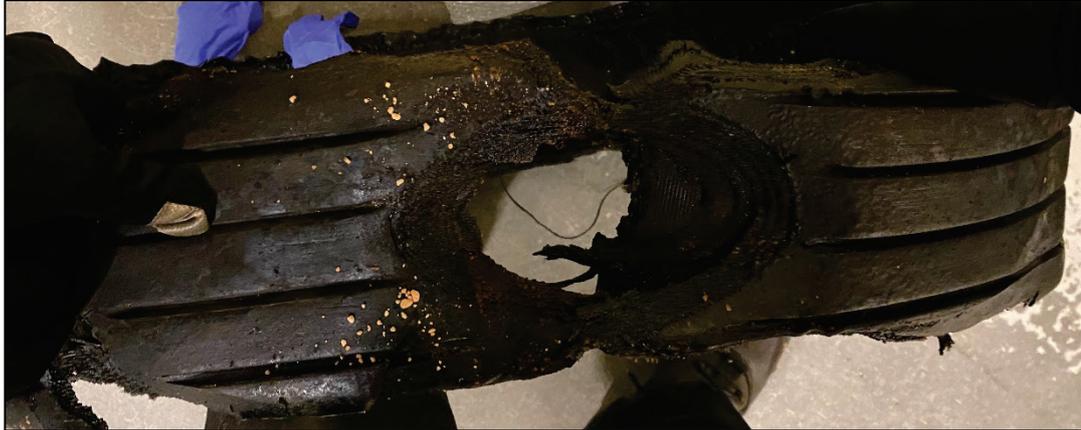
Figure 20. Tire #2

Tire #2 had disintegrated but was still loosely sitting on the rim. Maintenance personnel had to cut tire #2 to remove it and allow access for a jack. Inspection of the #2 tire revealed a significant flat spot.

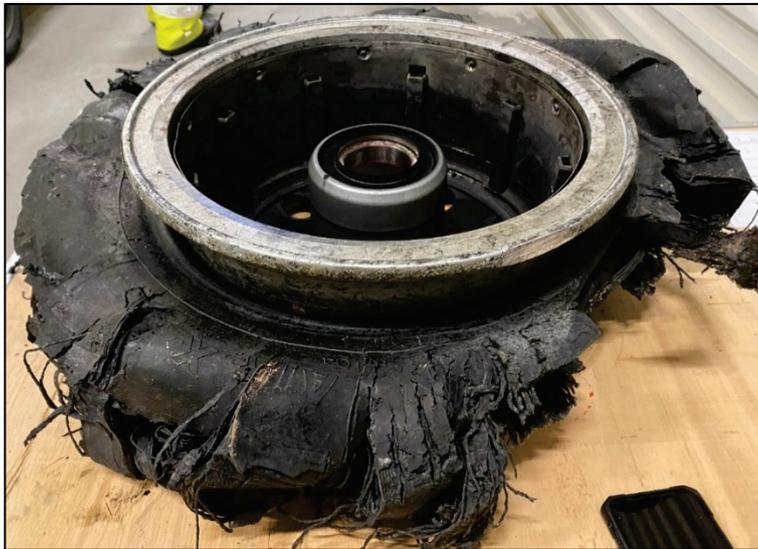
Figure 21. Rim #2

Rim #2 had a rub mark and small nicks all around the circumference. After jacking the aircraft, the rim was able to rotate.

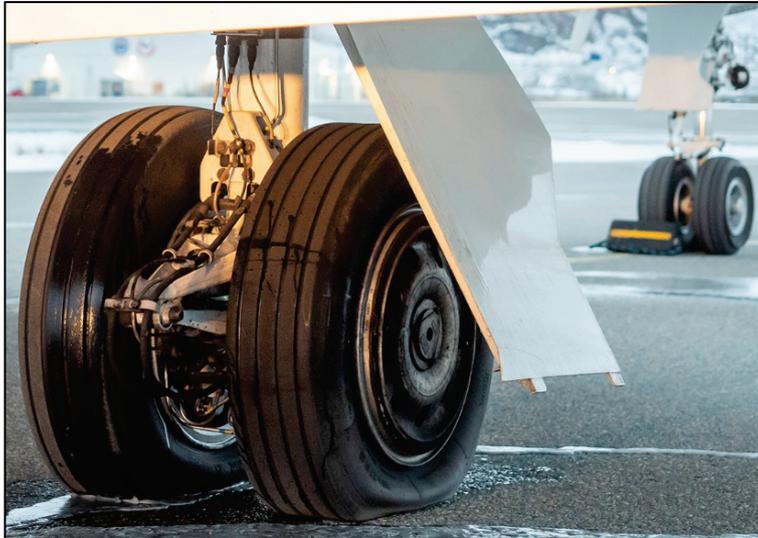
Figure 22. RH MLG

The inspection of the RH MLG revealed no damages.

Wheel #3 was pressurized. The disassembly and inspection revealed no damages or abnormalities on the #3 wheel or brake.

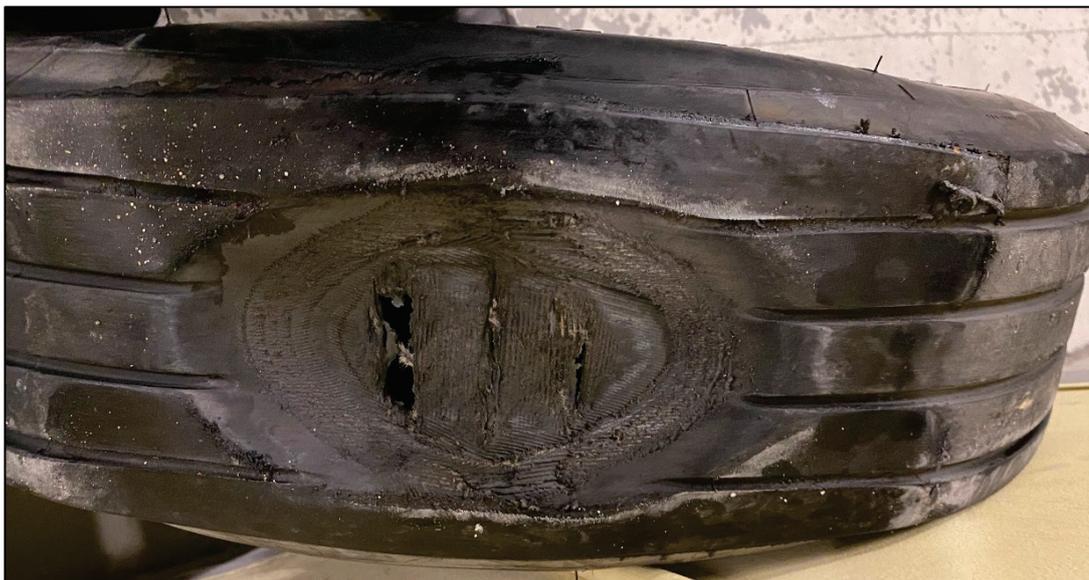
Figure 23. Tire #4

After jacking of the aircraft, wheel #4 was unable to rotate. After removal of wheel #4, a significant flat spot on the tire part that had been facing downwards was visible.

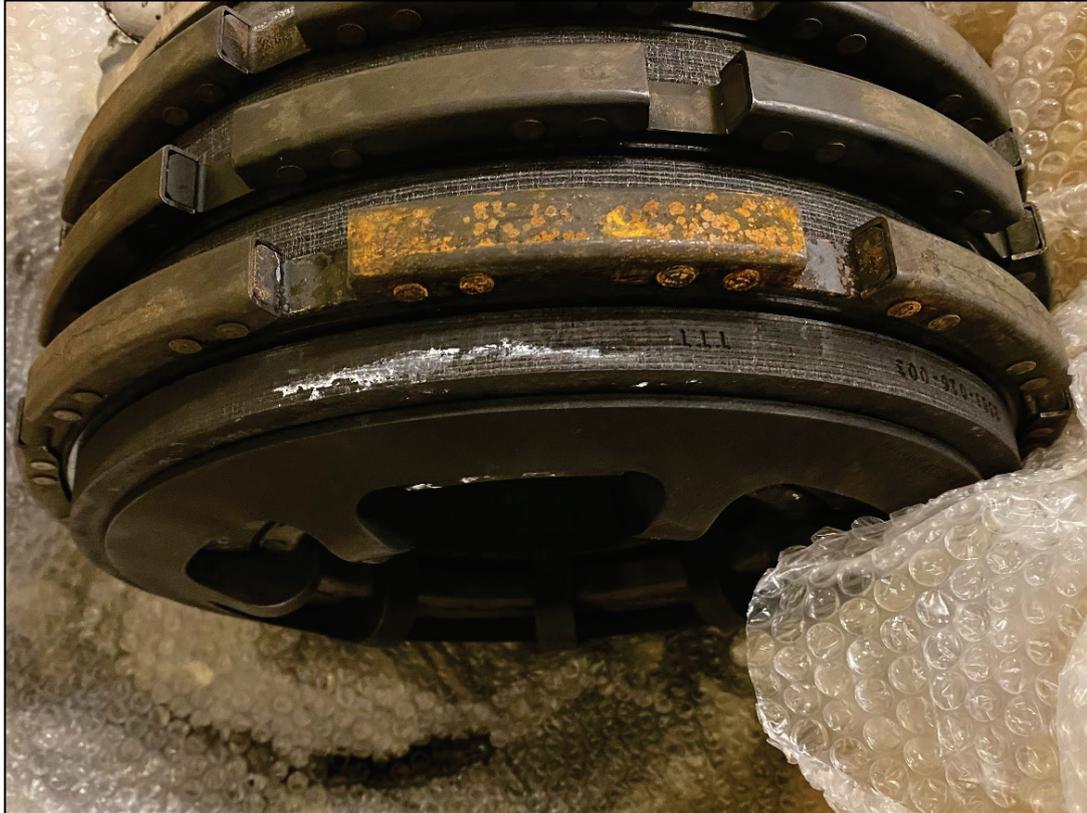
Two out of three disks on brake #4 were able to rotate. The center disk was unable to rotate. Maintenance personnel removed brake #4 and stored it at room temperature. After few hours, approximately 5 ml of liquid had emerged, and all three brake disks were able to rotate smoothly.

Figure 24. Brake #4 and liquid

AIB personnel collected the liquid and sent it out for analysis. See section [1.16.1](#).
