Havarikommisjonen

Accident Investigation Board Denmark

Bulletin 2022-127

Serious incident involving LN-PFI (Diamond DA40 NG) and an unidentified Unmanned Aerial Vehicle (UAV) 1.5 nautical miles north of the island of Laesoe on 21-3-2022

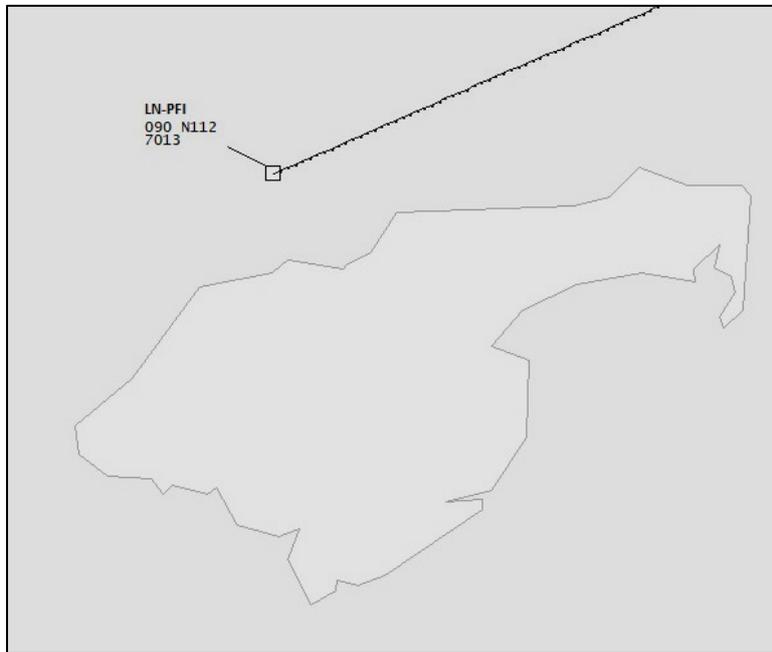
Radar replay at 10:42:03 hrs.

A playback of radar and Automatic Dependent Surveillance–Broadcast (ADS–B) data did not reveal any UAV operations in the area near the island of Laesoe at the time of the serious incident. [See appendix 1.](#)
