# **Havarikommissionen**

## **Bulletin 2020-260**

**Accident to OY-RUX (PZL-Bielsko SZD-59 ACRO) at Vesthimmerland (EKVH) on 9-7-2020.**

**ISSUED JUNE 2021**

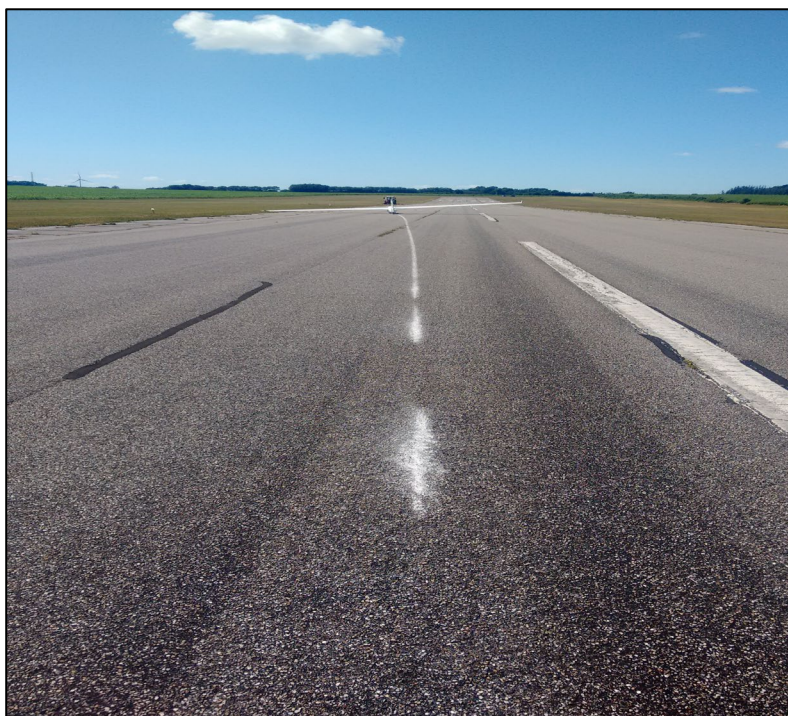
Photo no. 3: Scrape marks on the asphalt surface of runway 29.

There were no damages to the asphalt surface of runway 29. Paint and fibreglass from the glider caused white scrape marks on the asphalt.
