Accident Investigation Board Denmark

Report 2020-372

Serious incident to LN-OOZ (Airbus Helicopter EC135 P3) on short final for runway 23 at Ringsted (EKRS) on 6-11-2020.

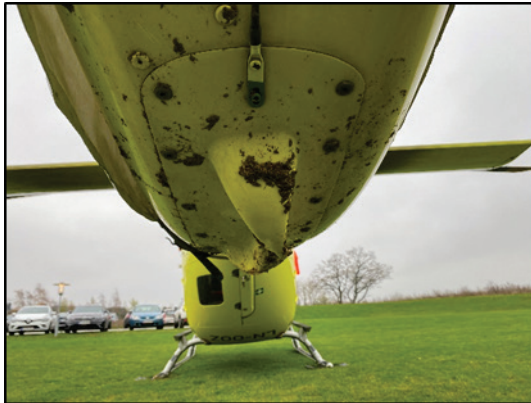
The helicopter sustained damage to the tail bumper and the landing skid.

Picture no. 1 – Damaged tail bumper

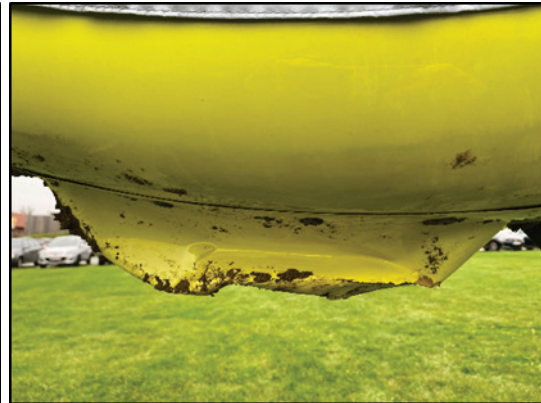
Picture no. 2 – Damaged tail bumper

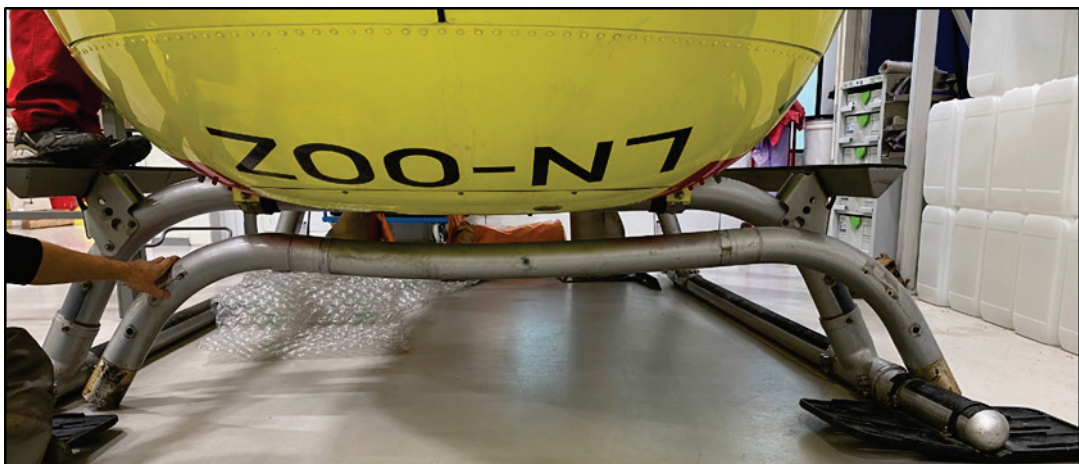
According to the helicopter manufacturer, a vertical touchdown speed of 200 - 500 ft/minute (min) would result in plastic deformation of the cross tubes but no damages to the fuselage.

Picture no. 3 – Removed damaged aft crossbeam compared to new installed.

A momentary high engine power output caused a main gearbox (MGB) overtorque situation. The operator replaced the MGB.

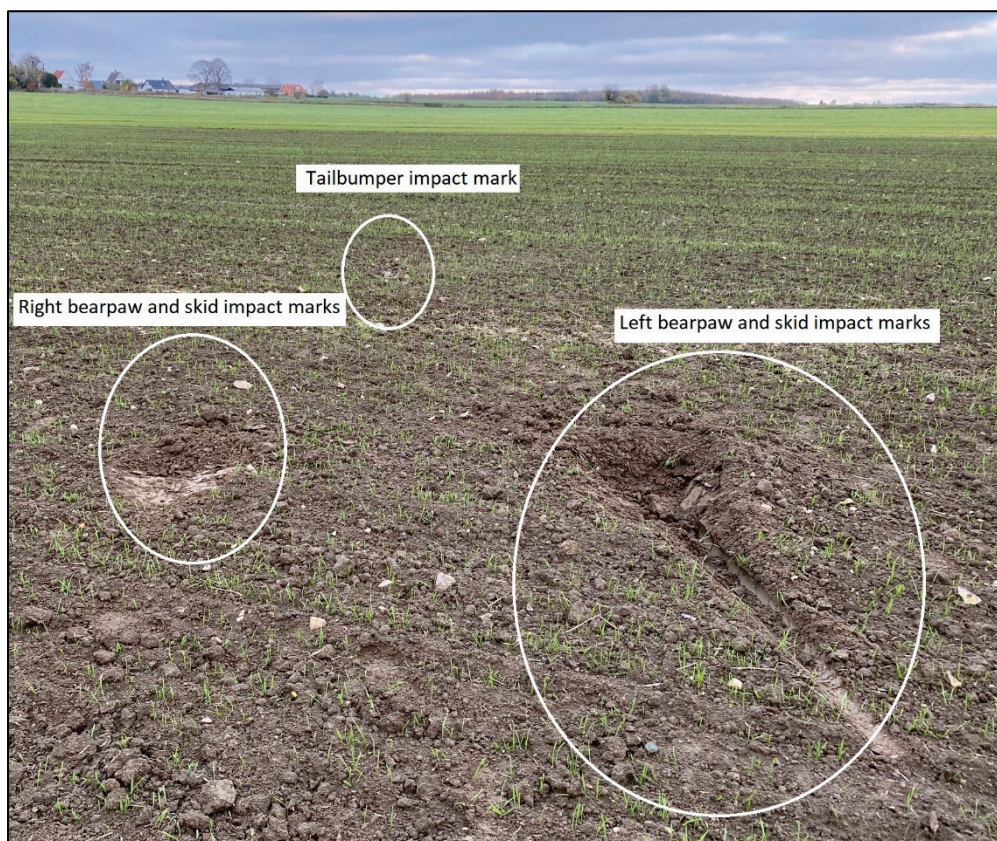
Approximately 210 m short of the helipad/134 m north of Haslevvej and on a magnetic track of approximately 225° (impact marks), the helicopter made a CFIT– [see appendix 5.11](#).

Picture no. 7 - The picture is seen from the opposite direction of the flight path, and shows the impact marks of the tail bumper, the right bearpaw and skid, and the left bearpaw and skid.

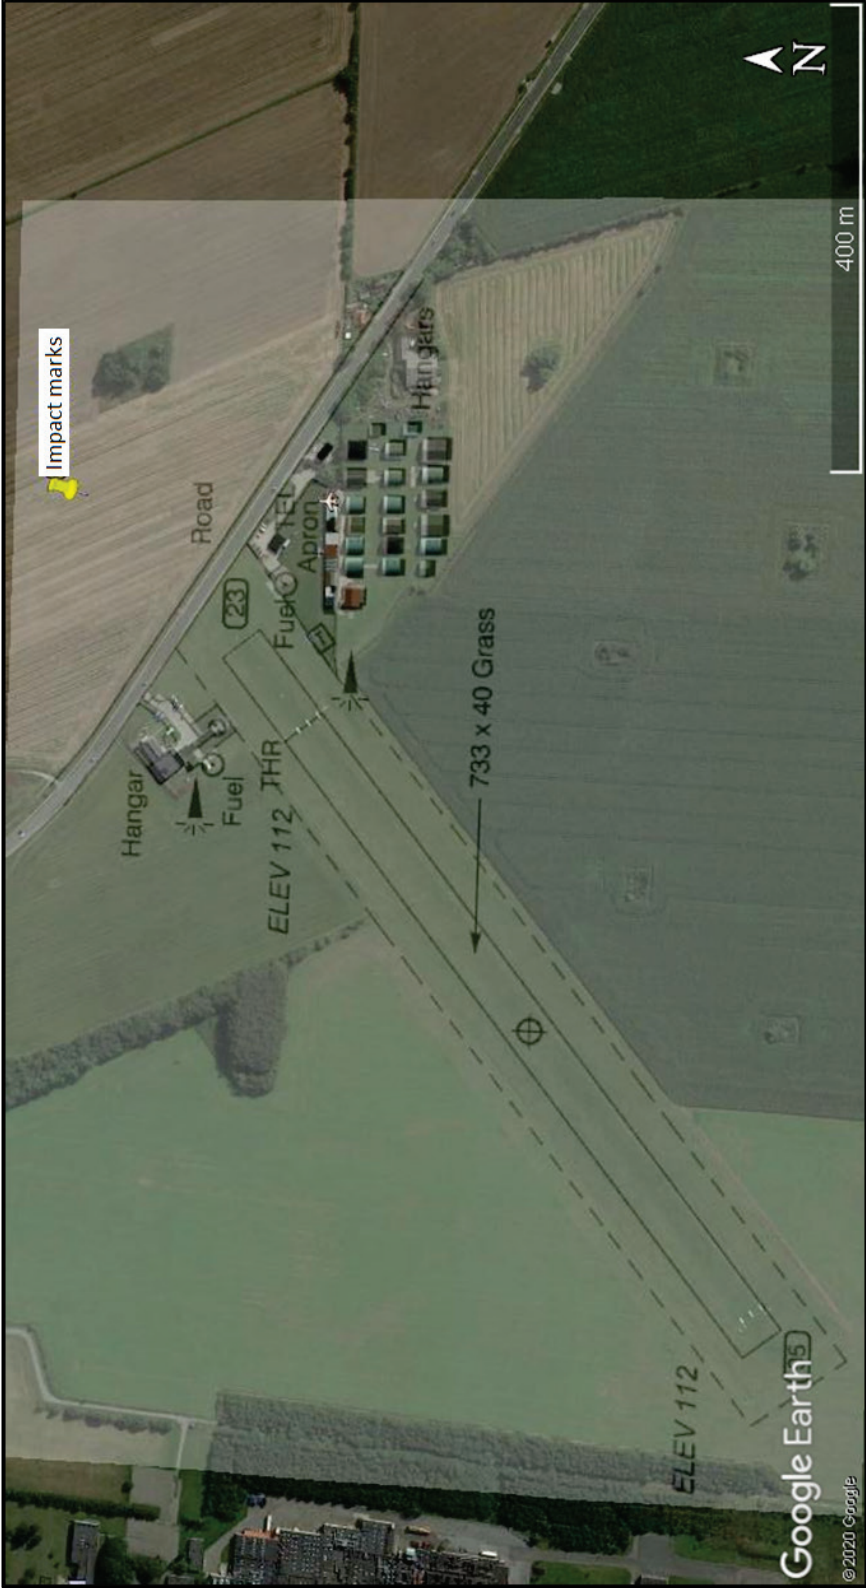
5.11 CFIT position

Note. The Google Earth overlay is not to scale.
