# Havarikommisjonen

## Bulletin 2020-322

**Serious incident to OY-BYC (Piper PA-28R-201T) near the village of Lundforlund south of Slagelse on 10-9-2020.**

ISSUED SEPTEMBER 2021

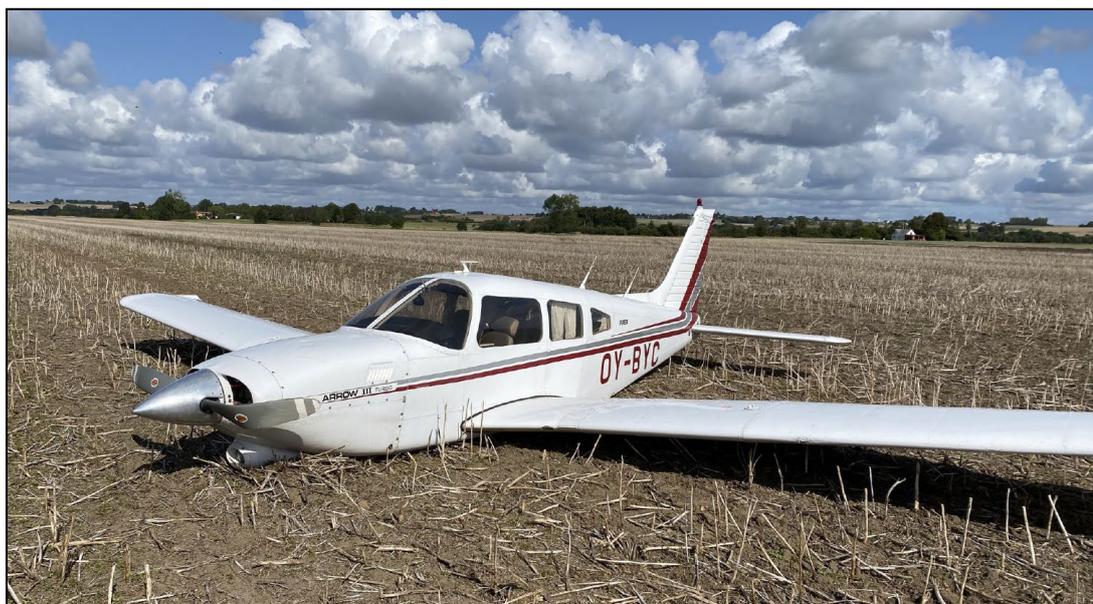
Upon touchdown the landing gear collapsed, and the lower part of the fuselage, wings and propeller touched the ground.

The propeller blades were deformed.

The left hand flap had a dent at the lower skin.

On the right hand side of the fuselage, the footstep aft of the wing trailing edge, was partly torn off from its attachment to the fuselage skin and frame.

The nose landing gear retraction actuator piston rod had fractured.

The nose landing gear doors were damaged.

Figure 1: Aircraft in the field after the forced landing.

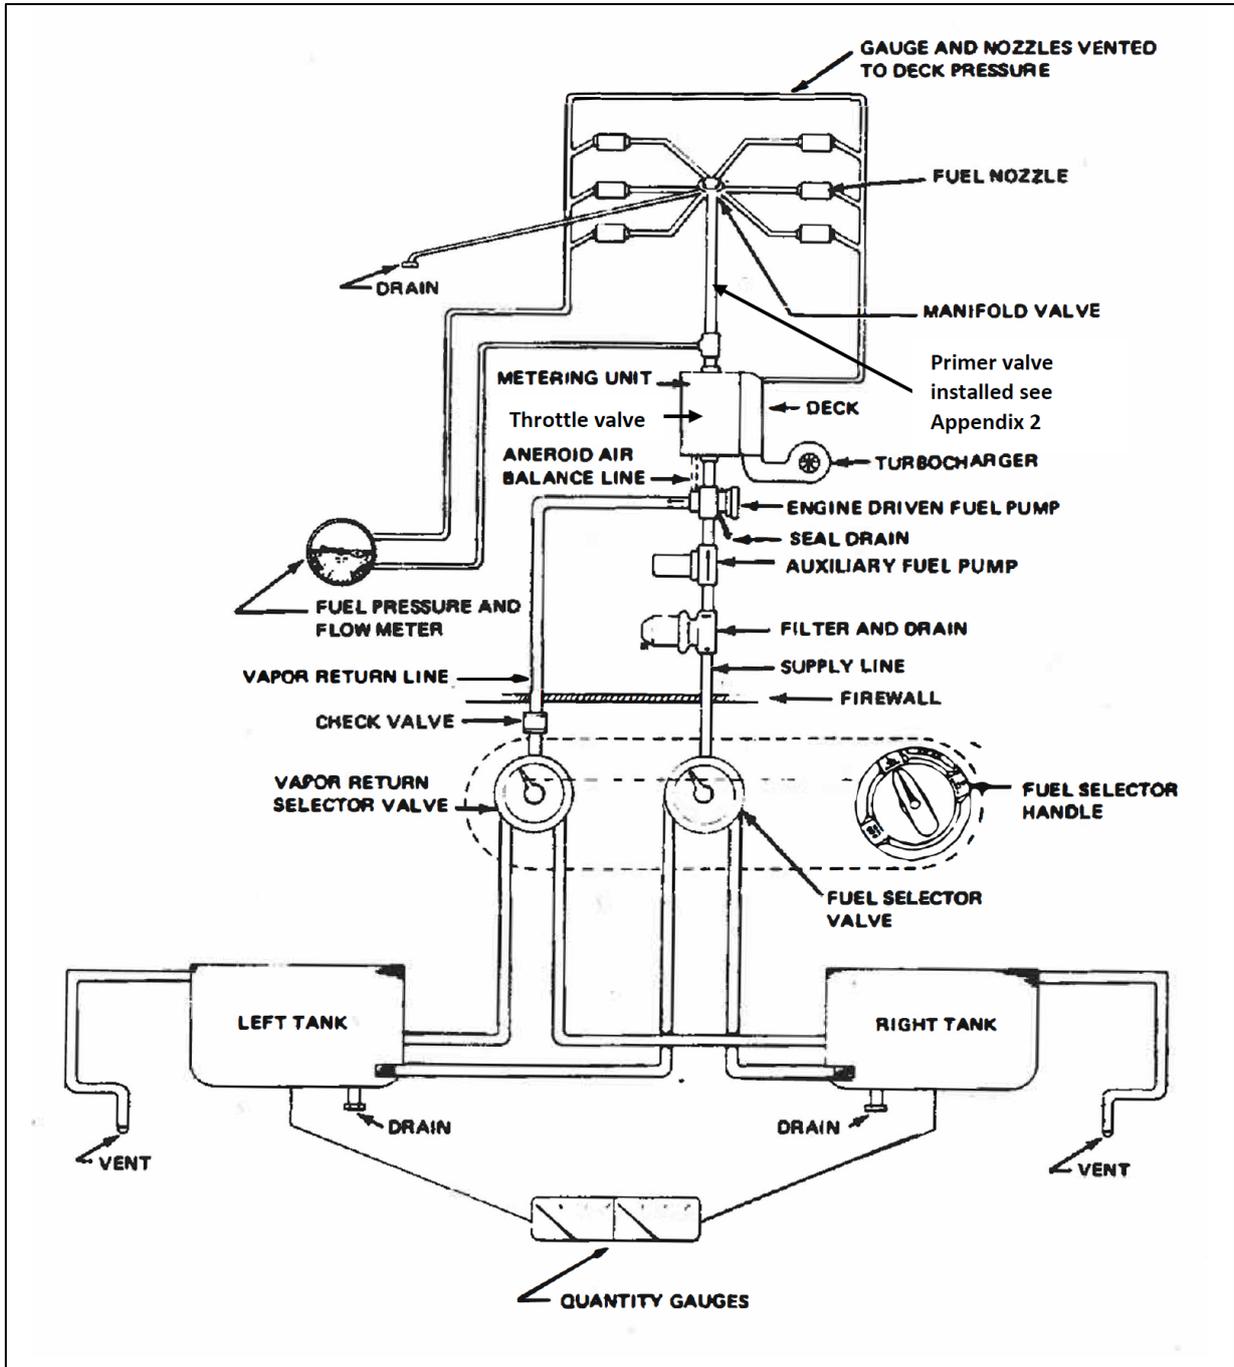
Appendix 1

An engine driven pump or an electrical pump pumped unmeasured fuel through pipes and filters from the selected wing fuel tank to the metering unit in the throttle valve. Metered fuel was then pumped through a pipe to the manifold valve and from the manifold valve distributed via six pipes to the six main fuel nozzles – one at each of the six cylinders.

In the metered fuel pipeline between the metering unit in the throttle valve and the manifold valve, a primer valve was installed. When the primer valve was electrically activated, through a primer switch in the cockpit, it would shut off fuel to the six fuel nozzles at the cylinders and only allowed fuel to the two primer fuel nozzles in the air induction pipes after the throttle valve.

When the primer valve was deactivated, the two primer fuel nozzles in the air induction pipes would shut off and the fuel line to the six main nozzles would open.

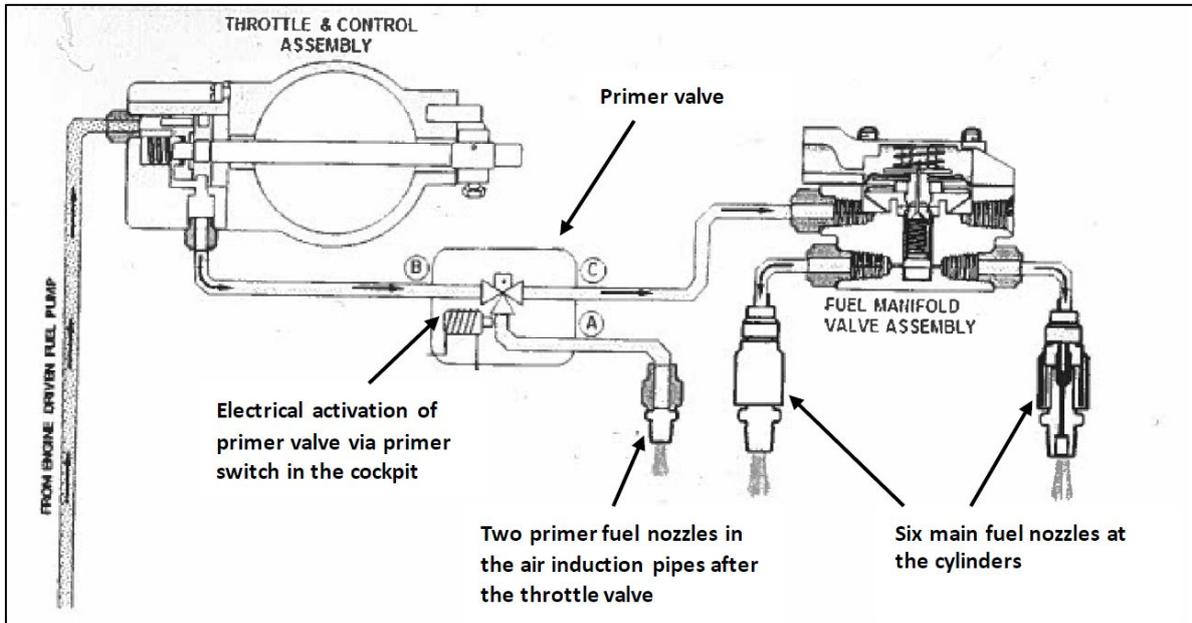
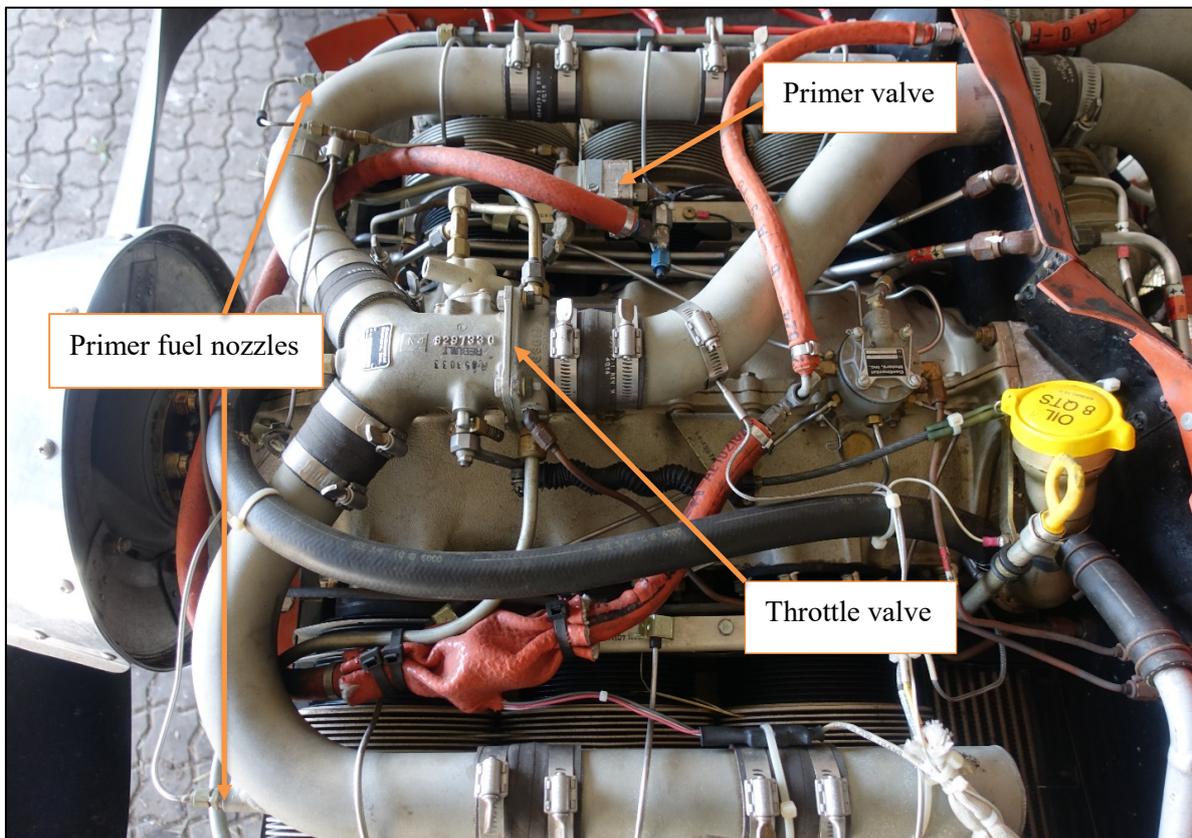
Appendix 2

Taking into consideration the results of the technical investigation and the provided Service Bulletins from the aircraft and the engine manufacturer, the AIB considers it likely, that the fuel primer valve, without pilot input, was activated and had a malfunction during flight, or the primer valve, without being activated, had a malfunction during flight.

In February 2019, Continental issued a Critical Service Bulletin CBS19-01 and Piper a cover Vendor Service Bulletin no. 267, to complete remove the primer valve in the fuel

system within the next 25 hours of engine operation or at the next scheduled inspection or engine service, whichever occurred first.

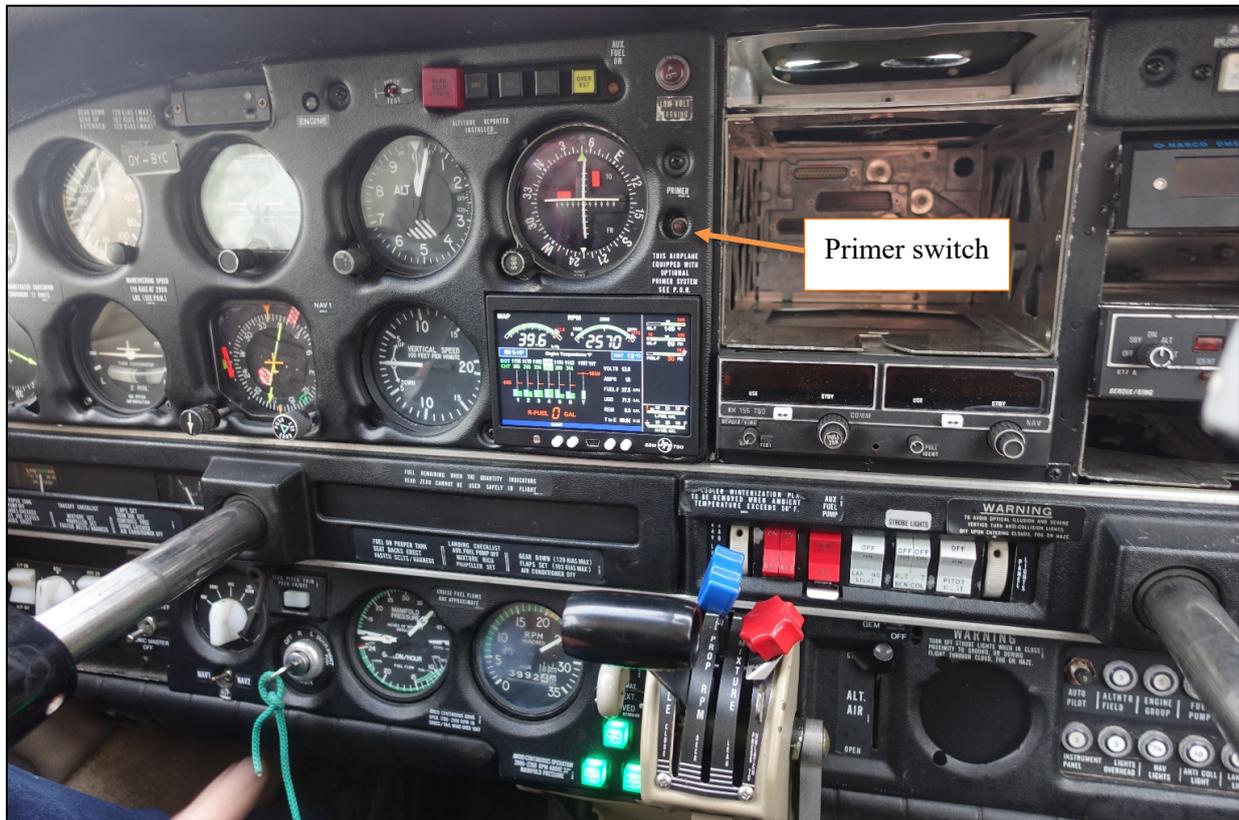
Appendix 3

The Service Bulletin described that an internal failure of the switch could allow uncontrolled activation of the primer valve, which could cause the engine to run rough and possibly stop.

At the time of the serious incident, the primer valve switch installed in OY-BYC had not been replaced, although OY-BYC had flown more than 100 hrs and had many regular maintenance events carried out since the issue date of the Service Bulletin.

In April 1989, Piper Aircraft Corporation issued Service Bulletin No. 905 concerning replacement of the primer valve switch at the next regularly maintenance event not to exceed 100 hours of time in service, which Piper Aircraft Corporation considered mandatory.
