Accident Investigation Board Denmark

Bulletin 2021-120

Serious incident to OY-JEC (Piper PA28-161 Cadet) at Roskilde (EKRK) on 8-4-2021.

ISSUED SEPTEMBER 2021

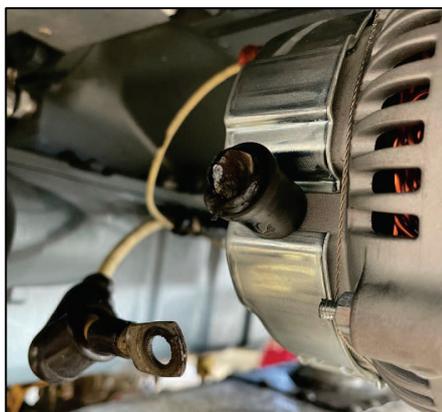
The B+ terminal stud on the alternator broke off during flight.

The technical investigation revealed that the B+ terminal stud on the alternator (Photo no. 1) broke off and that the alternator out switch (Photo no. 2) overheated/burned.

Photo no. 1: Hartzell 14V alternator model no. 10-1051

Probably just before the aircraft joined the downwind leg for runway 29, the B+ terminal stud on the alternator broke off during flight. The technical safety investigation did not reveal the cause of the broken terminal.

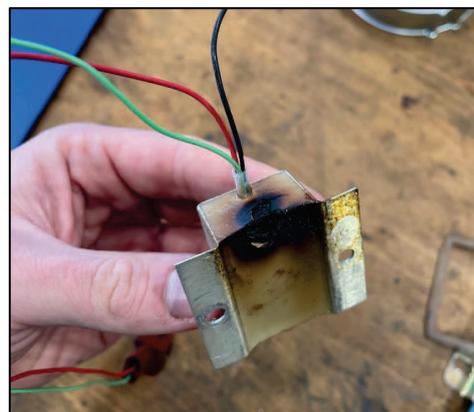
Photo no. 2: Alternator out light solid state switch Piper P/N PAC-587863, Lamar P/N A-00258-1

The result was an increase in alternator voltage output on the aux terminal, which was in excess of the alternator out switch design limitations.

An overheat/burn of the alternator out switch resulted in smoke formation in the cockpit.

In January 1996, the aircraft manufacturer published Service Bulletin (SB) 991A, addressing possible smoke formation from a failed alternator out switch. The SB provided instructions for the installation of a fuse on the alternator aux terminal.

However, to the AIB, the level of perceived smoke described by the flight instructor as *quite a lot*, makes compliance with the SB 991A worth considering.
