Statement 2021-406

Serious incident to OY-JRY (ATR 42-300) at Karup (EKKA) on 16-11-2021.

ISSUED DECEMBER 2021

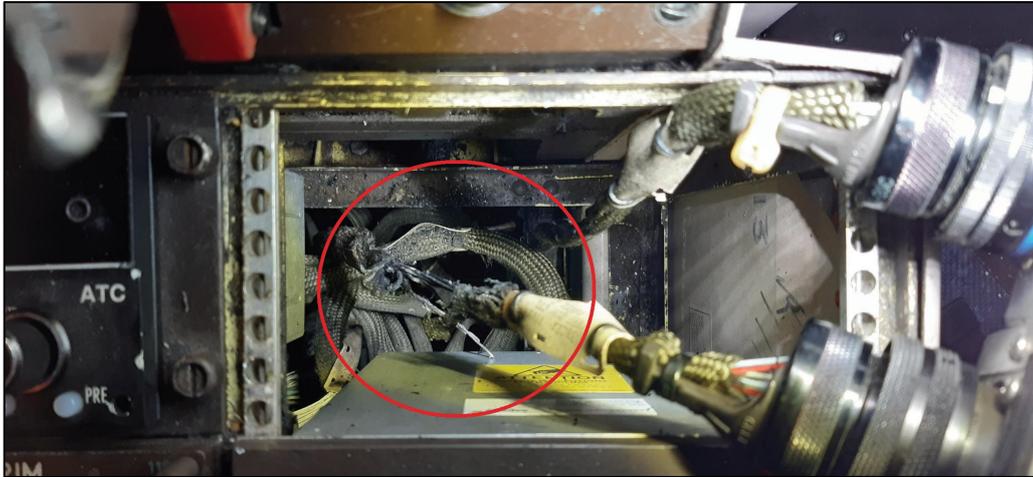
The inspection revealed a popped circuit breaker for the no. 2 Very High Frequency (VHF) communication radio and burned electrical wires connecting the no. 2 VHF communication radio.

Figure no. 1. Burned no. 2 VHF communication radio wiring (marked by red circle).
