Accident Investigation Board Denmark

BULLETIN

24-6-2019

Airbus Helicopters AS 350 B3

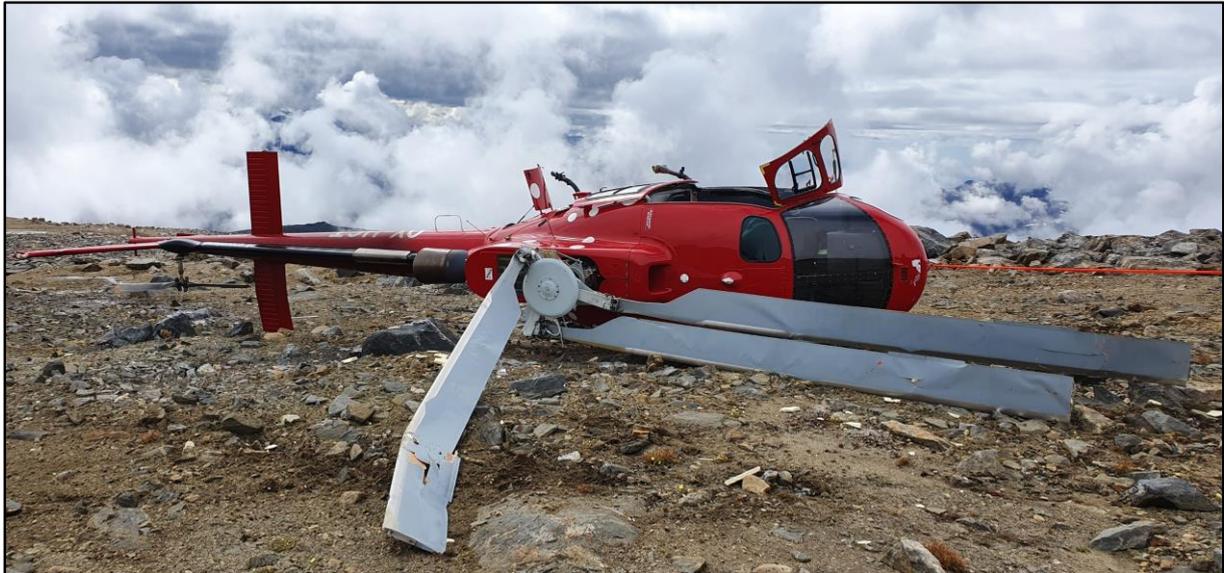
The accident led to substantial damages to the:

- undercarriage
- bottom of the fuselage
- cabin structure
- main rotor
- rotor blades
- horizontal stabilizer.

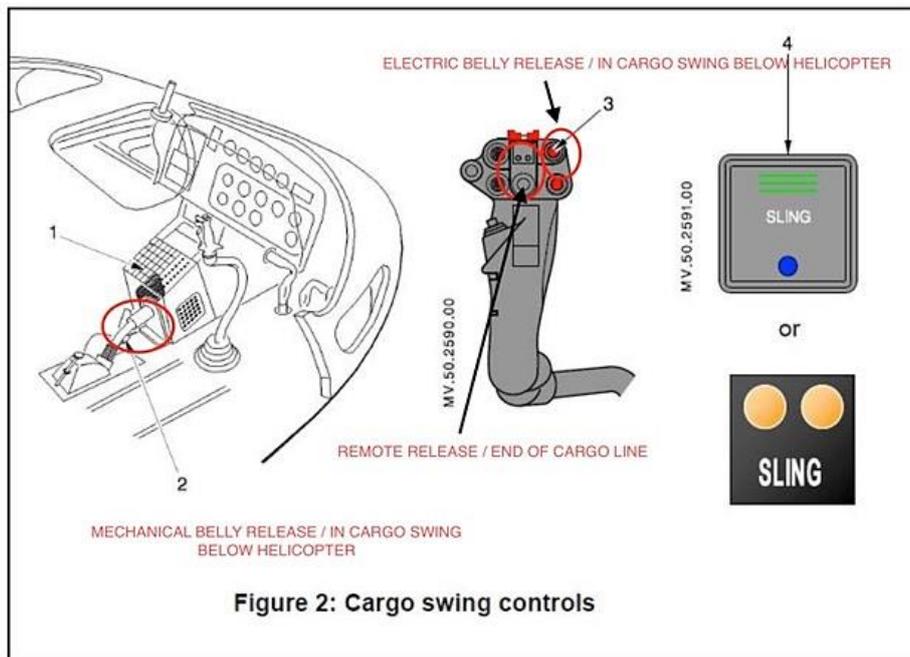
AIB note to figure 2.

- A control system for the pilot (Figure 2), including:
 - a [SLING] pushbutton (4) located on the console (1), for powering-on the installation,
 - a release control (3) on the cyclic stick (electrical mode),
 - a release handle (2) located under the collective lever (mechanical mode).

The AIB has inserted 3 explanatory texts in red, 3 marking circles in red, and 2 pointing arrows in black.

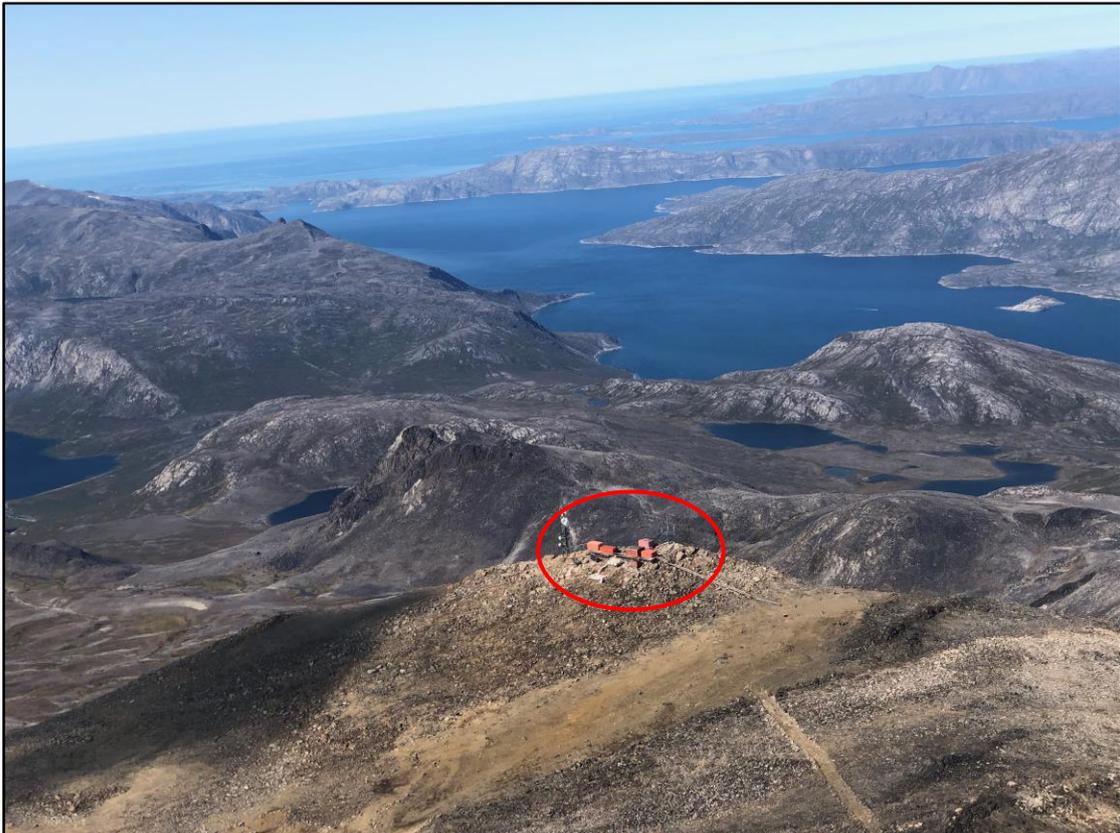
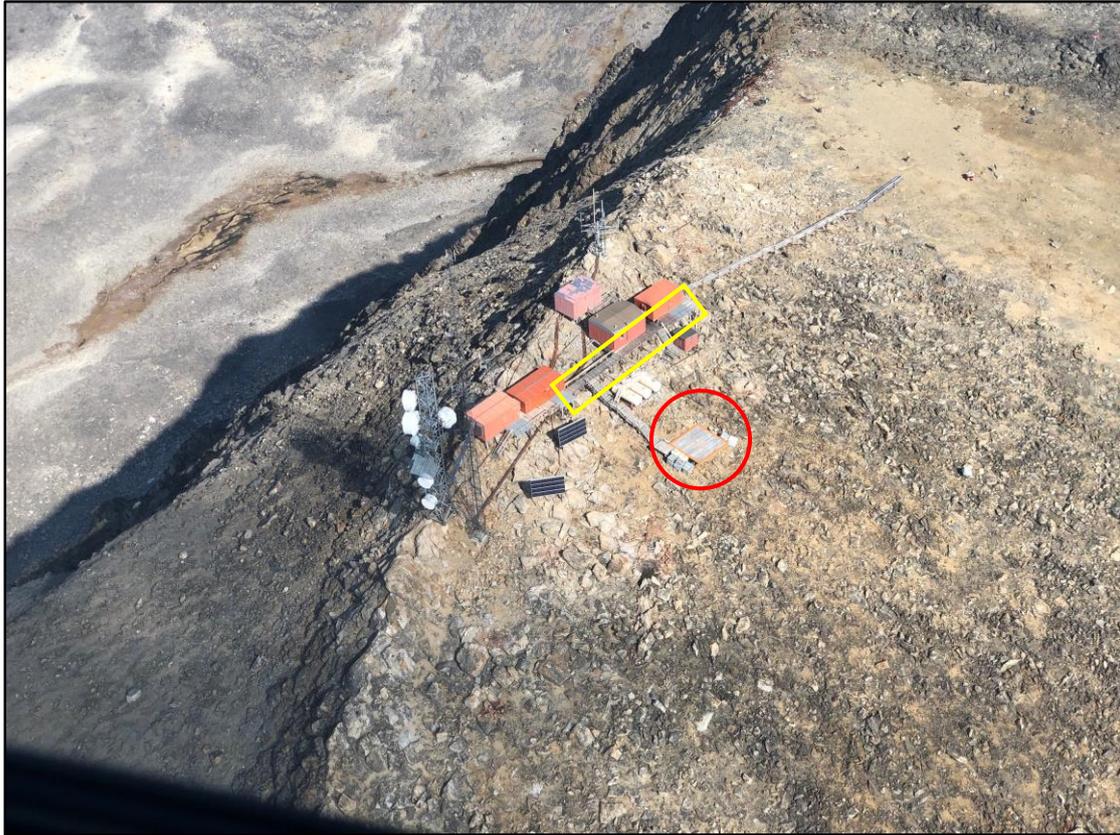
The helipad is marked with a red circle.

A footbridge along the station buildings is marked with a yellow square.

The footbridge compared to the helipad required, in the opinion of the AIB, more pilot precision and head down external focus, which in combination with the actual weather conditions at the mountaintop probably reduced and/or eliminated pilot perception of changes to the available external visual cues.

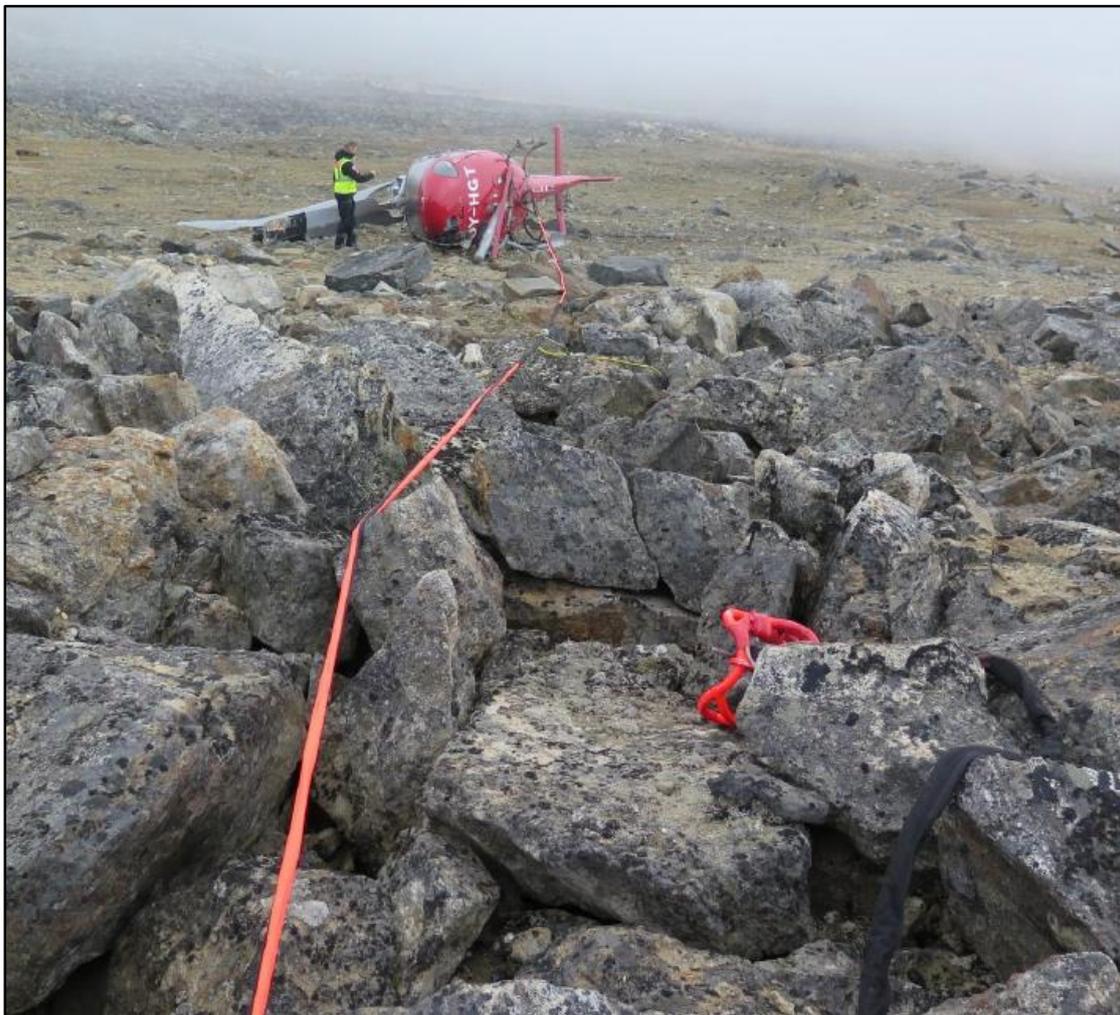
During the recovery manoeuvre and downhill, the fuel tank at the end of the 30-meter long line started colliding with rocky terrain.

Approximately 30 m downhill from Telesite Dye One, the pilot successfully released the fuel tank at the cargo hook installed at the end of the 30-meter long line.

On a position approximately 100 m downhill, the helicopter skids impacted with rocky terrain, and the long line entangled with rocks, became tight and slowed down the forward energy.

The helicopter ended up on its right hand side with the nose section facing towards Telesite Dye One

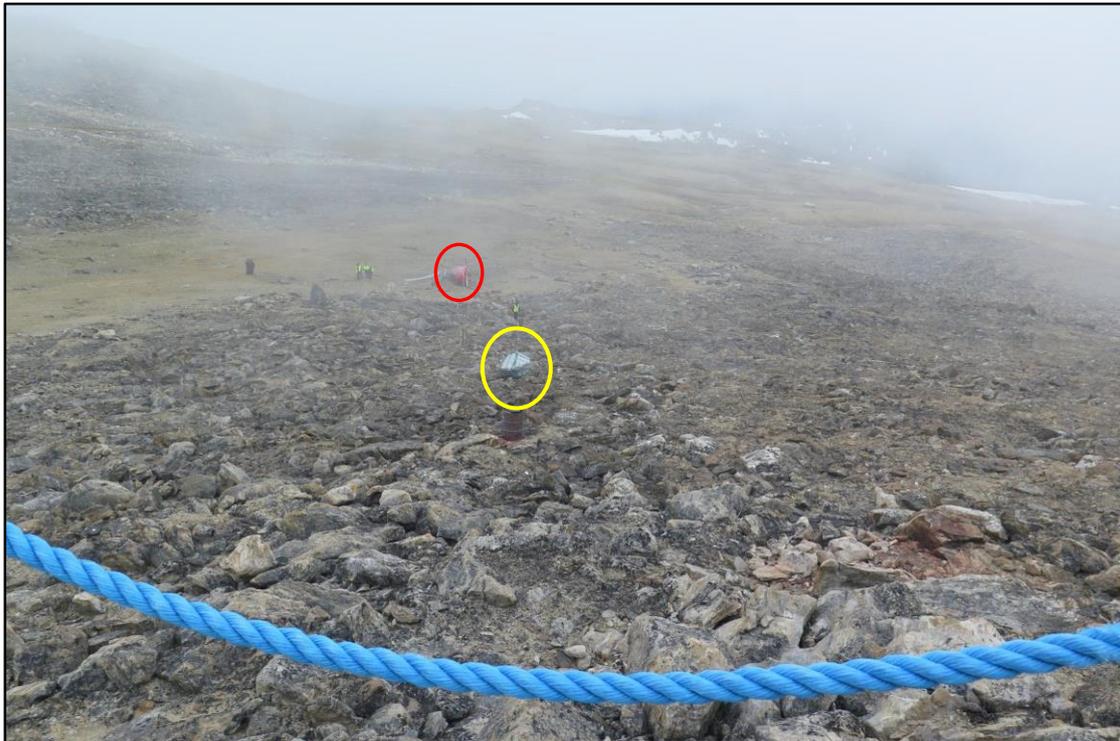
At approximately 19:35 hours, the local Police took the below picture (taken from Telesite Dye One toward the accident site).

The fuel tank is marked with a yellow circle.

The helicopter is marked with a red circle.
