Havarikommissionen
Accident Investigation Board Denmark

BULLETIN

MORANE SAULNIER MS894 A

G-BCLT

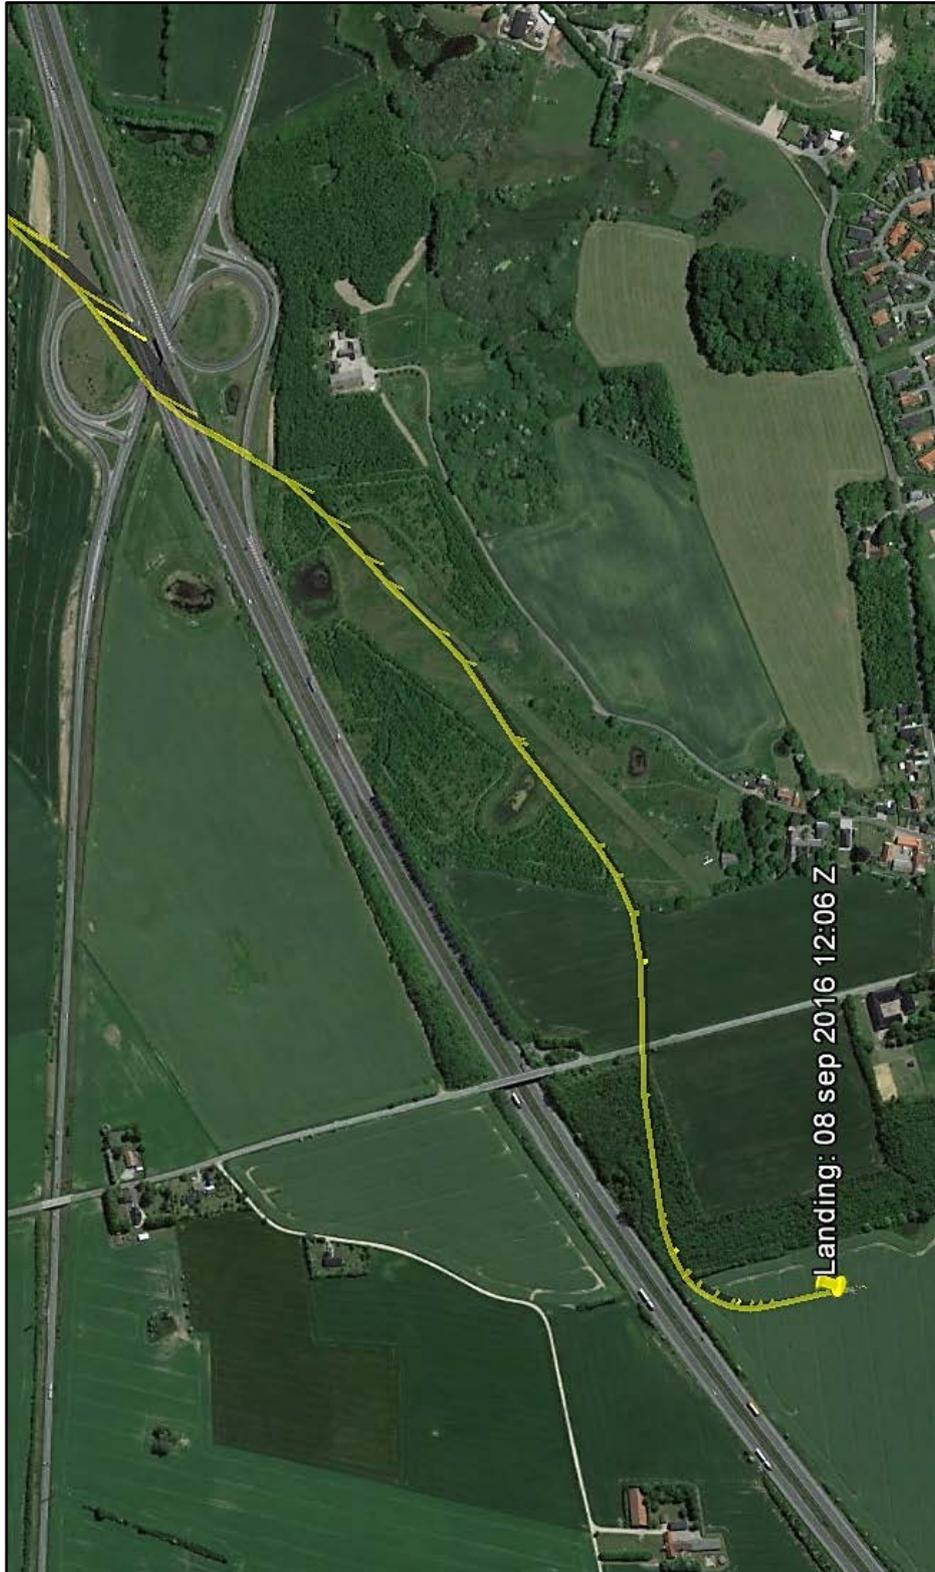
APPENDIX 4

However, in order to avoid trees, the pilot scrubbed the idea of returning and decided to do an emergency landing in a stubble field positioned south of the nearby motorway. [See appendix 4.](#)

In the final turn for the stubble field at a low altitude, the pilot observed the airspeed to be below the minimum airspeed for the present aircraft configuration.

The aircraft was exposed to a sudden high sink rate. The aircraft made a hard landing in the stubble field and came to a full stop after a landing roll of 10 metres.

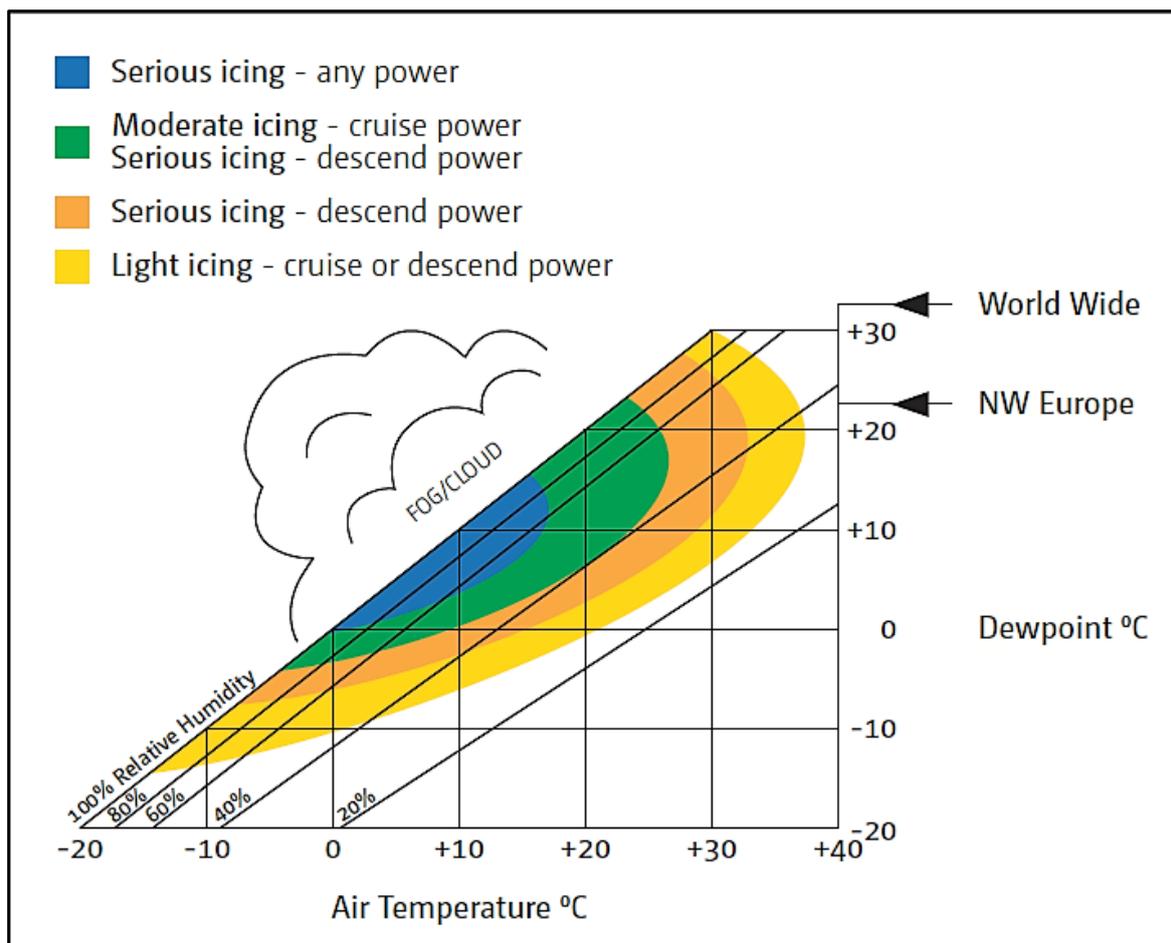
APPENDIX 10

The risk of serious carburettor icing at any power (actual temperature and dewpoint at 1500 feet - Tunoe) and the risk of serious carburettor icing at descend power (actual temperature and dewpoint at 2 meters - Aarhus South) were present.

Taking into consideration the sequence of events, the AIB finds it most likely that the partial loss of engine power at 1500 feet was caused by carburettor icing developed during the continuous cruise descent.

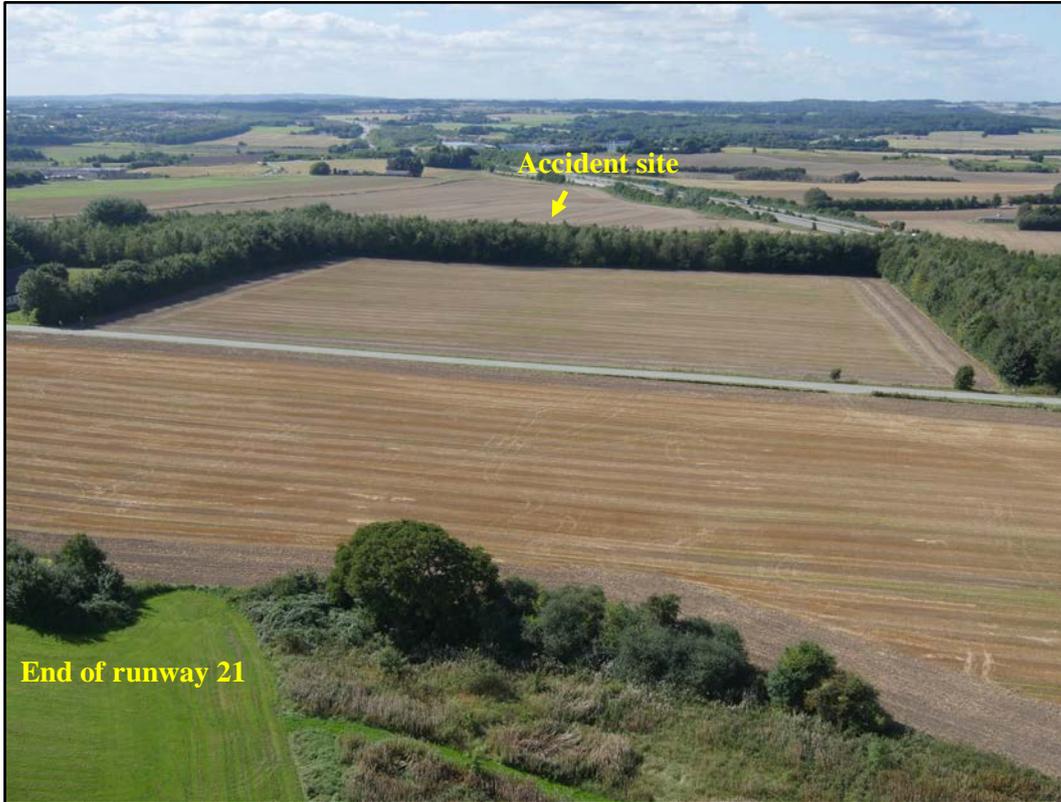
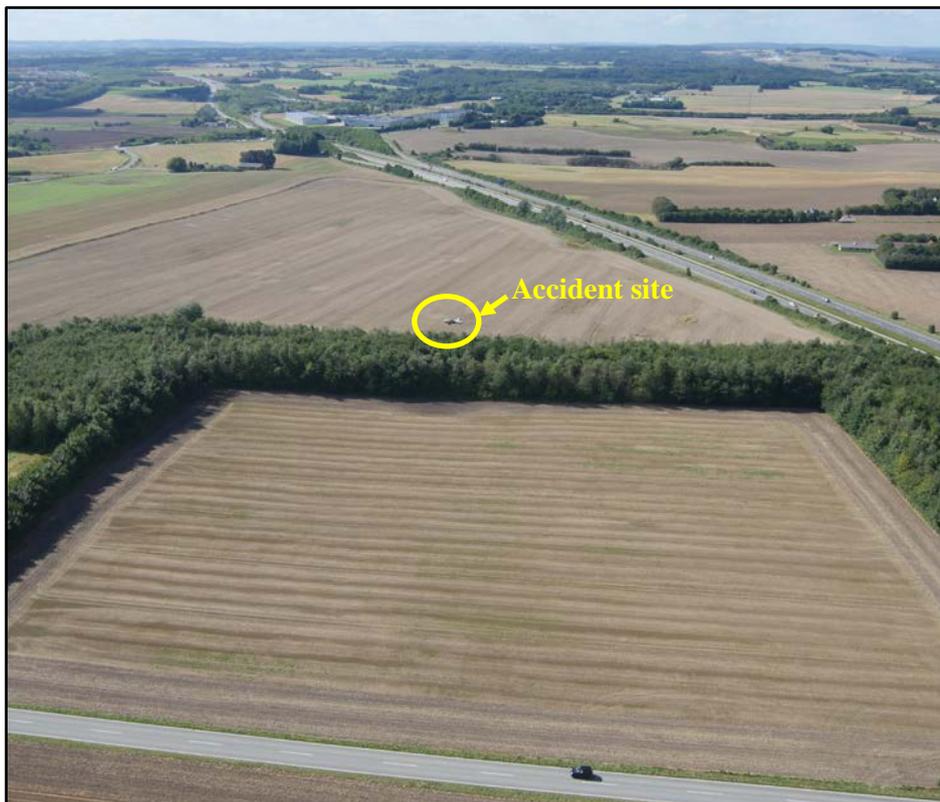
APPENDIX 11

The aircraft came to a full stop in a stubble field 0.4 nm southwest of the intended landing airstrip and 0.5 nm north of the town of Kolt.

The impact marks in the stubble field in combination with the damages to the aircraft were consistent with a hard landing. The landing roll distance was 10 meters.

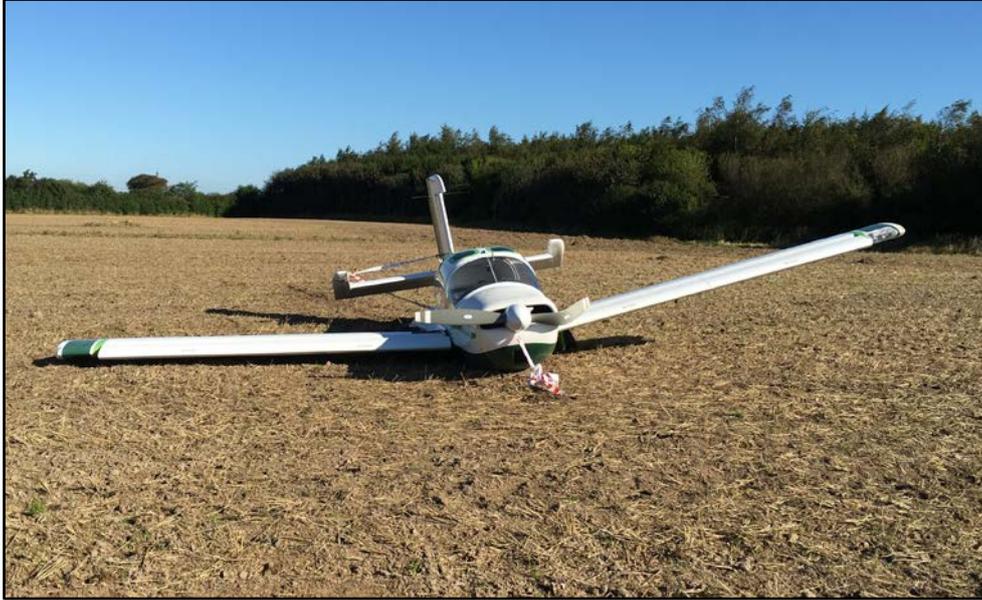
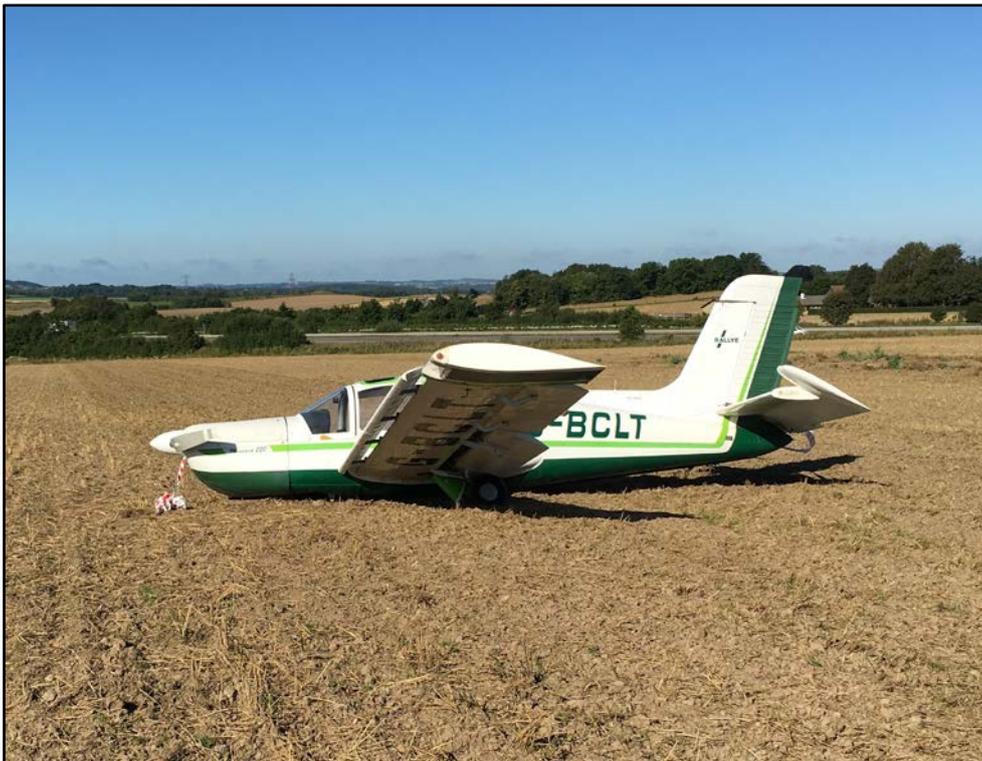
APPENDIX 13

Damages to the aircraft: The landing gear collapsed upon impact.

The propeller came in contact with the ground, and one propeller blade bended.

There were damages to the right wing and the lower fuselage.

The aircraft was destroyed.
