Havarikommisjonen
Accident Investigation Board Denmark

BULLETIN

BOMBARDIER CL600 2D24 900

OY-KFF

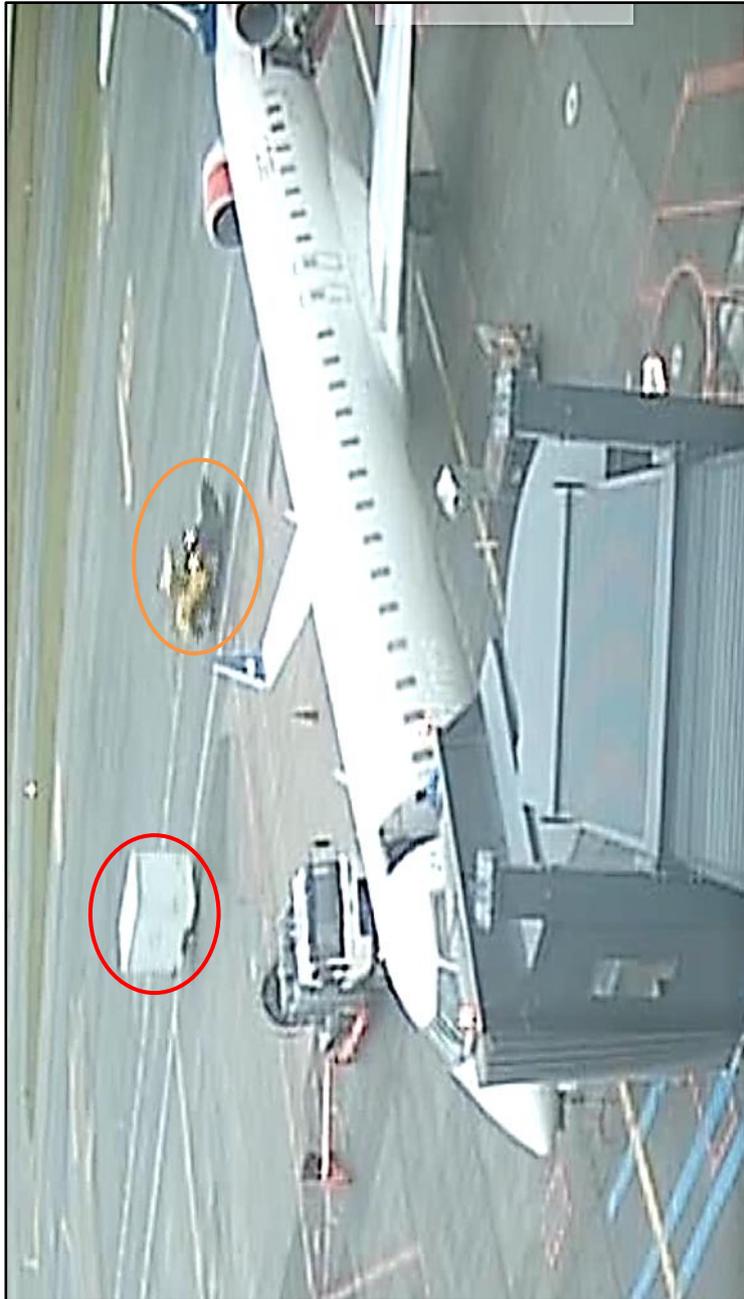
APPENDIX 3

The x-ray trailer detached from the tractor on the southern service road, continued rolling, and collided with the aft fuselage of OY-KFF at aircraft stand A17.

X-ray trailer

Tractor

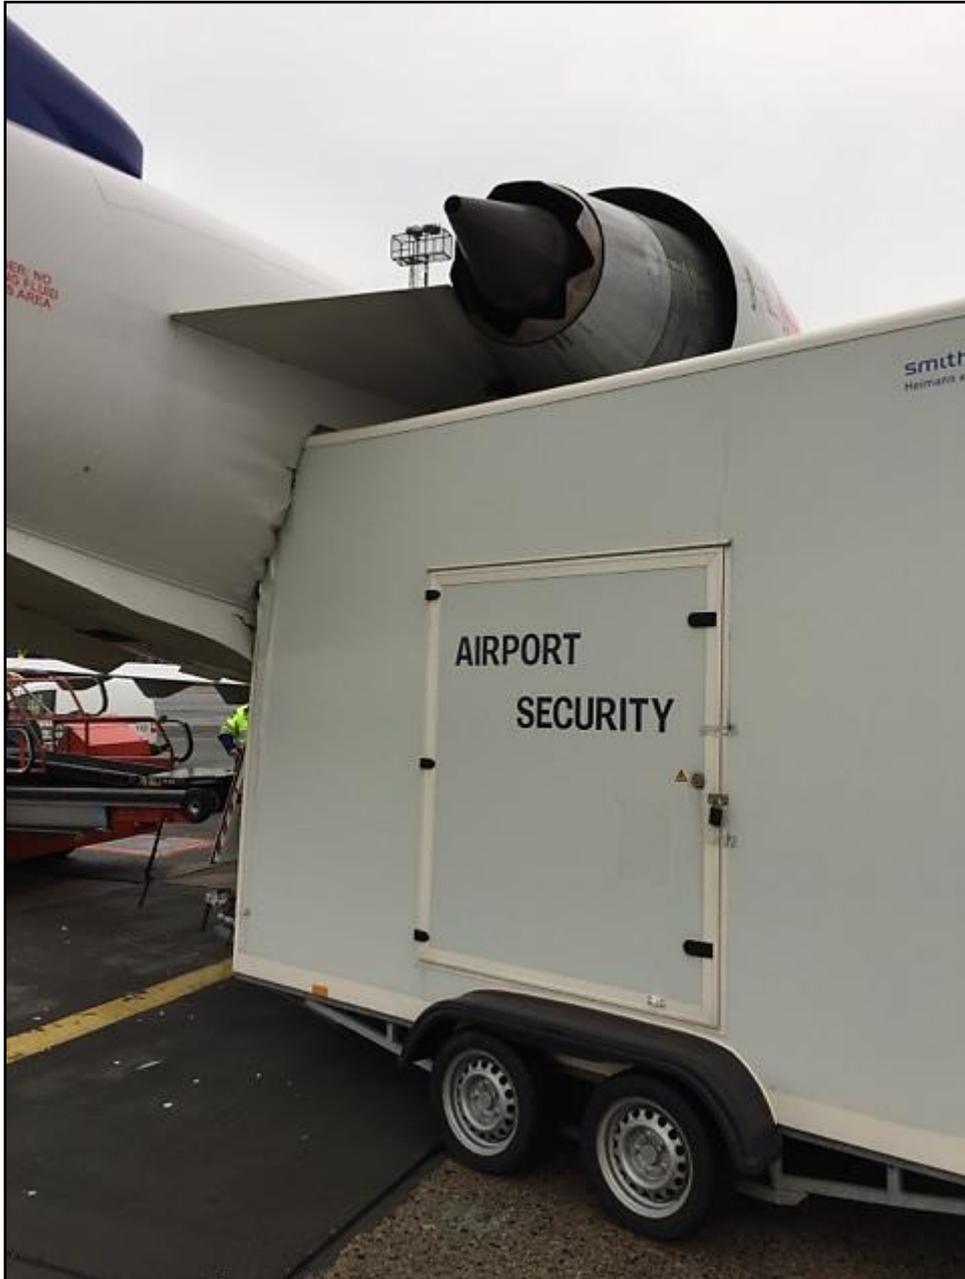
APPENDIX 4

The x-ray trailer detachment caused substantial damages to OY-KFF parked at aircraft stand A17.

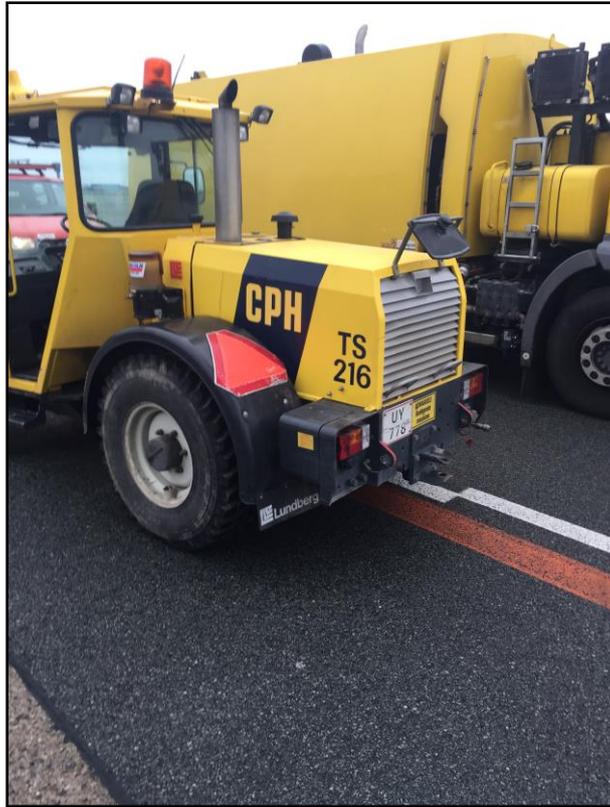
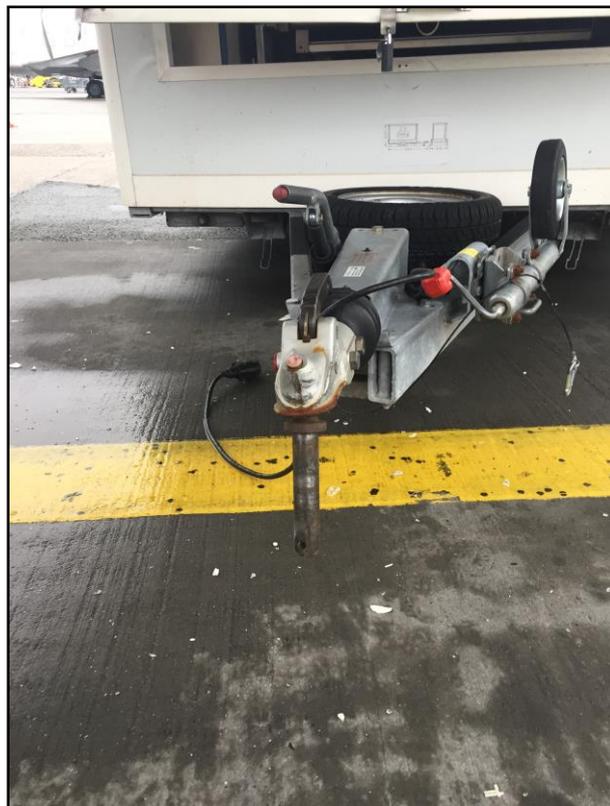
APPENDIX 5

The hitch pin locking ring of the trailer hitch and the safety wire for the x-ray trailer braking system were not installed.

The non-installation of the safety wire for the x-ray trailer braking system and the lack of adequate inspection of the x-ray trailer attachment as a whole had a direct influence on the sequence of the events.

When passing abeam aircraft stand A14, the bump on the road most likely forced the hitch pin upward leading to a detachment of the x-ray trailer from the tractor.
