# **Final Report No. 2342**

Concerning the serious incident involving  
the SAAB 2000 aircraft, HB-IZW, operated  
by Etihad Regional/Darwin Airline under  
flight number AB 8054,

on 10 December 2015

4.5 NM east of Billund Airport (EKBI),  
Denmark

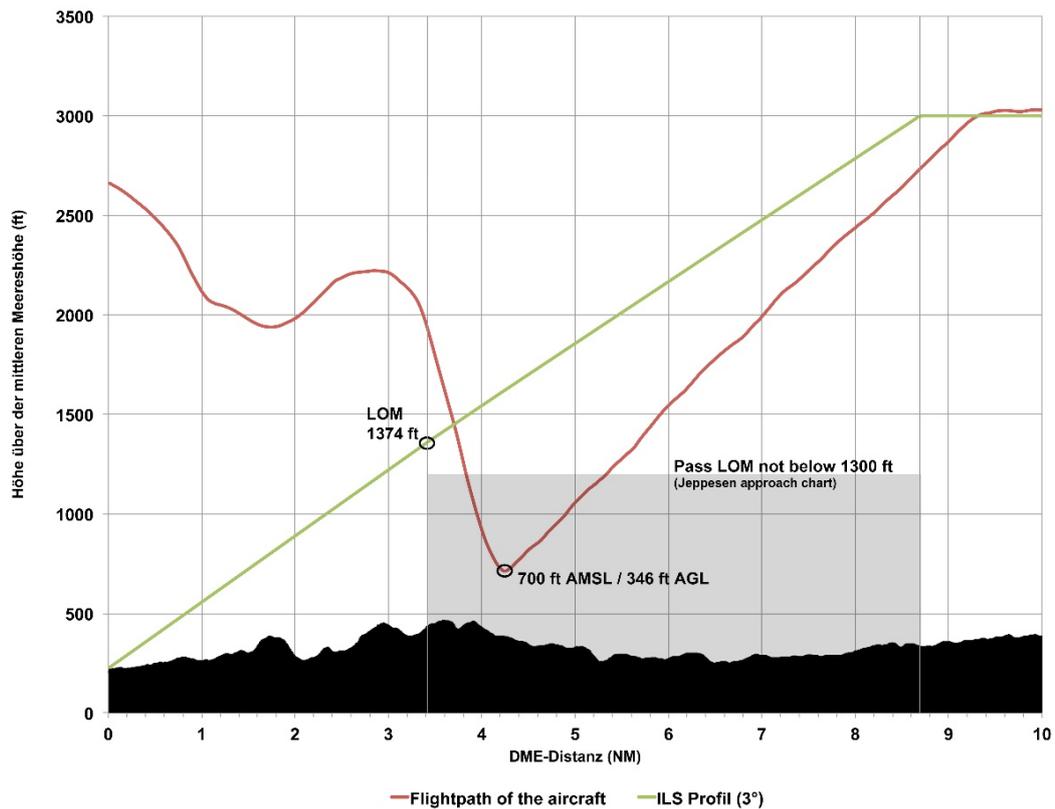
**Illustration 1:** The vertical profile of the localiser approach according to the DFDR data (red line) compared to a continuous descent final approach<sup>9</sup> (green line). The grey area shows the lower approach limit, which an aircraft must not fly below until reaching the outer marker (LOM).

The average vertical approach speed was 771 ft/min. The indicated airspeed (IAS) was approximately 140 kt. The average ground speed was 103 kt. This resulted in an average vertical flight angle of -4.2 degrees.

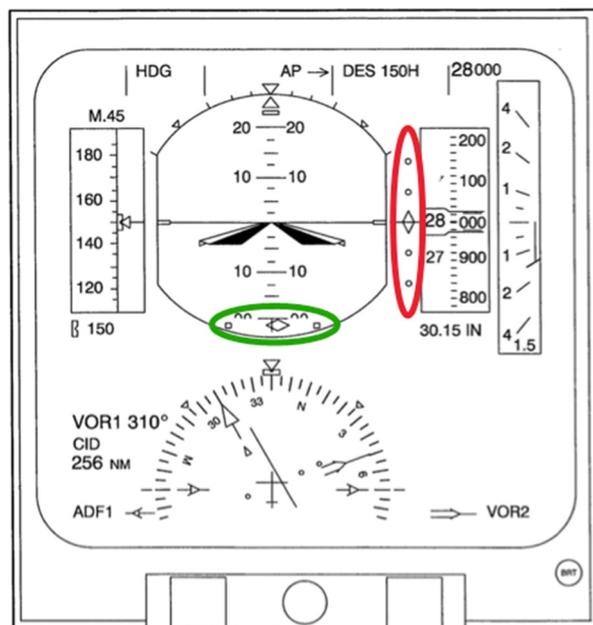
After the autopilot had switched to capture mode, the glideslope indicator moved upwards to 'fly up' and the autopilot followed the indicator (see illustration 3). At 8.5 NM the glideslope indicator was centred, however, subsequently it fluctuated between 'full fly up'<sup>4</sup> and the centred display. This caused the aircraft to climb.

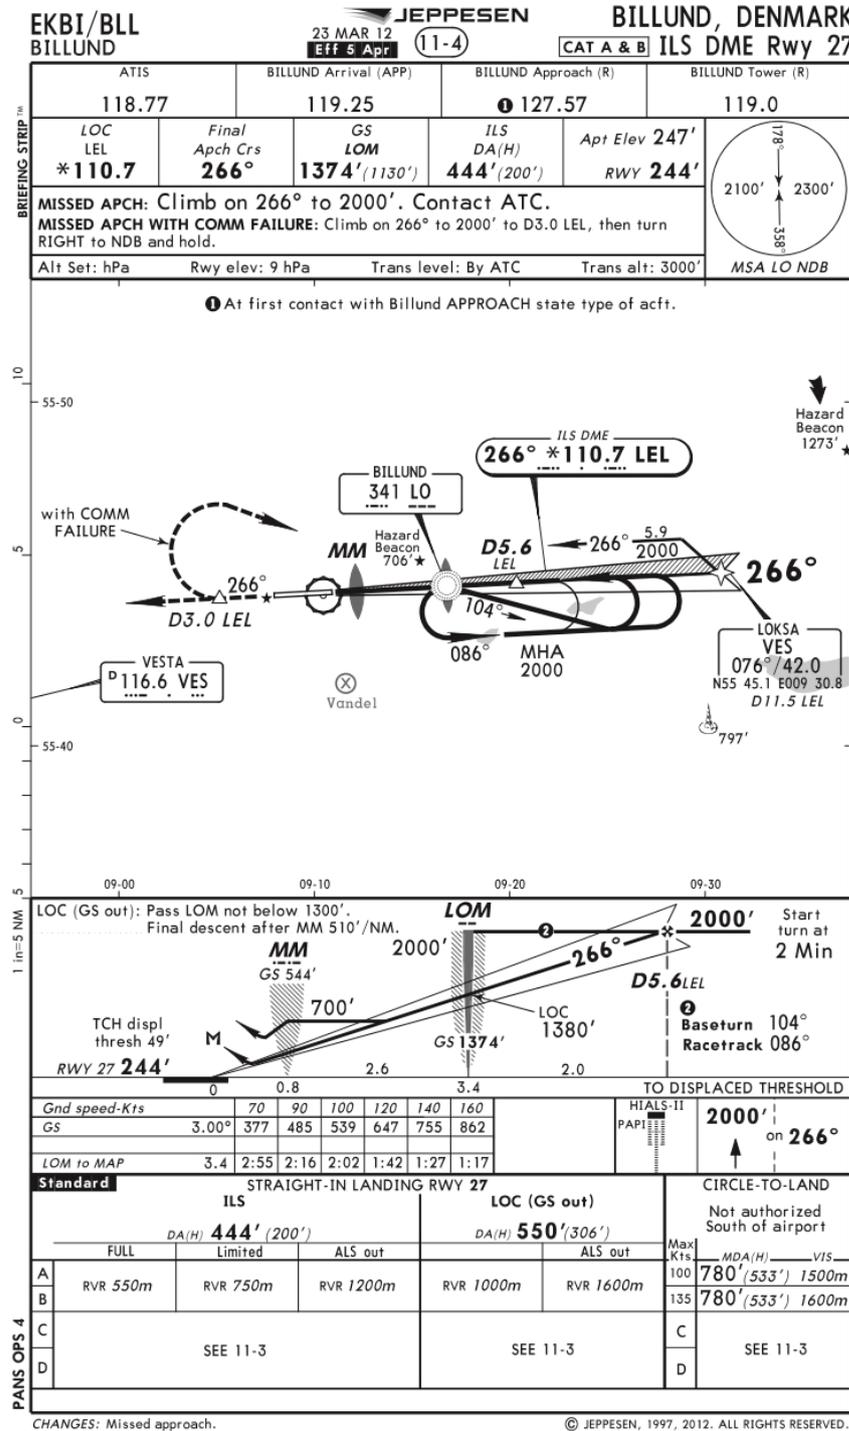
Illustration 6: ILS/LOC approach chart for runway 27 at Billund Airport (copy of the Jeppesen chart EKBI 11-4, 23 MAR 12, eff 5 Apr, valid at the time of the serious incident)

A recommended altitude descent table is not displayed in this chart.

The Jeppesen approach chart for an ILS/LOC approach to runway 27 at Billund Airport (version 23 MAR 12), which was valid at the time of the serious incident, did not have a recommended altitude descent table. This would have made it easier for the pilots to monitor the vertical profile.

The approach charts are now provided with recommended altitude descent tables.
