**Havarikommisjonen**  
Accident Investigation Board Denmark

# **BULLETIN**

**SCHEMPP HIRTH (Arcus T)**

**OY-XJT**

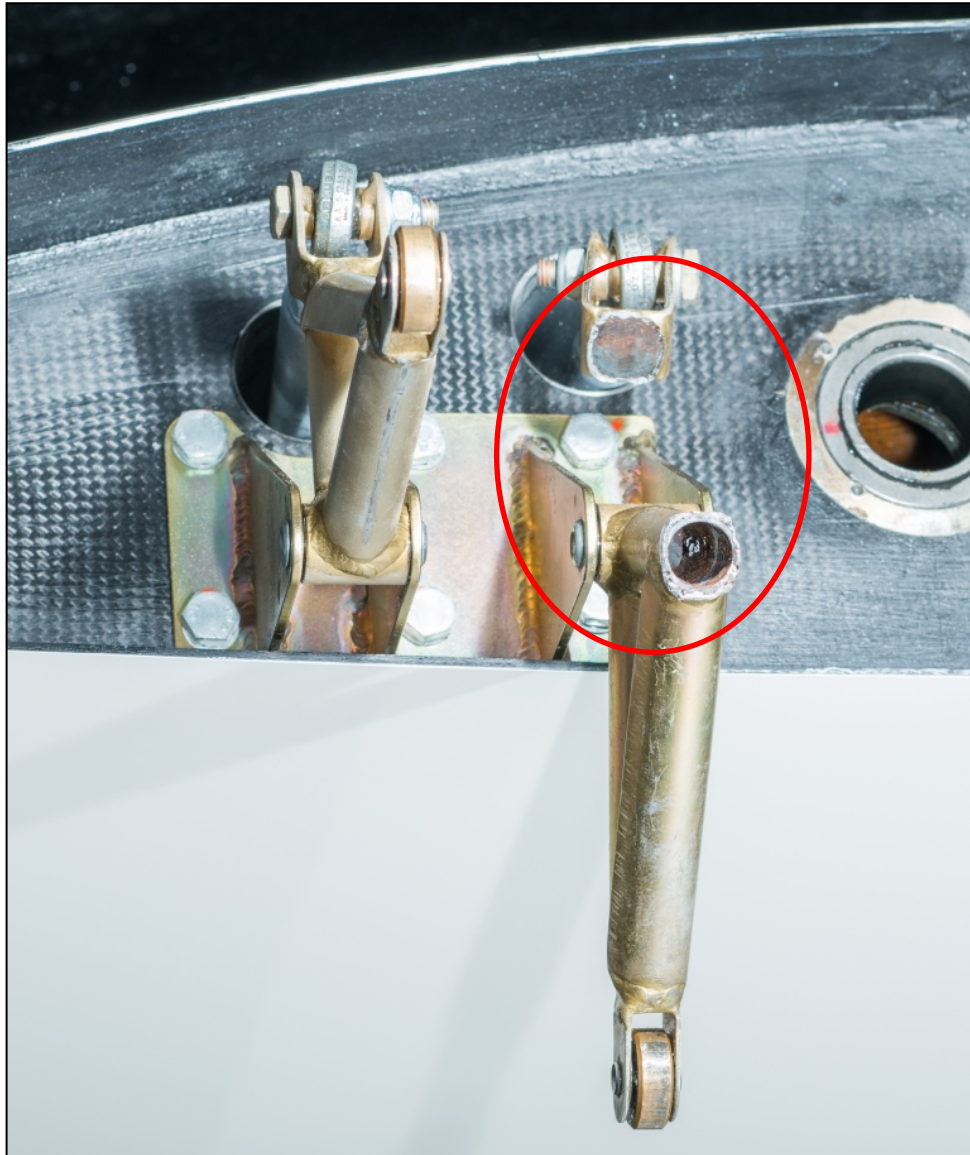
After removal of the left wing from the fuselage, an initial examination revealed rupture of the airbrake bell crank. See below.

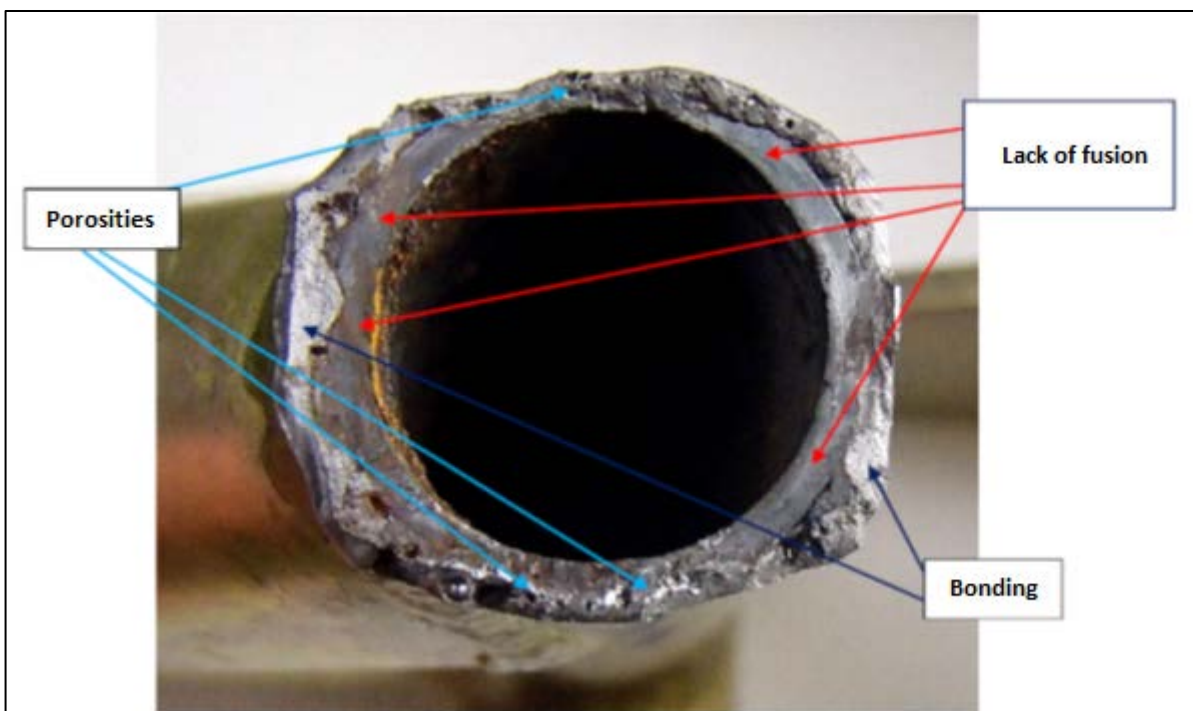
The ruptured parts revealed porosities and lack of fusion.

Bonding was only observed in the light gray areas (see below).

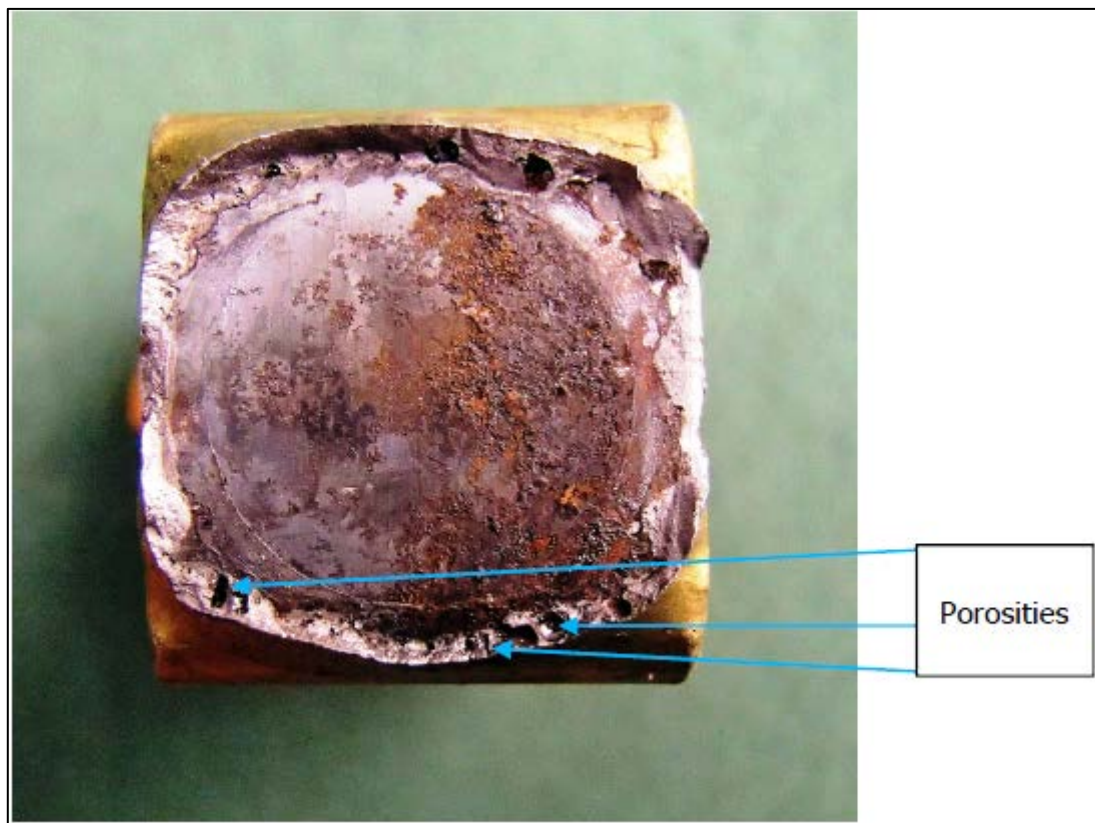
An examination of the “fork” part weld also revealed porosities (see below)

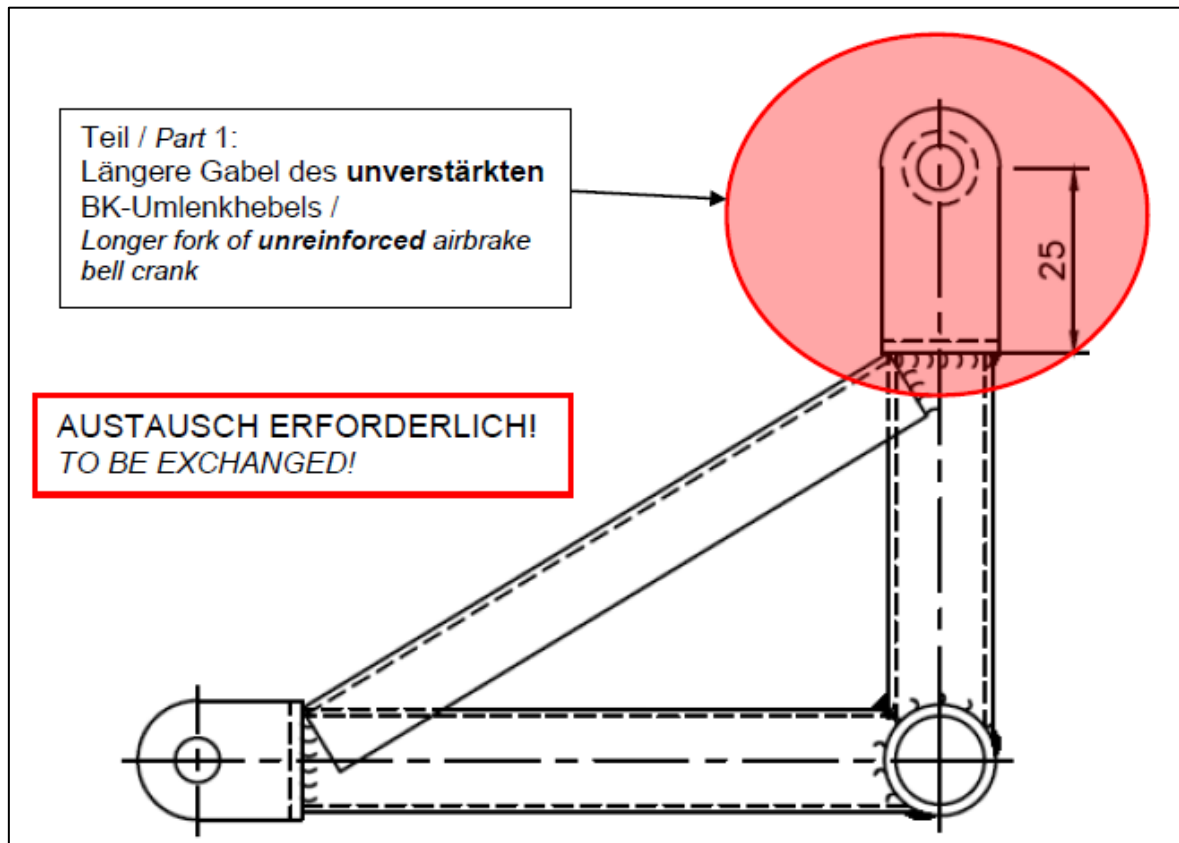
The installed airbrake and aileron bell crank and levers were not the correct types for the Arcus T.

According to the glider manufacturer, this type of bell crank and levers should not have been installed on the Arcus T.

The installed airbrake and aileron bell crank is illustrated below.

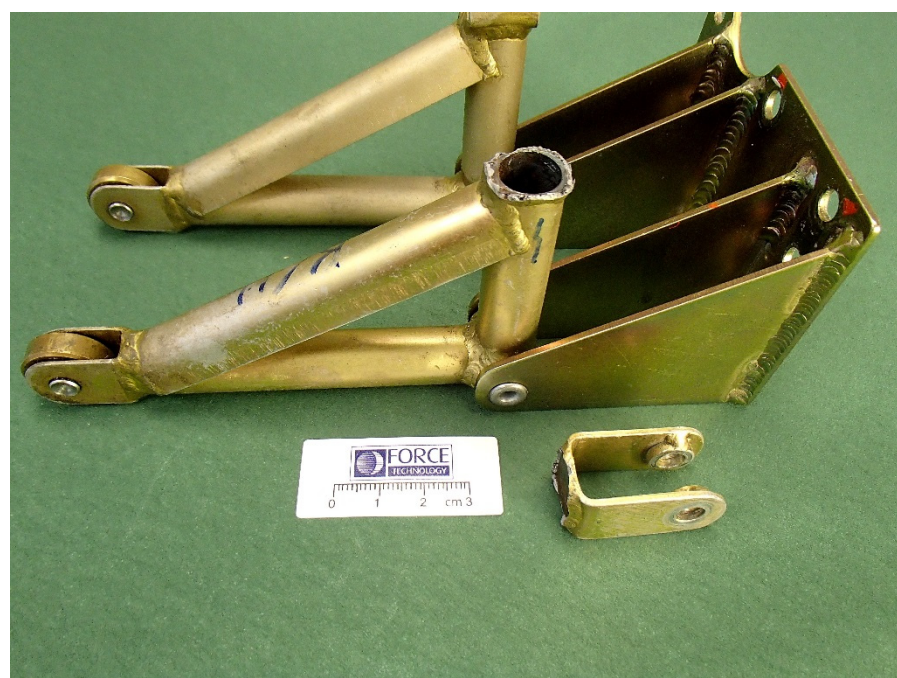
Figure 2 The left wing fractured bell crank as received.

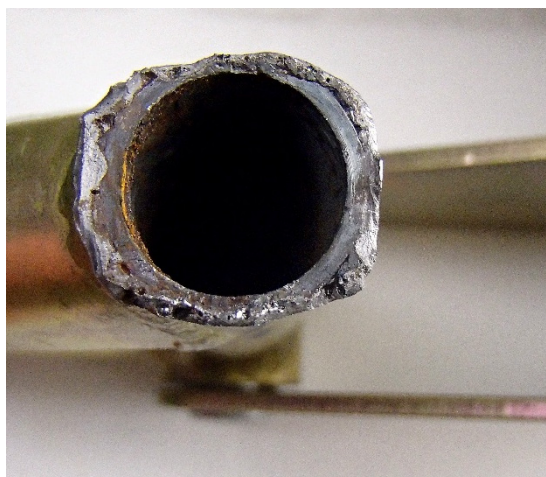
The fractured surface was examined using stereomicroscopy. The fracture appeared in the welding section between the tube and the mounting fitting. The quality of the weld is considerably poor, leaving large areas lacking fusion, as well as the presence of cold runs and areas with notable porosity. The bonded area is less than 10 %. Cf. figures 3 - 6.

The observed fracture in the left wing bell crank was caused by the grossly unsatisfactory weld quality.

Figure 3 The fractured surface on the bell crank side.

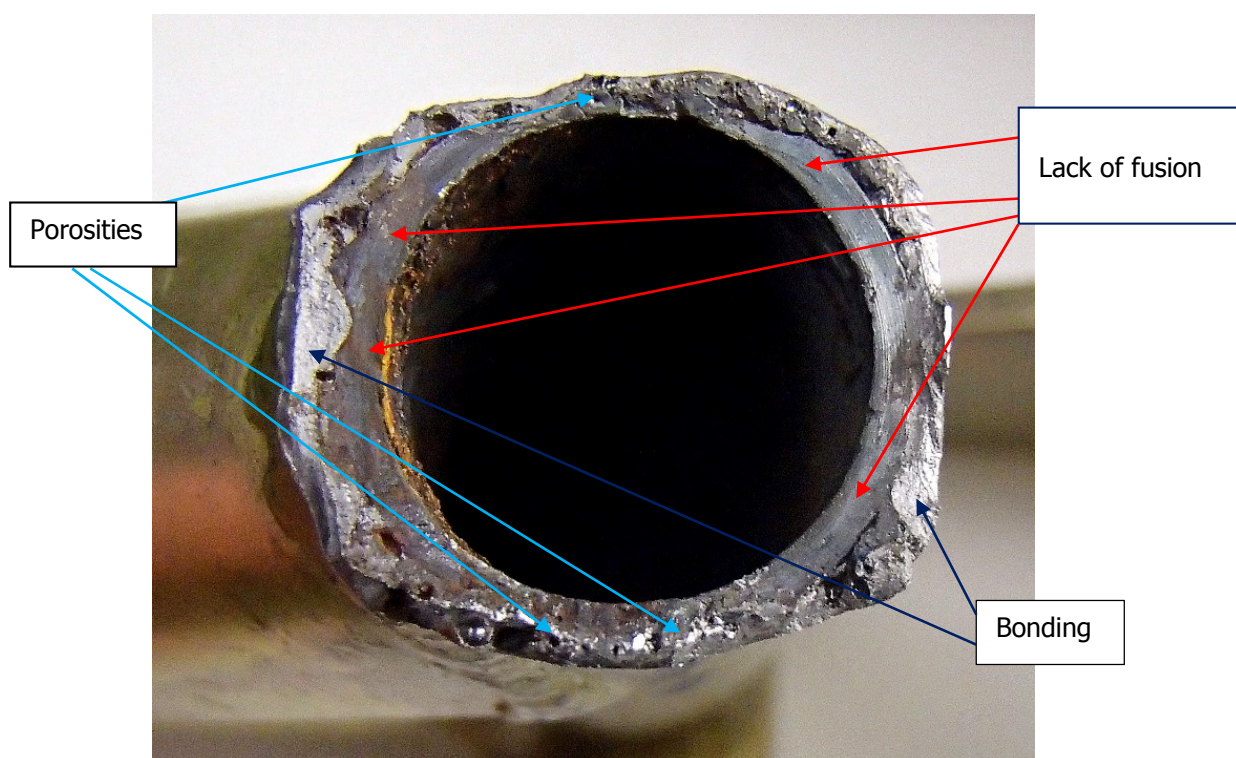
Figure 4 Close up of figure 3. Note bonding is only observed in the light grey areas.

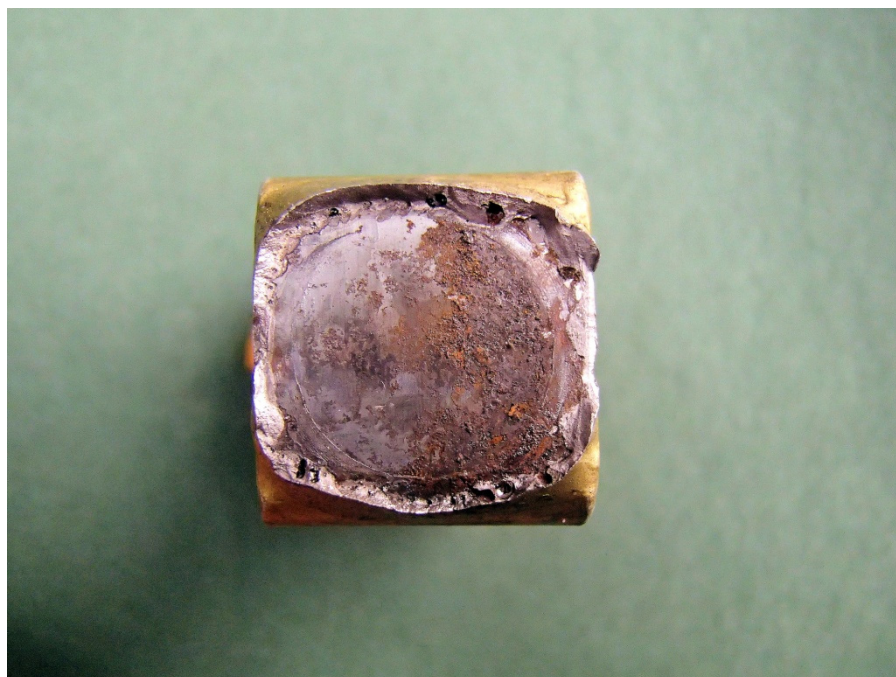
Figure 5 The fracture surface from the opposite side.

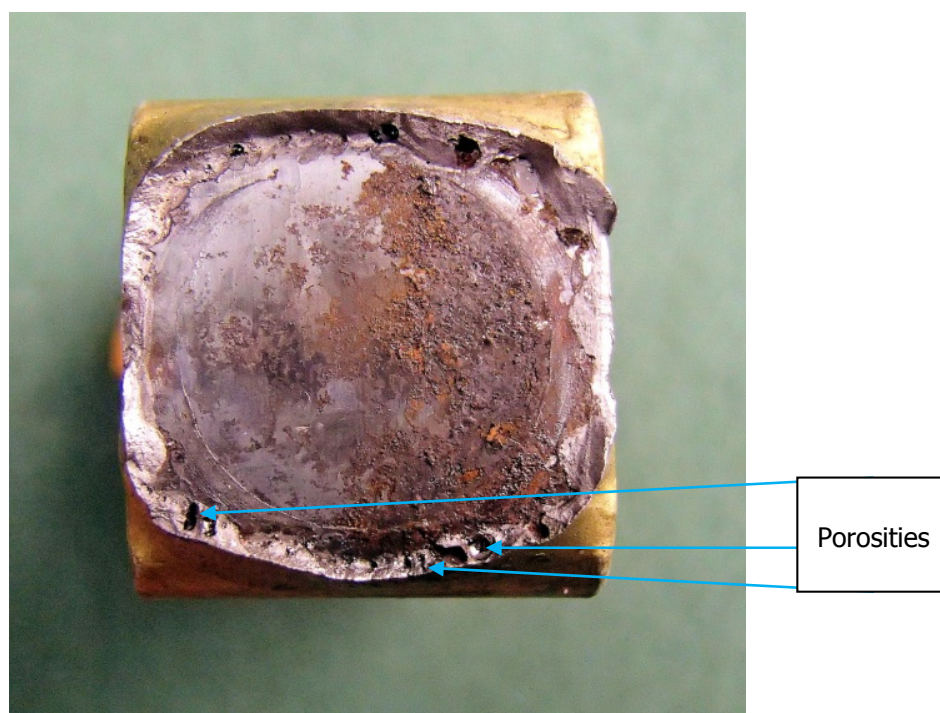
Figure 6 Close up of figure 5.

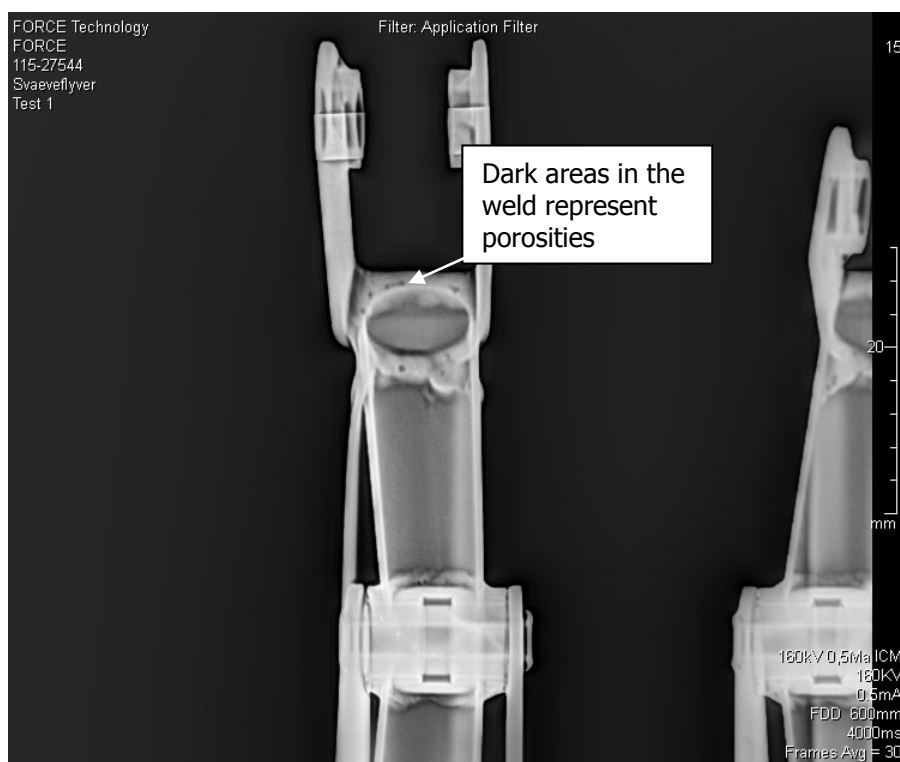
In order to determine the quality of the similarly placed welds on the intact bell crank from the right wing spoiler, digital X-ray testing was performed. The results showed a similarly poor weld

quality with pores measuring up to a diameter of 1.1 mm. Cf. figures 7 – 8, where the dark rounded areas within the weld represent the presence of pores.

Figure 7 Digital X-ray of the red squared area in figure 1.

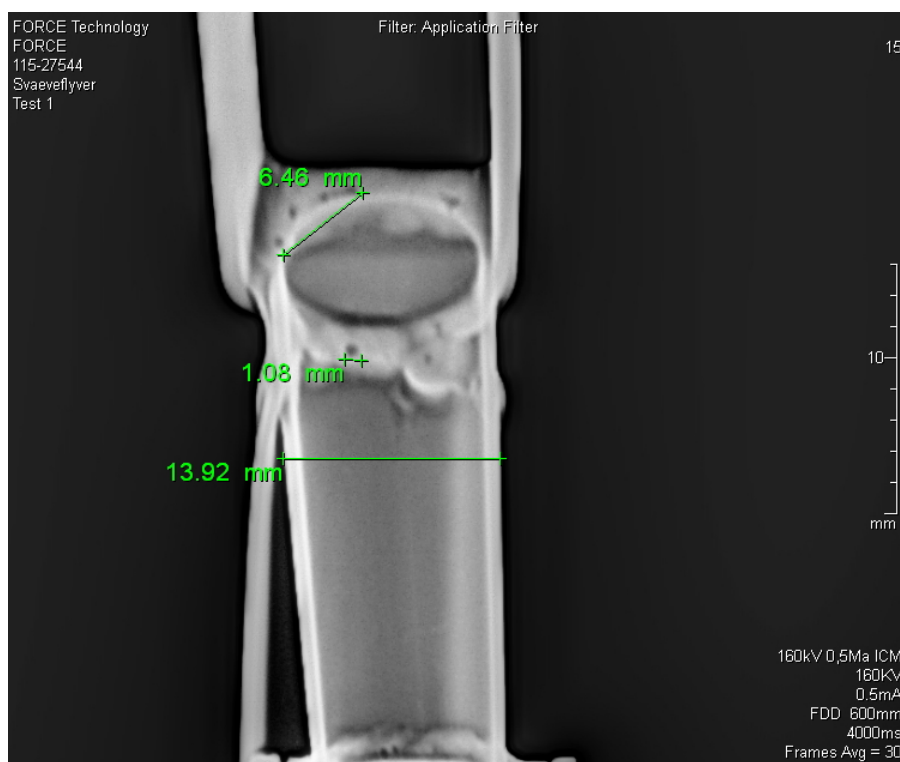
Figure 8 Close up of figure 5.
