Accident Investigation Board Denmark

Summary 2020-307

Summary on accident to D-EQCA (Rockwell Commander 114B) near Fur (EKFU) on 30-8-2020.

ISSUED JANUARY 2021

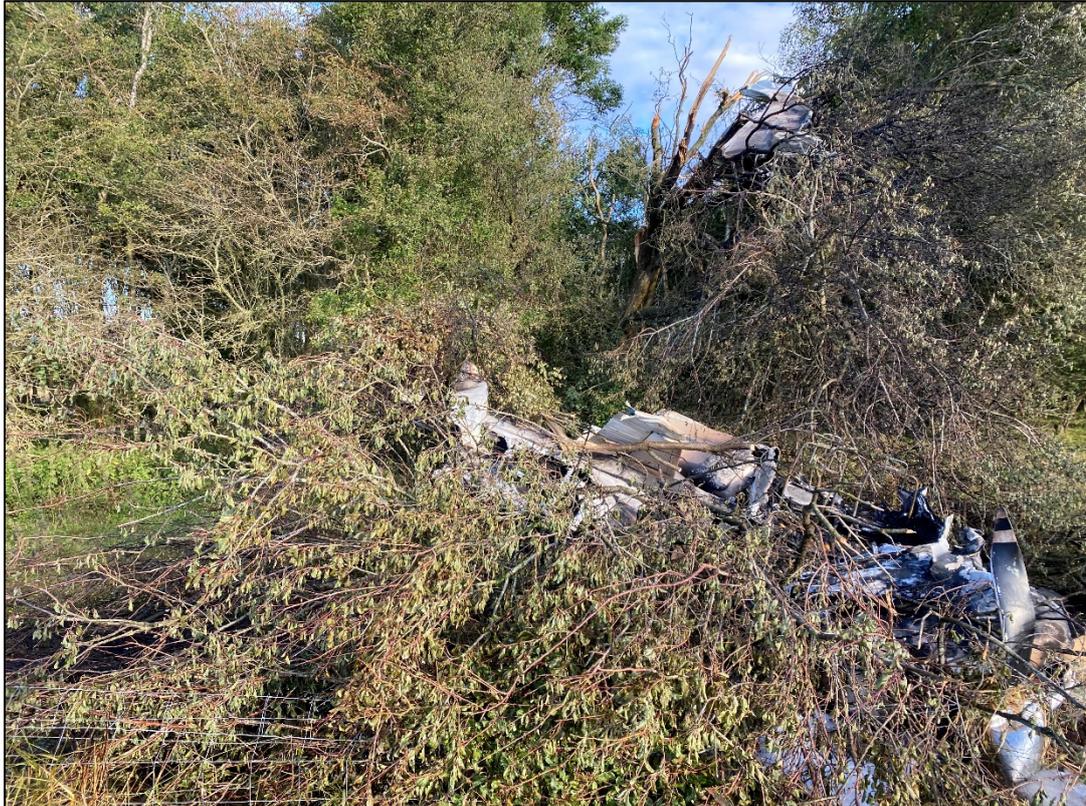
As a consequence of the collision with trees and the post impact fire, the aircraft was destroyed.

Photo no 1 - The wreckage site.

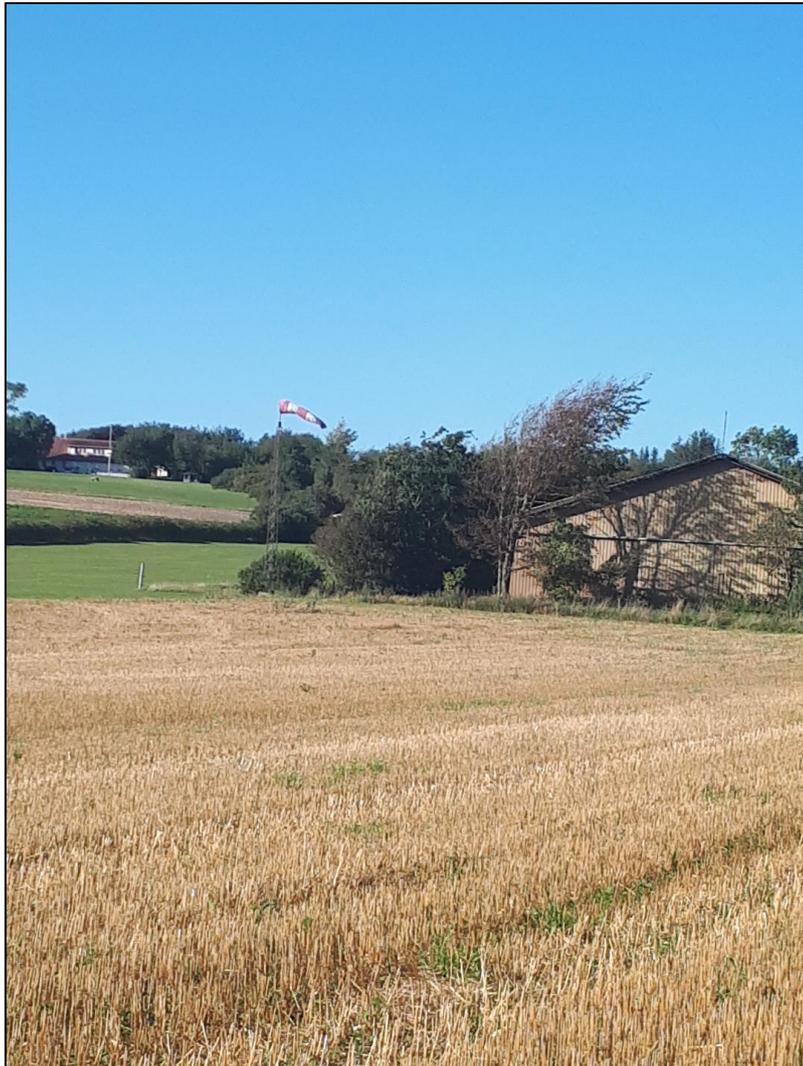
Photo no 2 - The airstrip wind sock.

13. There were no formalized requirements to the wind sock at EKFU.
14. The dimensions of the wind sock at EKFU deviated from the regulation for CAA VMC approved aerodromes.

15. The deviation might have prevented pilots from making an objective evaluation of wind direction and wind speeds at EKFU.
16. AIB calculations of ground roll and take-off distances (calm wind) for both runway 12 or runway 30 revealed marginal operations for this aircraft type.

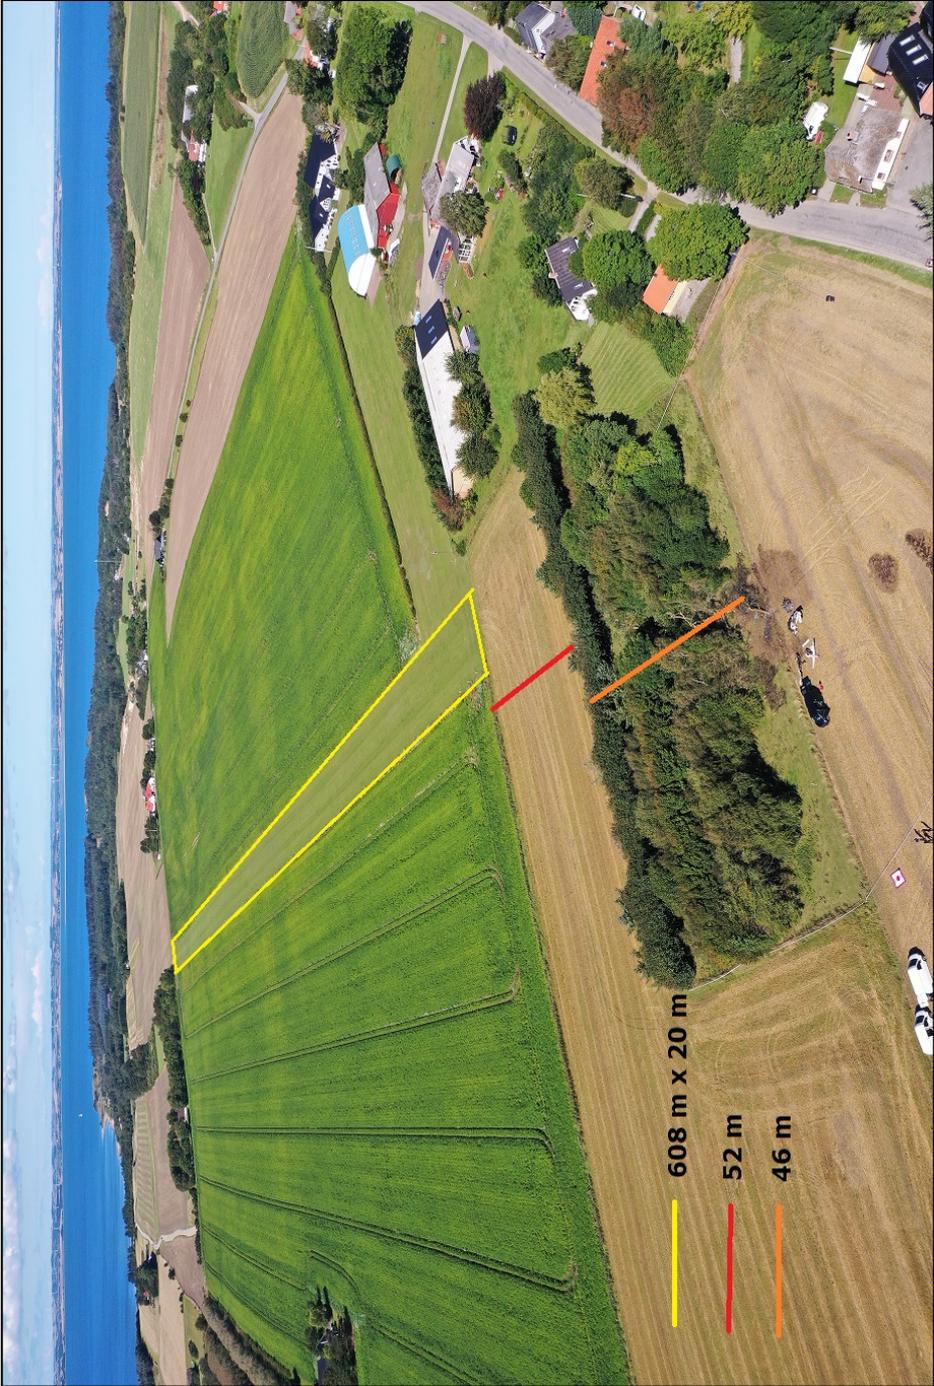
Appendix 3

A drone photo containing AIB measured distances - [see appendix 3](#).

Note. The drone photo is not to scale.

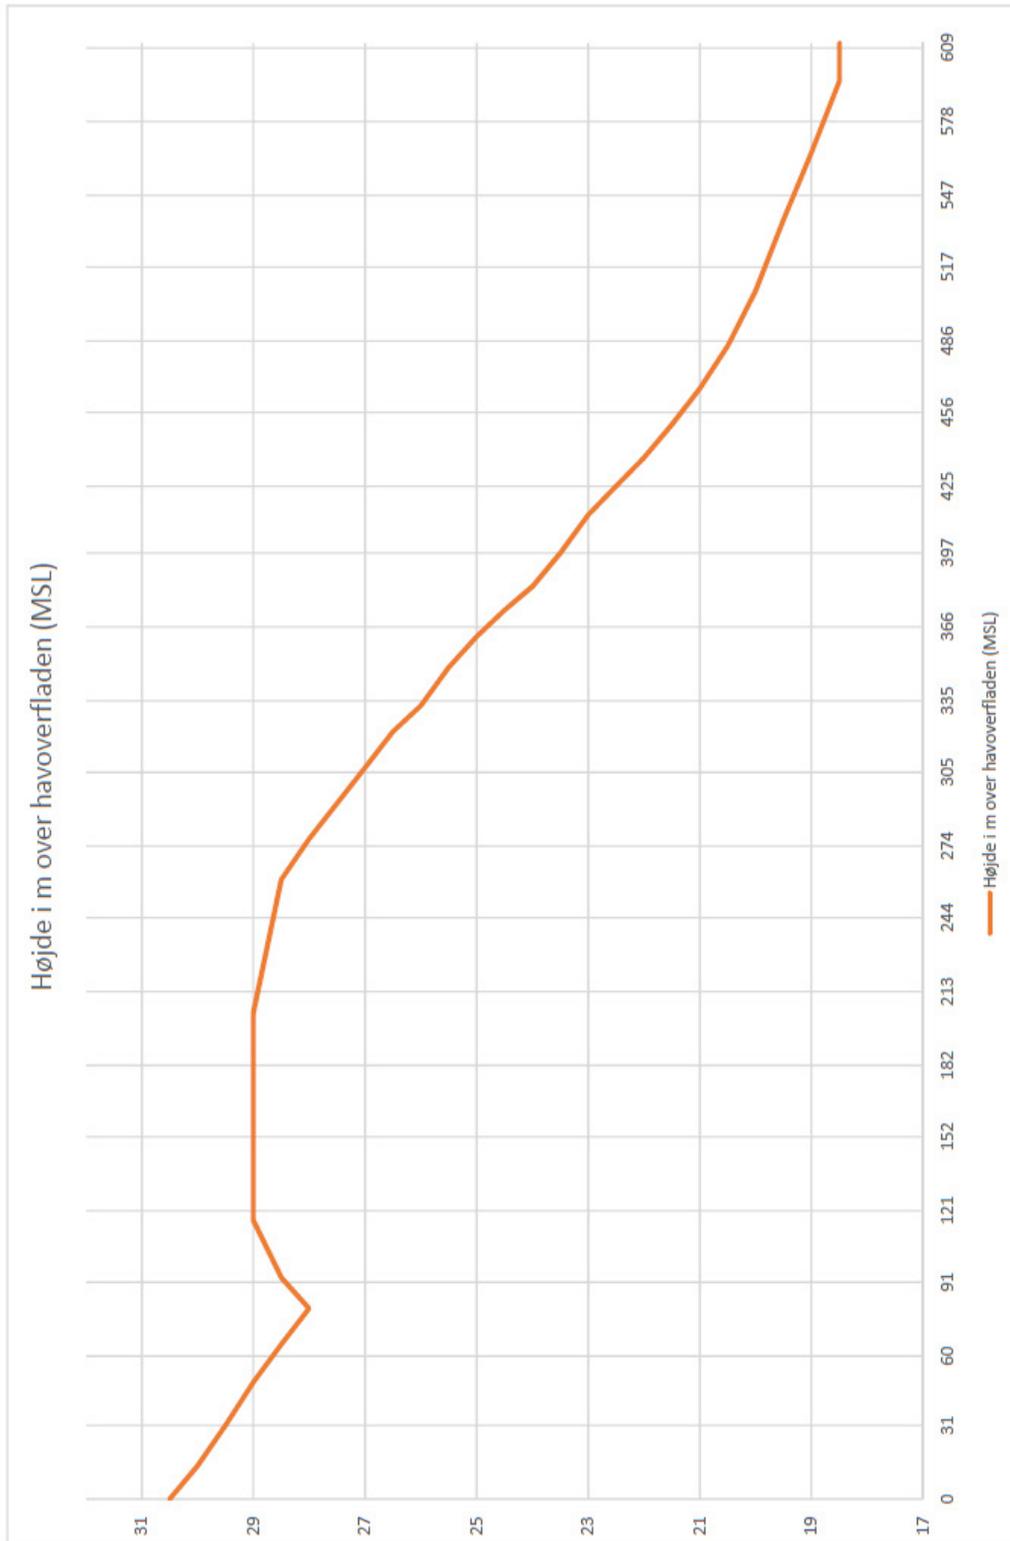
Downslope of runway 12

Note. The graphic illustration is not to scale.

9. The pilot was aware of presented obstacles.
10. During landing on runway 30 in the morning, the pilot was surprised of the degree of the runway upslope.
