**Summary 2021-170**

**Accident to OY-TFX (Grob G102 Club Astir III b) at Toelloese (EKTO) on 29-5-2021.**

**ISSUED OCTOBER 2021**

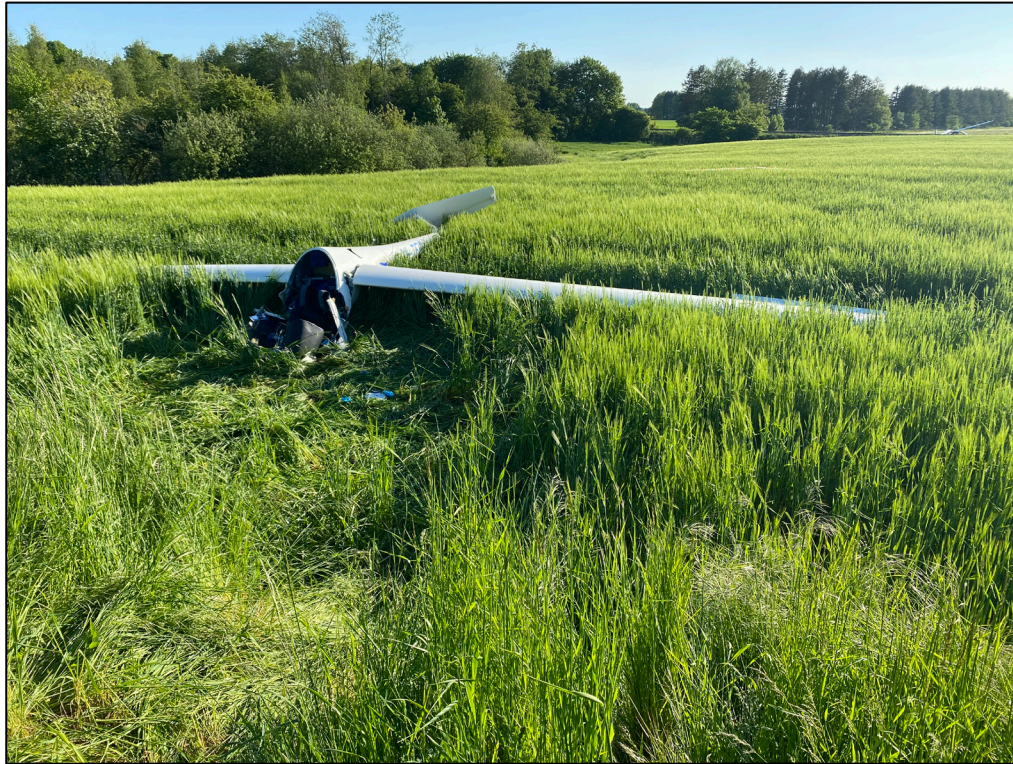
The ground impact destroyed the glider.

Photo 1. The wreckage in the farm field.

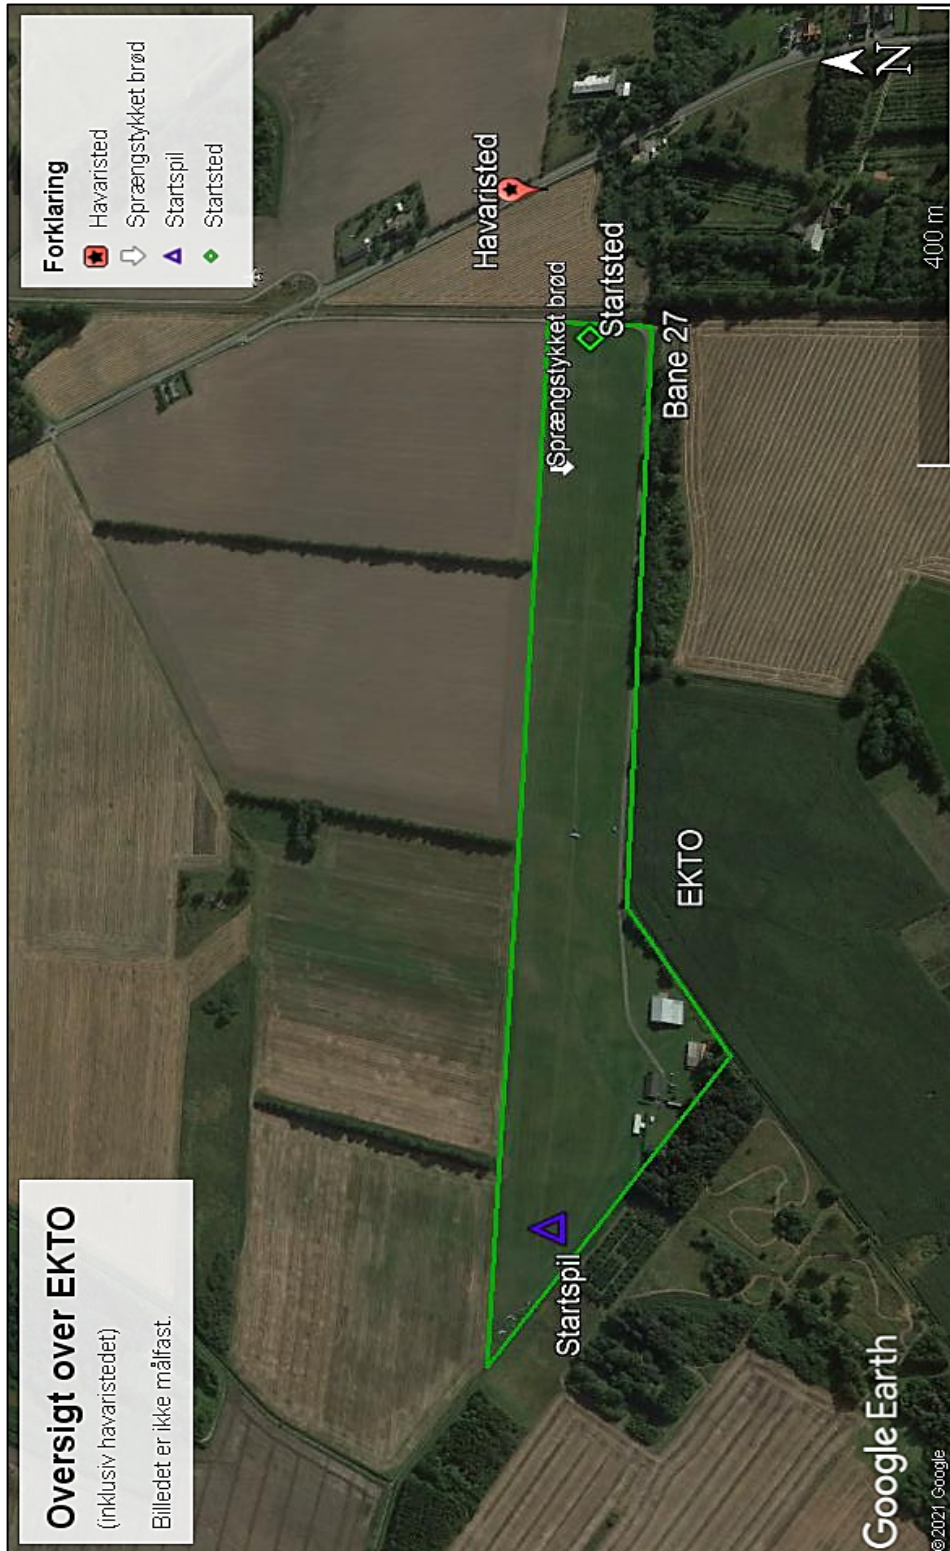
Appendix 2

[See appendix 2](#) (notes are in Danish).
