**Havarikommisjonen**  
Accident Investigation Board Denmark

**Bulletin 2023-271**

**Accident to D-EIRX (Reims F 172P) on Fur (EKFU) on 24-4-2023.**

**ISSUED AUGUST 2023**

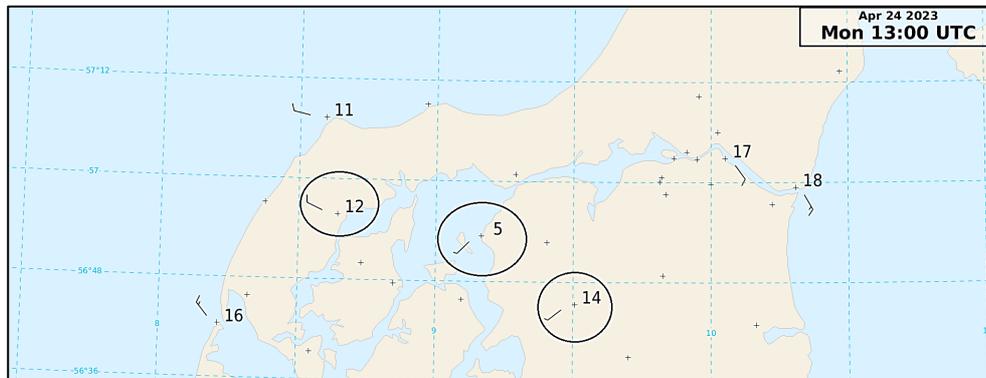
Figure 5. Observations of surface mean wind (wind barbs) and maximum wind "gusts" (black numbers).

Silstrup: 12:30 hrs 167° 12 gusting 18 kt.  
 (Approximately 25 km northwest of the island of Fur) 12:40 hrs 174° 11 gusting 14 kt.  
 Note. Auto-SYNOP. 12:50 hrs 180° 9 kt gusting 14 kt.  
 13:00 hrs 232° 6 kt gusting 14 kt.  
 13:10 hrs 240° 3 kt gusting 6 kt.

However, nearby showers could cause wind gusts. At exactly 13:00 hrs, a small shower passed the island of Fur and there were other showers in the area. Therefore, the wind at EKFU might have been more variable and maybe gusting up to approximately 20-25 kt. However, the showers in the area did not seem to be very intense and probably did not cause that much wind gust. The strongest wind gust measured in the area was 18 kt at Aars Syd (southeast of the island of Fur) at 12:30 hrs.
