# **BULLETIN**

**Serious incident**

**14-12-2017**

**PIPER PA46 350P JetProp DLX**

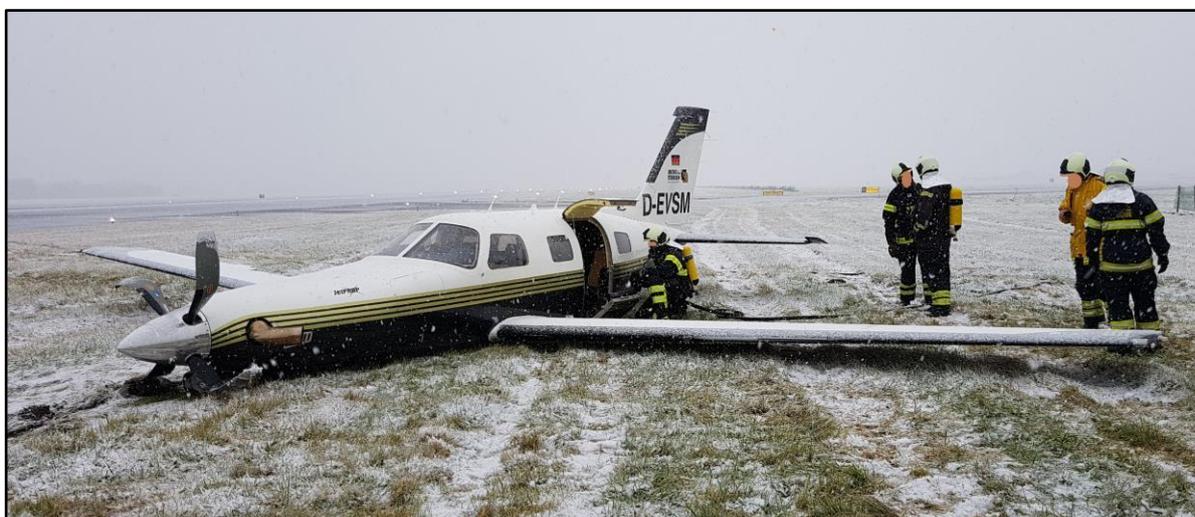
Within few minutes upon landing, EKYT RFFS examined the aircraft with a thermal camera.

According to the RFFS, no smell of burned material was present in the aircraft. A very faint smell of electrical fumes was present in the aircraft.

No trace of fire or burned material was found in the aircraft. The highest temperature recorded by the thermal camera was 45-46° C (radio stack).
