**Havarikommisjonen**  
Accident Investigation Board Denmark

# **BULLETIN**

**Serious incident**

**BOEING MD-82**

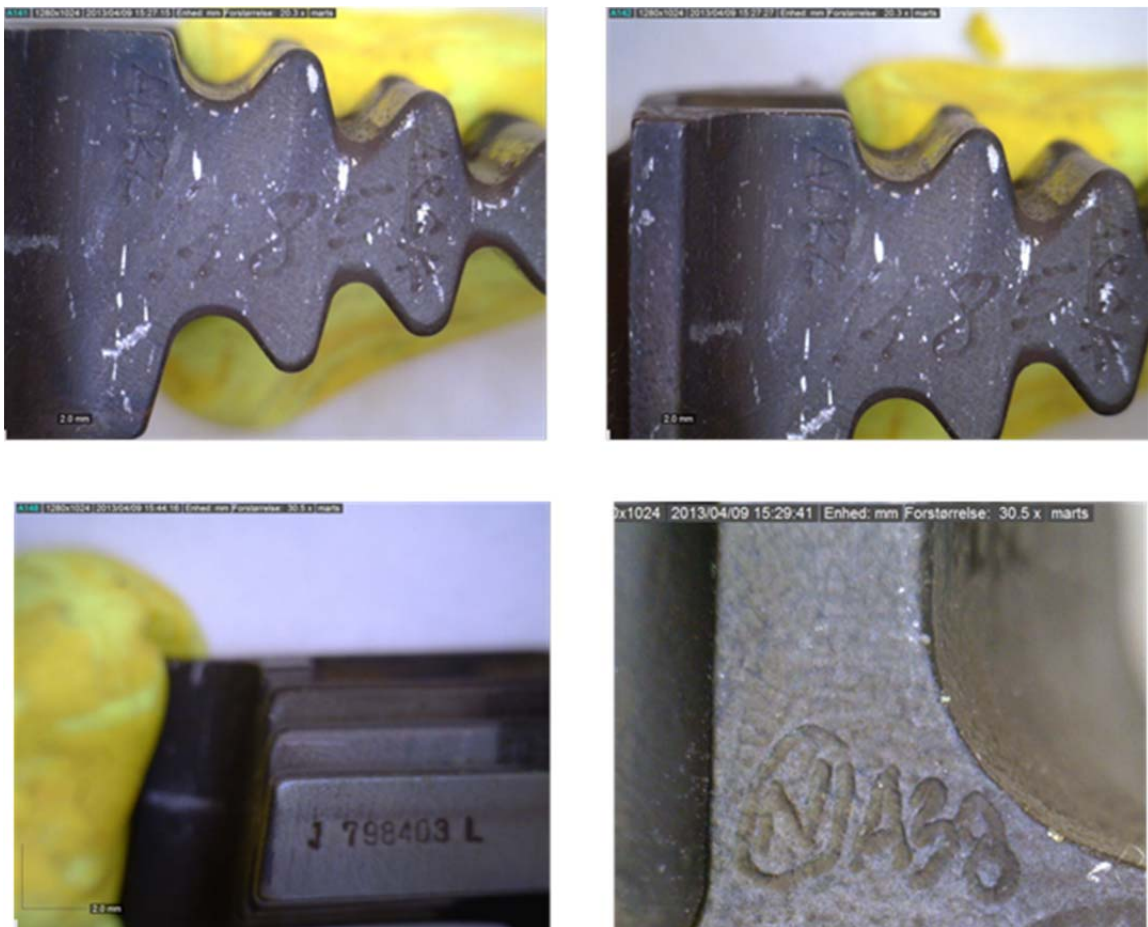
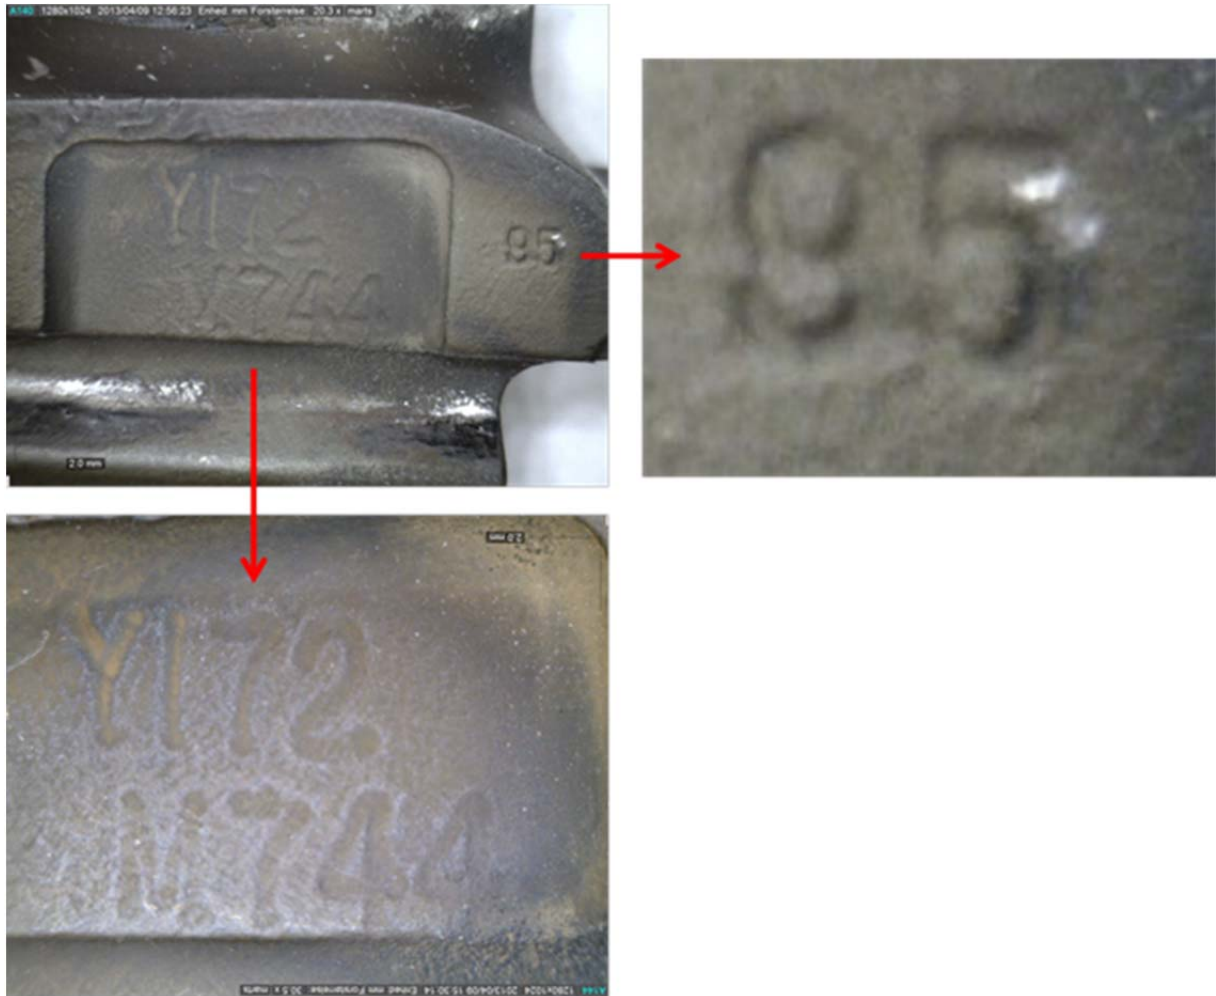
Fig. 20

Almost all 3<sup>rd</sup> stage LPT blades had unique markings. The marking on the suspected blade number one is shown in figures 20 and 21.

*The markings "Y 172" & "M 744" (blade No. 1), "J 625" & "T 397" (blade No. 2), and "T 347" & "G 697" (blade No. 88) are in areas of the blades designated for Heat Code and X-Ray Film marking, per figure 22.*

The “1185”, “ARGK”, and “AORZ” markings are in the area of the blade designated for Service Time Marking per figure 22. The overhaul records should be reviewed to determine if the “1185” is related to service time on this blade.

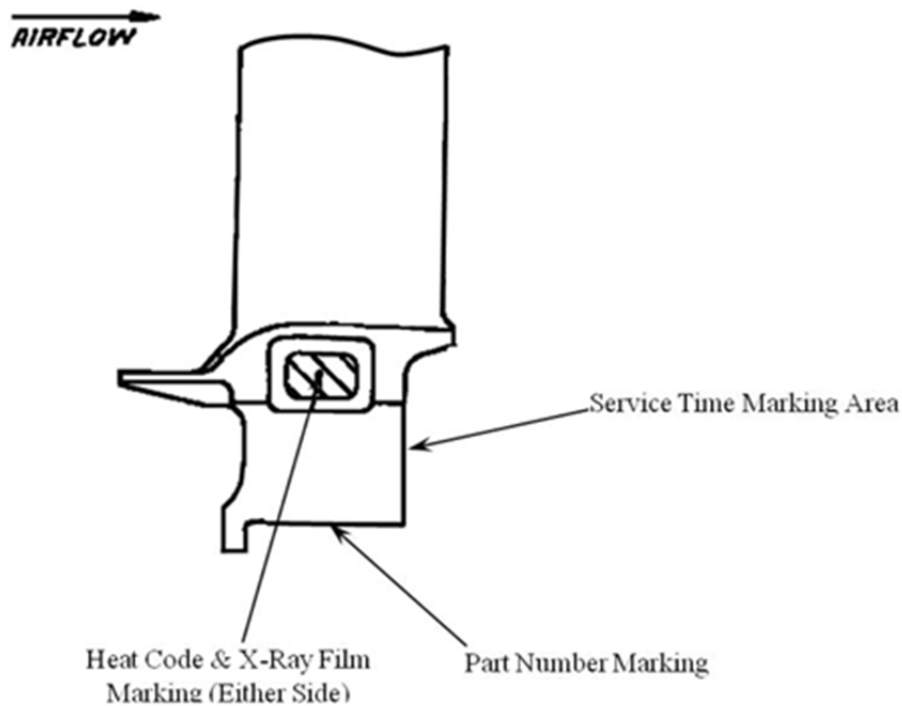
Fig. 22

*The 3<sup>rd</sup> stage blade includes multiple areas designated for marking information with respect to this part. A figure 22 provides a diagram for the markings in the areas of interest on this blade.*

Figure 22 is an excerpt from the part detail drawing utilized at Original Equipment Manufacturer (OEM). There are other opportunities in the life of a blade where markings could be applied that are not specified on the part detail drawing, including at the time the casting from which the finished part is produced, during the inspection process, and during overhaul.
