REPORT

HCLJ510-2012-96	Serious incident	
Aircraft:	SAAB 2000	Registration: SE-LOM
Engines:	2 - Allison AE 2100A	Flight: Scheduled, IFR
Crew:	3 - no injuries	Passengers: 47 – no injuries
Place:	Copenhagen Airport, Kastrup (EKCH)	Date og time: 20.3.2012 at 06:10 UTC

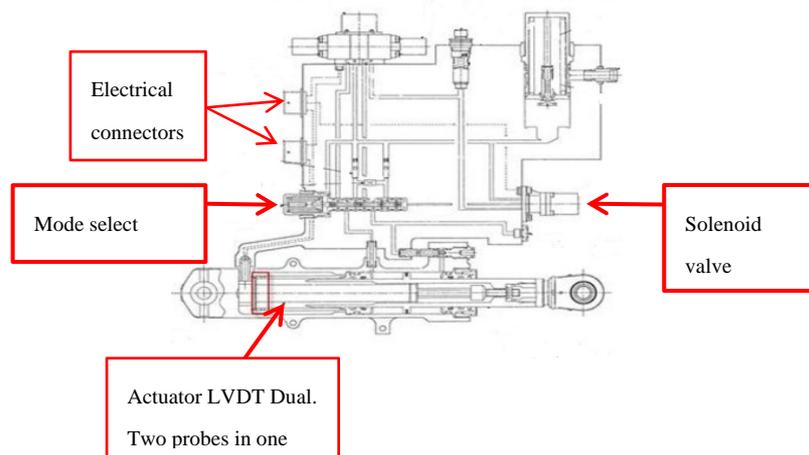
Inboard elevator servo P/N 7U7852-1, Serial no. 0188

Visual external inspection of the unit revealed no obvious damage. All hydraulic ports and electrical ports, with the exception of the hydraulic return port were observed sealed with caps.

No mechanical malfunction or anomalies were noted which would preclude normal operation.

The unit was subsequently partially disassembled in order to gain access to the LVDT assembly. The piston rod end was removed, revealing the LVDT cavity the two cylindrical ferromagnetic core probes. Both probes exhibited curling damage at their bases. The LVDT cavity and both probes were clean, and free of contaminants.

Examination of the LVDT case revealed that both probe coil sleeves had become displaced about 3 mm longitudinally, and broken out of their potting compound.

Furthermore, the LVDT probes were found bended in the LVDT cavity where the coils were placed. The bending of a probe would not necessarily degrade the elevator function.
