Final Report

HCLJ510-2012-148

Serious incident to Eurocopter AS350 B3
Registration OY-HUB
At Nyhavn, Mestersvig, Greenland
On 25 August 2012

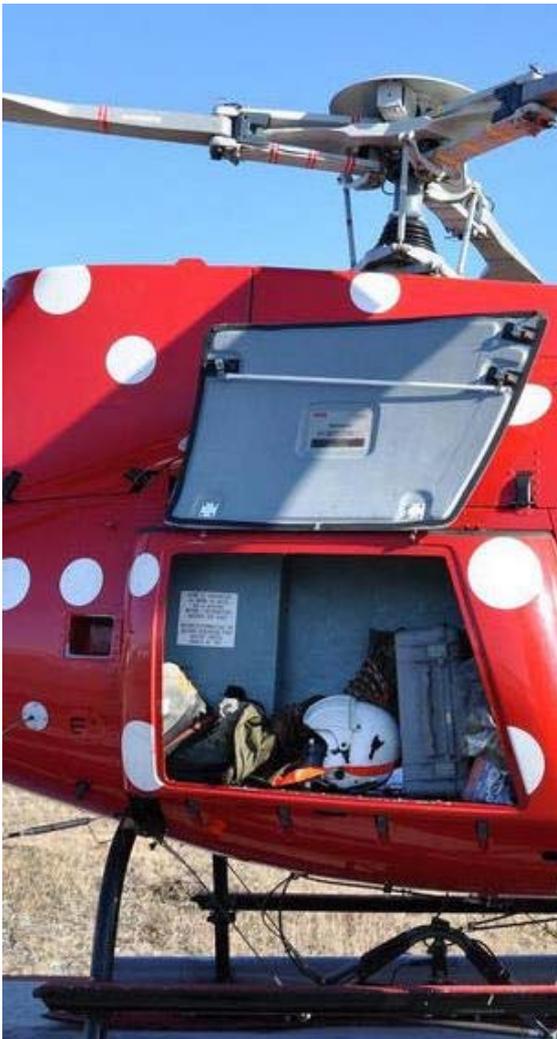
Dart Spacepod – upward opening door – installation.

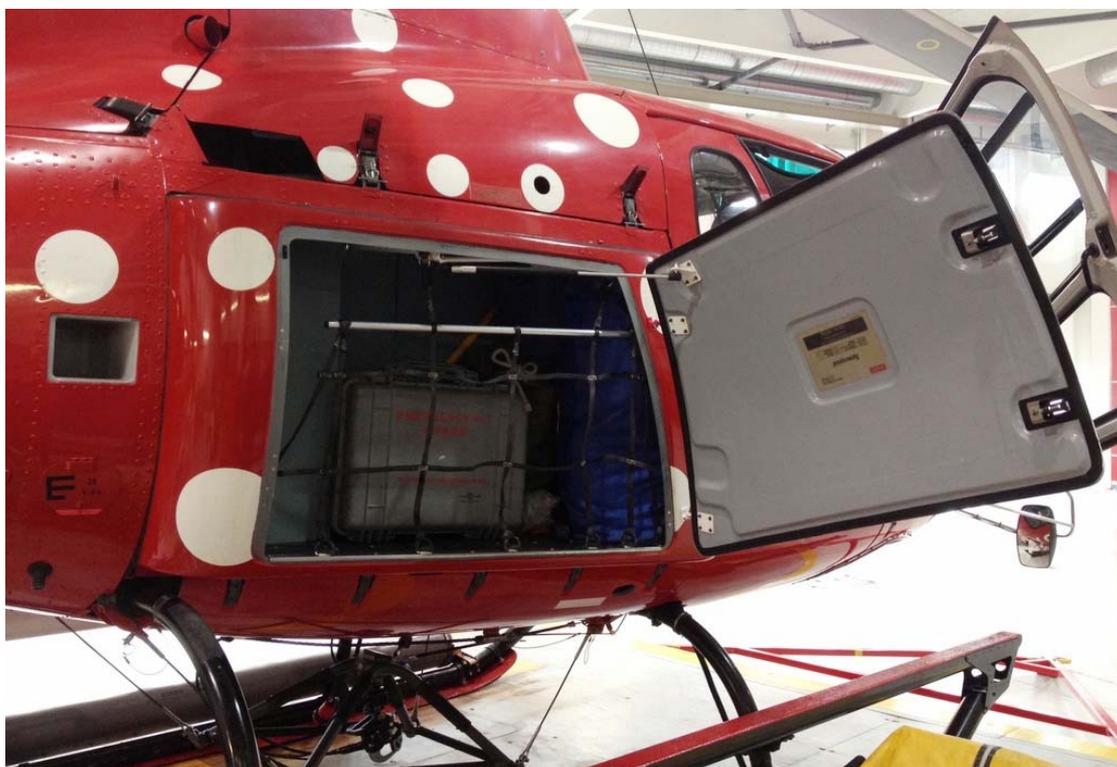
The operator was of the opinion, that the forward opening door type if opening in flight would stay closed as a result of the airflow force during forward flight.

All helicopters in the fleet except OY-HUB was modified before the year 2012 season. The installation was modified to the forward opening door type as shown on the picture below.

The AIB-DK is of the opinion that forward opening Spacepod doors will not completely reduce the risks of foreign object damage.
