Accident Investigation Board Denmark

Bulletin 2021-120

Serious incident to OY-JEC (Piper PA28-161 Cadet) at Roskilde (EKRK) on 8-4-2021.

ISSUED SEPTEMBER 2021

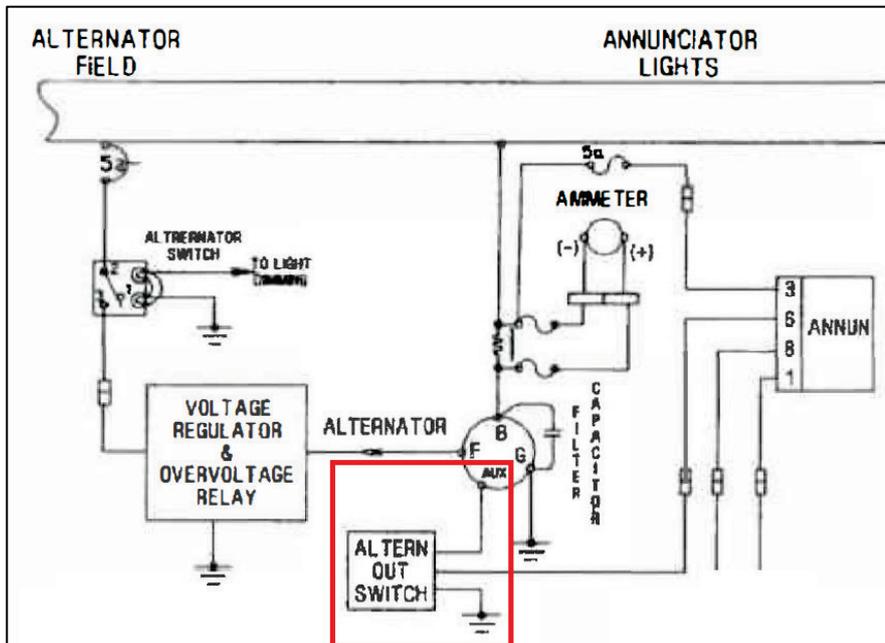
Figure no. 1: POH Figure 7-11 “Alternator and starter schematic” (extract of figure)

The electrical system includes a 14-volt, 60-amp alternator, a 12-volt battery, a voltage regulator, and a master switch relay (Figure 7-11). The battery is in a box mounted on the forward right face of the firewall. The voltage regulator is located on the forward left side of the fuselage behind the instrument panel.
