# **Final Report No. 2342**

Concerning the serious incident involving  
the SAAB 2000 aircraft, HB-IZW, operated  
by Etihad Regional/Darwin Airline under  
flight number AB 8054,

on 10 December 2015

4.5 NM east of Billund Airport (EKBI),  
Denmark

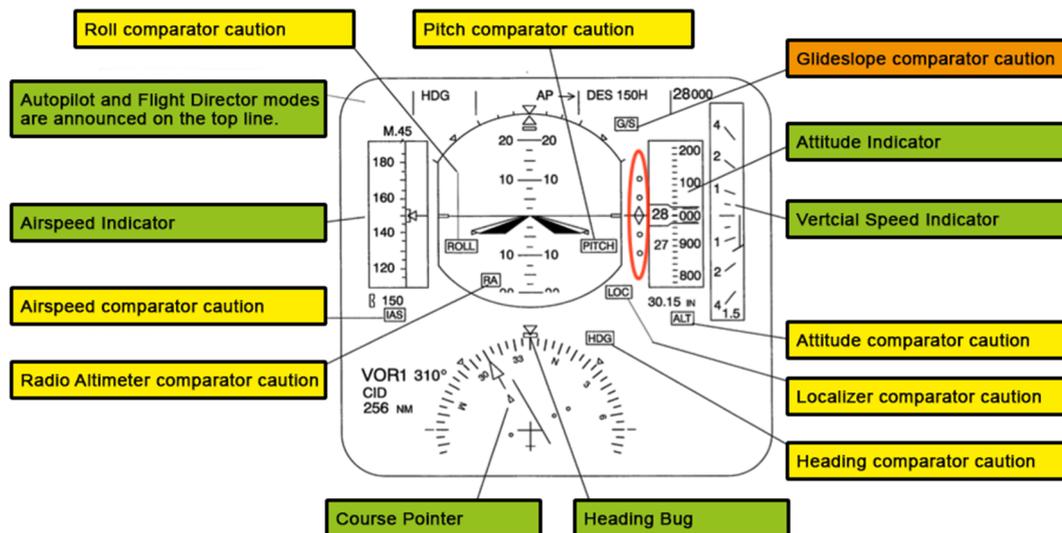
For redundancy reasons, large parts of the avionic system are provided twice. The EFIS receives data from these duplicate systems and compares most of the data for discrepancies. If there are differences between these data, the crew is warned through appropriate notifications (see illustration 4). In this investigated incident, the discrepancies of the glideslope indicators caused by the fluctuation of the glideslope signal during the first approach led to a glideslope comparator caution warning being displayed on the PFD.

**Illustration 4:** The PFD with various indicators (green boxes), possible warnings regarding a discrepancy between the redundant systems (yellow boxes) and the above-mentioned warning regarding the glideslope (orange box).

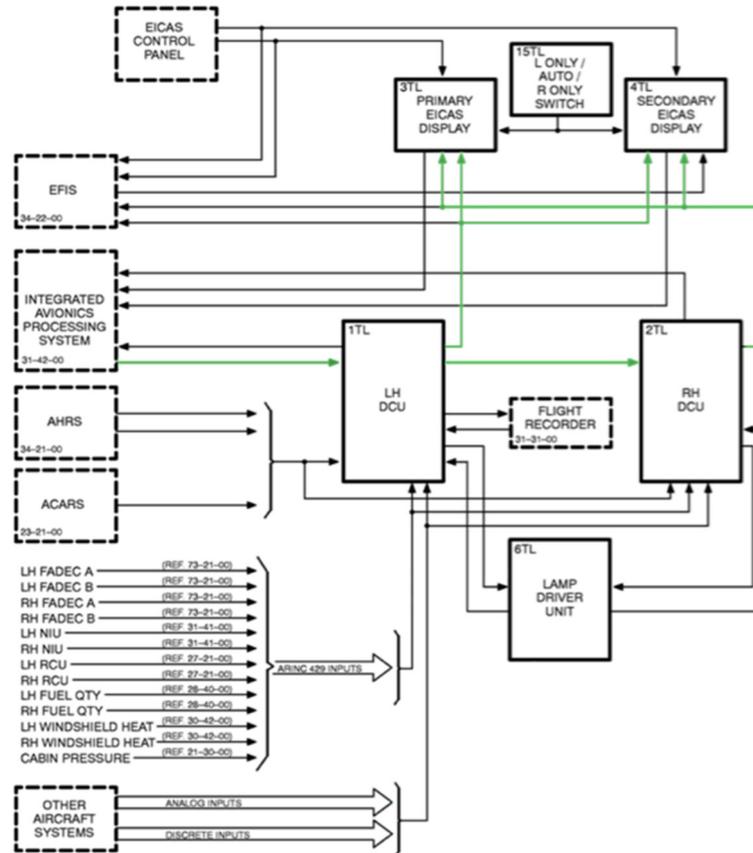
The DCUs are connected to the ILS receiver via the integrated avionics processing system (IAPS), which collects and checks data from various systems (see illustration 5).

**Illustration 5:** The glideslope signal's data flow (green arrows) from the IAPS via the DCUs to the primary EICAS display.
