**Havarikommisjonen**  
Accident Investigation Board Denmark

# **BULLETIN**

**SCHEMPP HIRTH (Arcus T)**

**OY-XJT**

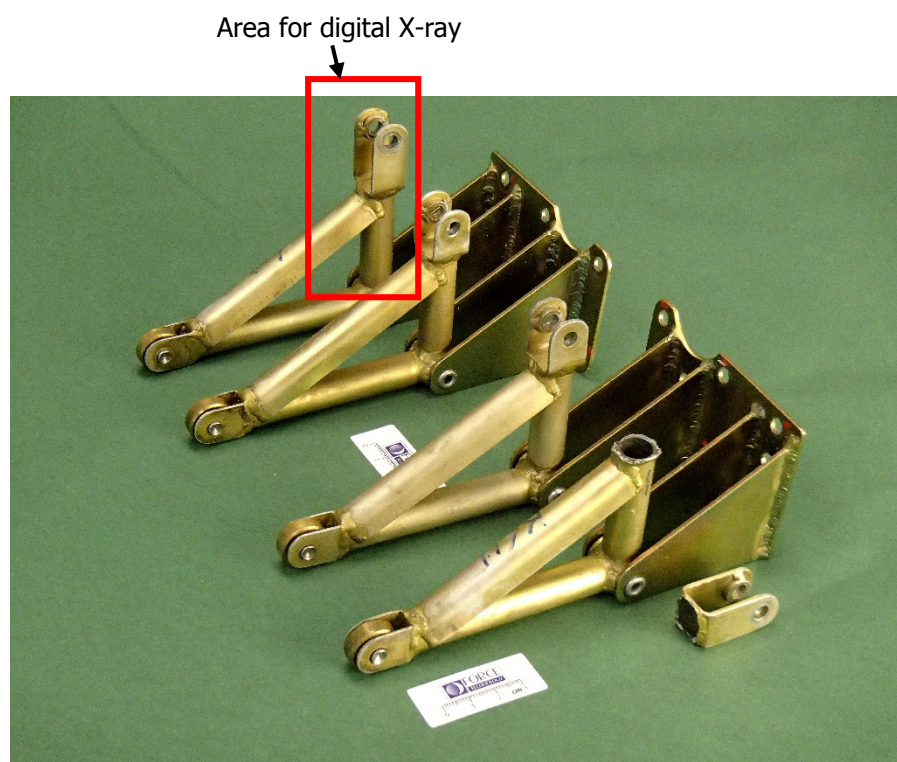
Figure 1 The two bell cranks from aircraft OY-XJT as received.

The fractured surface was examined using stereomicroscopy. The fracture appeared in the welding section between the tube and the mounting fitting. The quality of the weld is considerably poor, leaving large areas lacking fusion, as well as the presence of cold runs and areas with notable porosity. The bonded area is less than 10 %. Cf. figures 3 - 6.

The observed fracture in the left wing bell crank was caused by the grossly unsatisfactory weld quality.

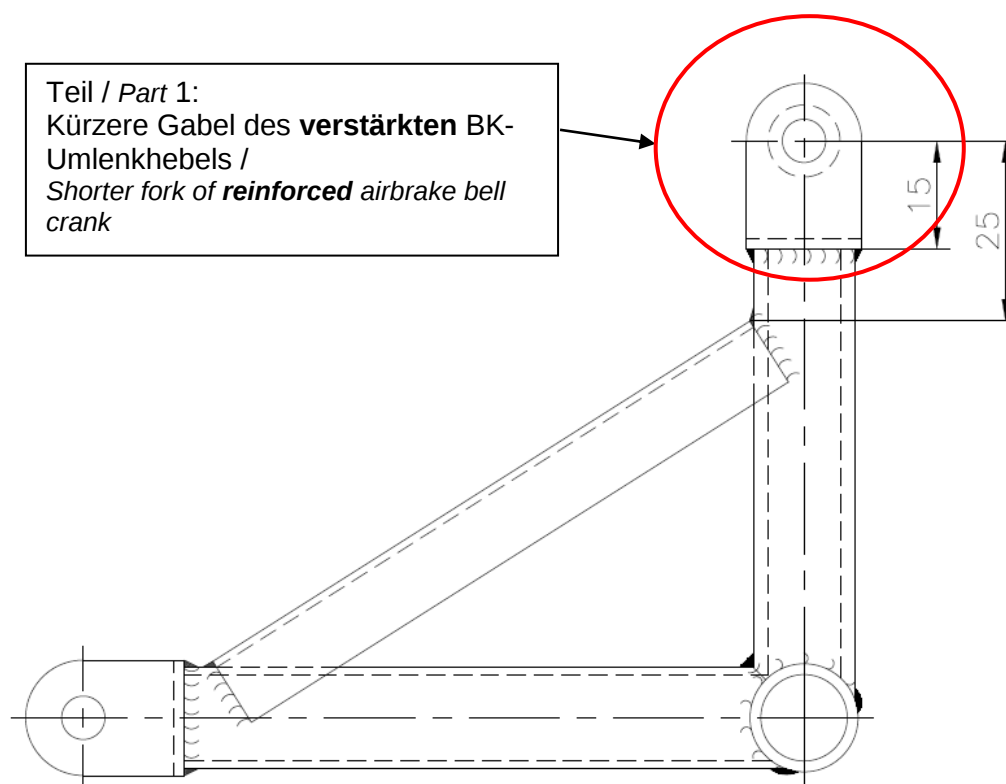
**Bild 1: Verstärkte Version des BK-Umlenkhebels nach HS11-50.016 ab Revision a**  
**Picture 1: Reinforced version of airbrake bell crank according to HS 11-50.016, Revision a or later**

*The reinforced version of the airbrake bell crank can be recognized on the shorter fork (part 1). If the distance between the hole center and the bottom of the for is 15 mm long, the airbrake bell crank has not to be replaced and the actions 2 and 3 are obsolete.*

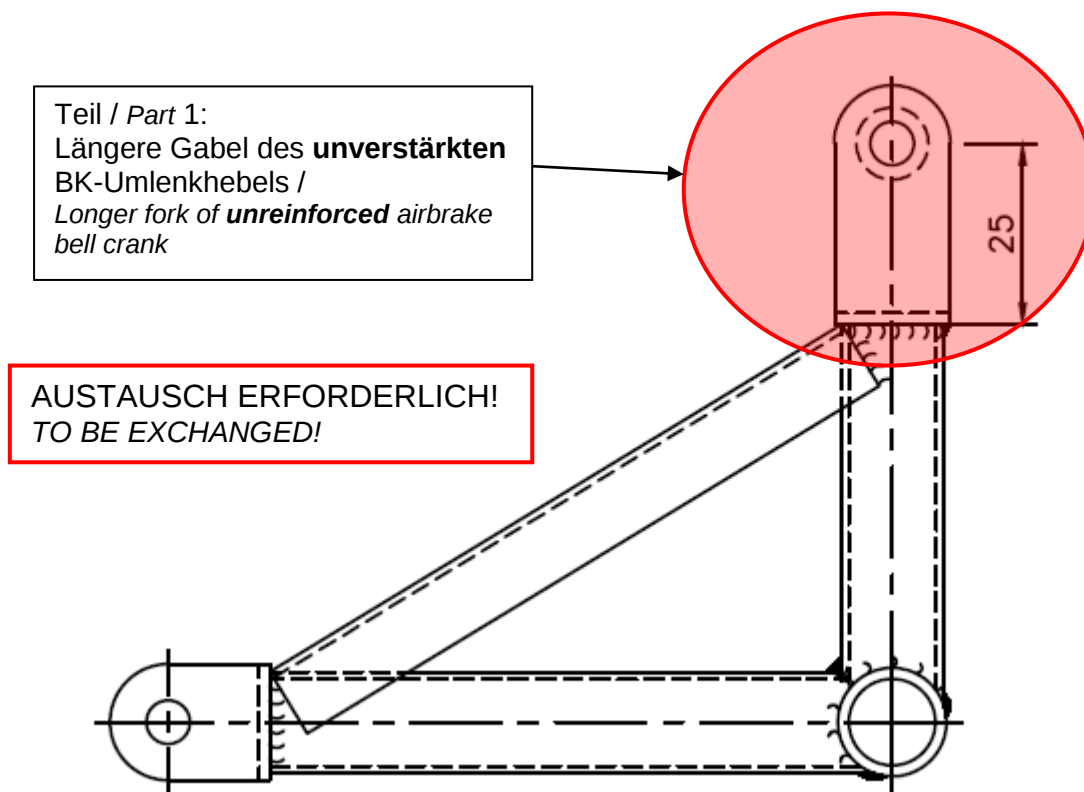
Bild 2: Unverstärkte Version des BK-Umlenkhebels  
 Picture 2: Unreinforced version of airbrake bell crank

Beträgt der Abstand dagegen 25 mm so ist der BK-Umlenkhebel durch die verstärkte Version zu ersetzen. Nach Durchführung der Maßnahmen 2a) und 2b) kann das Flugzeug für 50 Flugstunden weiter betrieben werden. Die Prüfung nach Maßnahme 2a) muß dann alle 50 Flugstunden wiederholt werden, bis Maßnahme 3 durchgeführt wurde.

*If the distance is 25 mm long, the airbrake bell crank has to be replaced by the reinforced version. After implementation of action 2a) and 2b), the aircraft can be operated for 50 operating hours. The inspection according to action 2a) has to be repeated every 50 operating hours until action 3 has been implemented.*

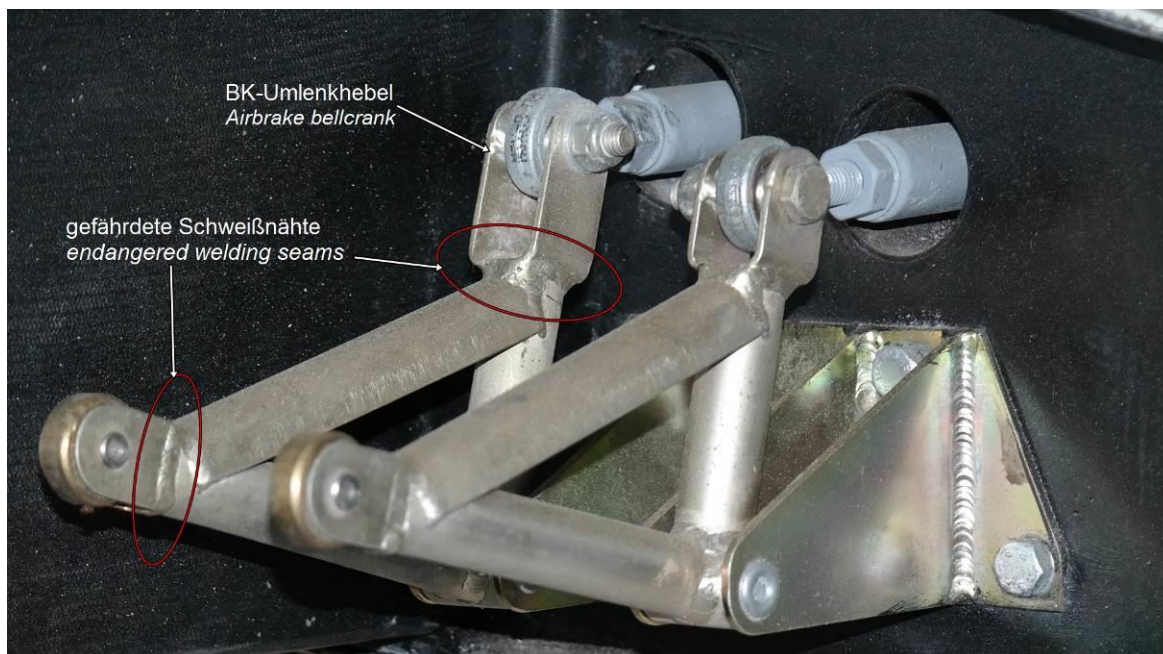
Bild 3 / Picture 3  
 Wurzelrippe beim Arcus (T/M) / Root rib of Arcus (T/M)

*With the wings disassembled check the airbrake bell cranks at the root rib of both wings. Pay special attention to possible cracks and damages at the welding seams. For the control of the airbrake bell cranks use standard magnifiers (at least 3 times magnification) and mirrors:*

*If cracks resp. damages at the Airbrake bellcranks have been found, action 3 has to be conducted before the next take off. If no cracks resp. damages can be found, after the implementation of action 2b) the aircraft can be operated for 50 operating hours before action 2a) has to be repeated resp. until action 3 has been implemented.*

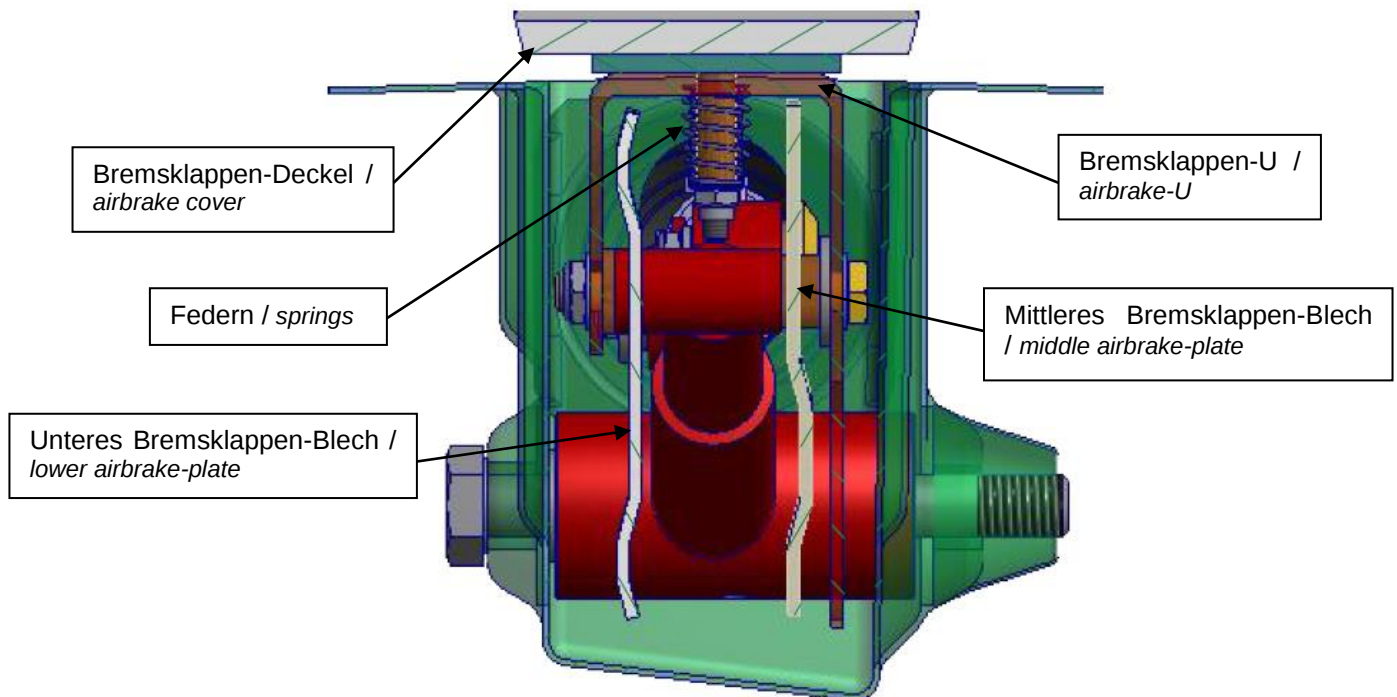
Bild 1: Schnitt in Flugrichtung durch Bremsklappenkasten bei eingefahrener Bremsklappe  
Picture 1: Section in direction of flight through airbrake box with retracted airbrakes

*The biggest load on the airbrake bellcrank at the root rib of the wings occurs when the dead center position is exceeded while retracting the airbrakes. The springs inside the airbrake-U are then compressed by the airbrake cover.*

*The load on the airbrake bellcrank will be too large, if an additional load is added to the forces caused by locking the airbrakes. Additional loads on the airbrake control system may occur, for example, if the locking of the airbrakes is hindered by an obstacle.*
